Bioengineering Demonstration and Education Project - 2019 Monitoring Report

The City of Calgary Riparian Monitoring Program

July 14, 2020

Final report prepared for:
The City of Calgary - Water Resources

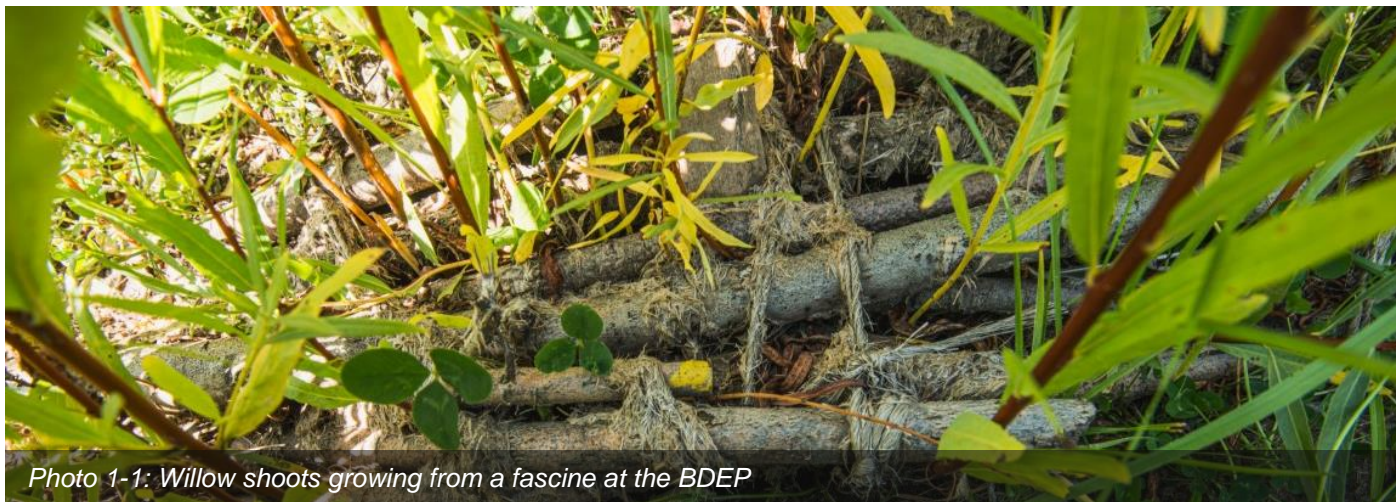
Photo 1-1: Willow shoots growing from a fascine at the BDEP

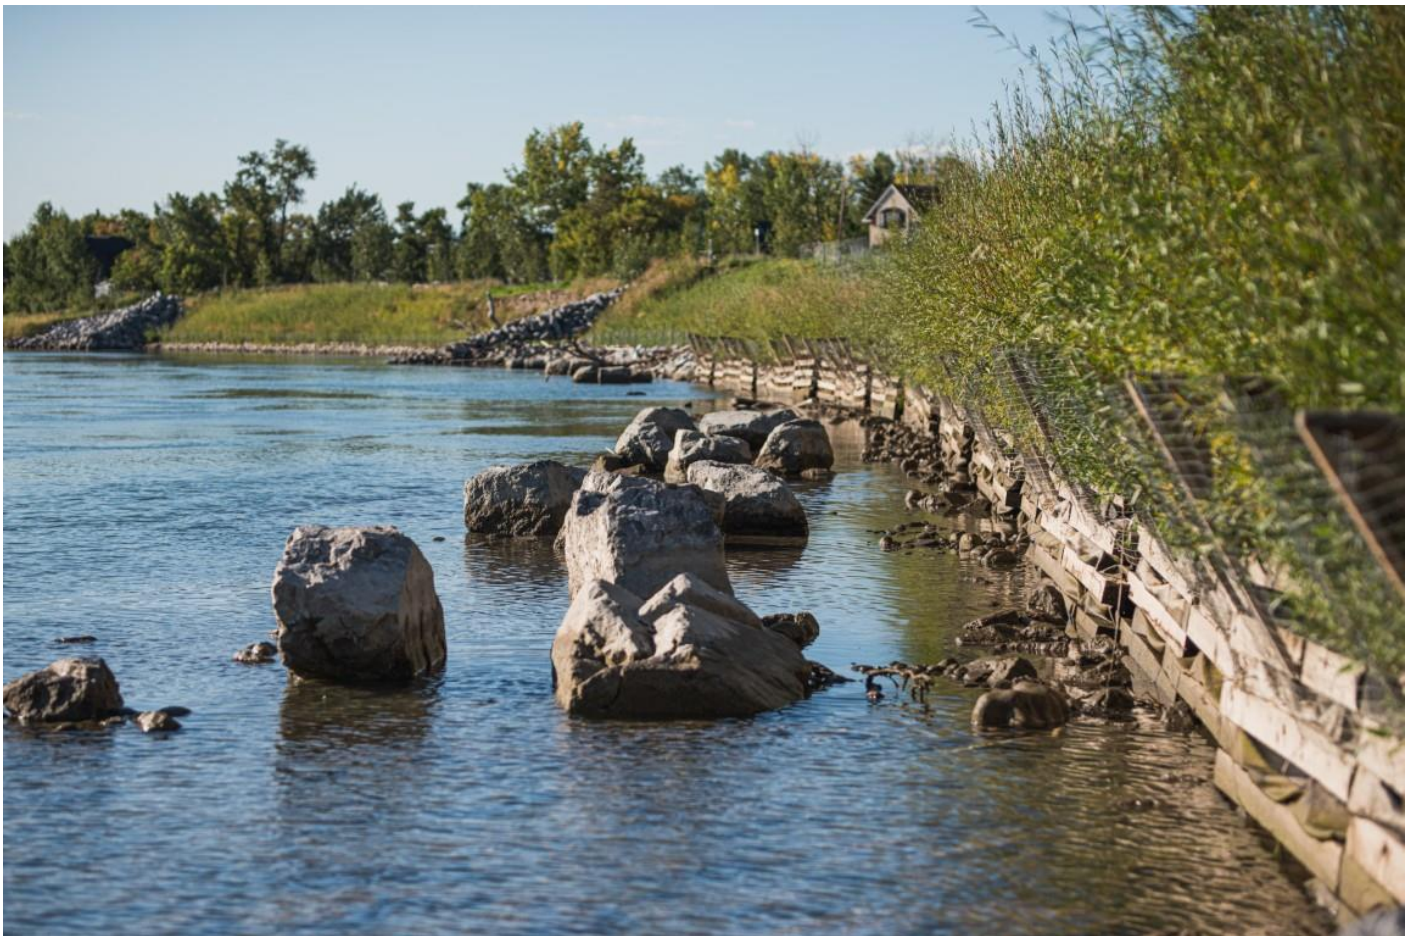
Photo 2-1: Timber crib wall and fish habitat enhancement boulders at Site 1-3.

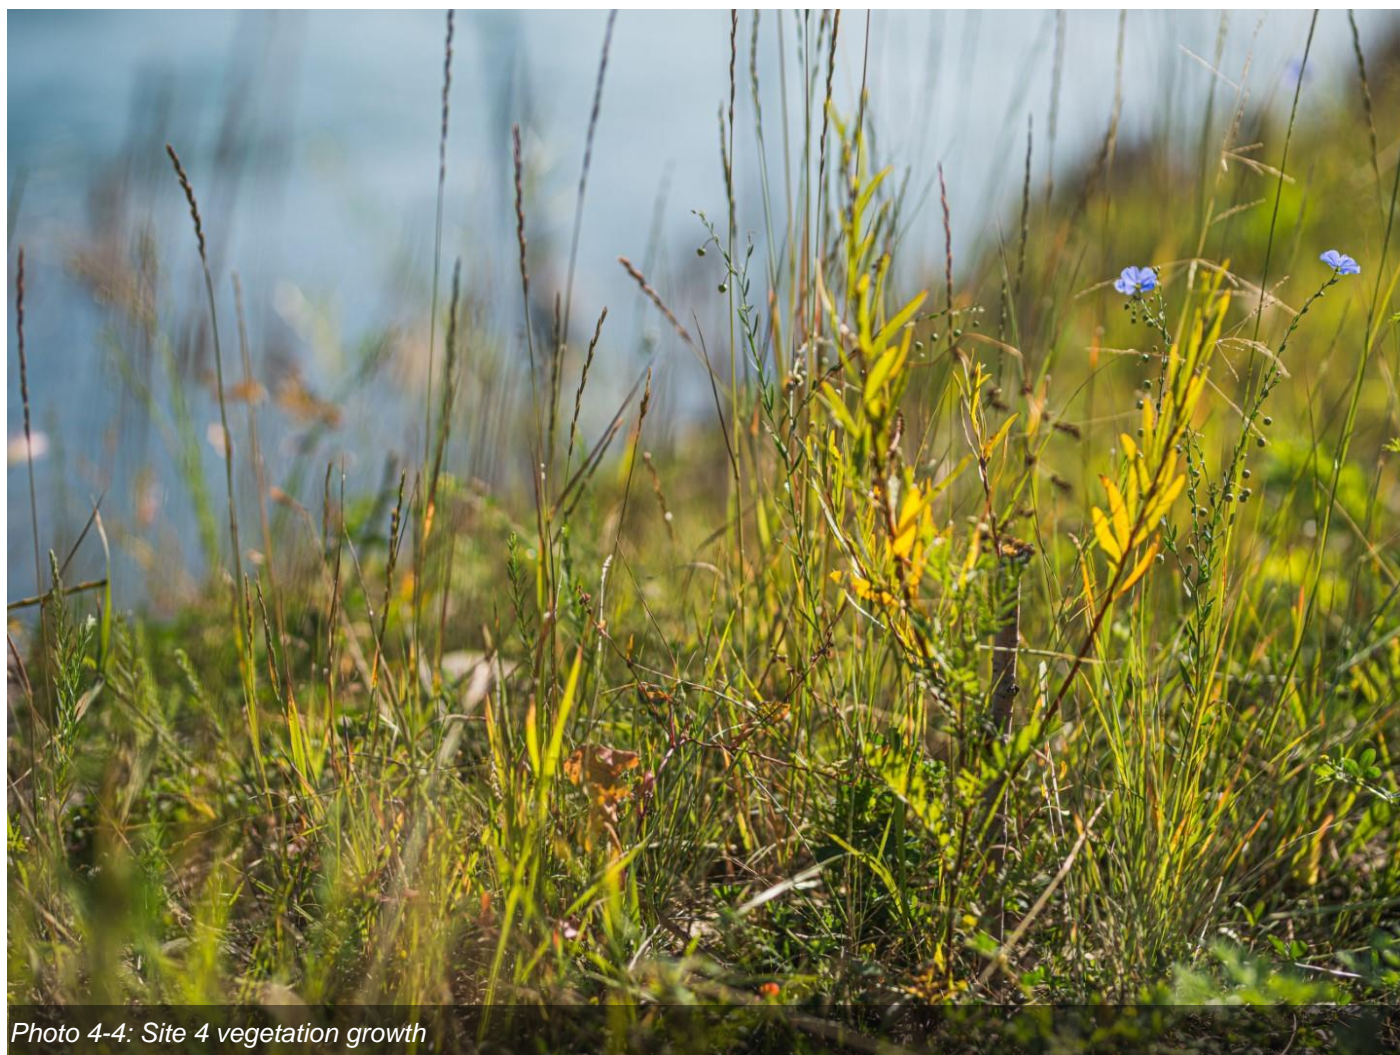
Photo 4-4: Site 4 vegetation growth

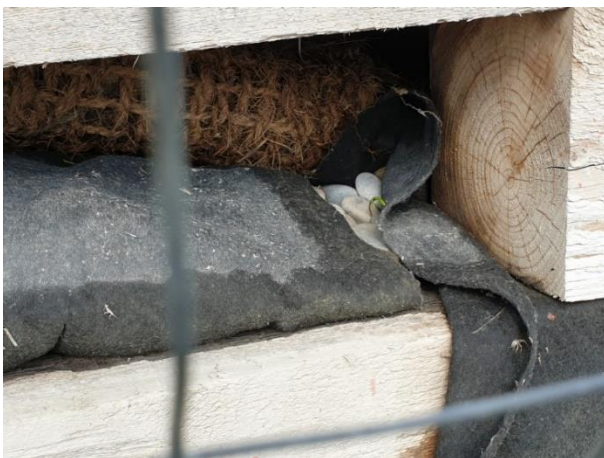
Photo 5-1: Gaps in non-woven geotextile used for material containment in the timber crib wall at Site 1-3

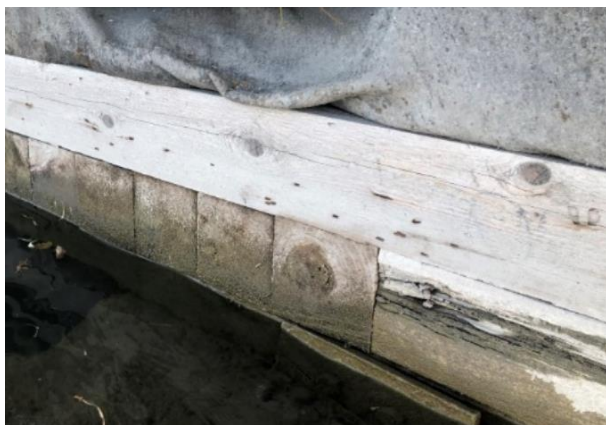
Photo 5-3: Crib wall timber with signs of insect damage and dry rot (October 25, 2019)

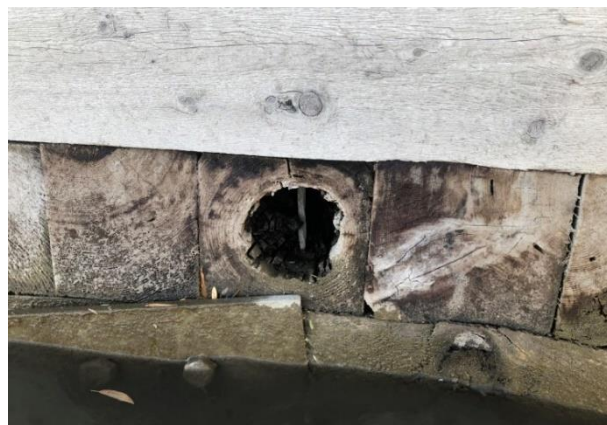
Photo 5-4: Crib wall timber with signs of dry rot (October 25, 2019)

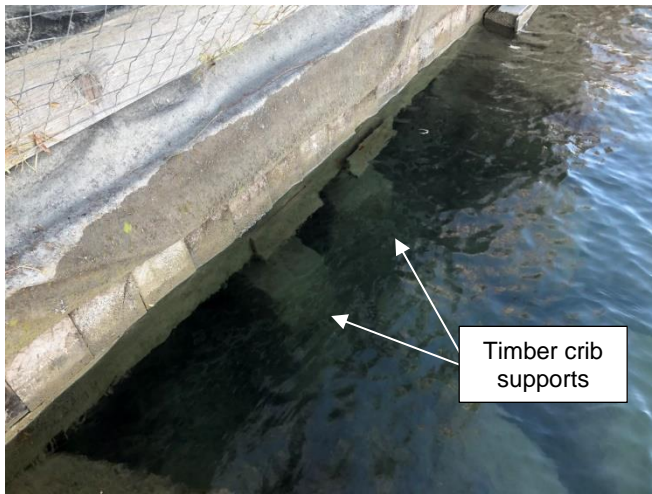
Photo 5-5: Fish shelter and timber crib supports (October 25, 2019)

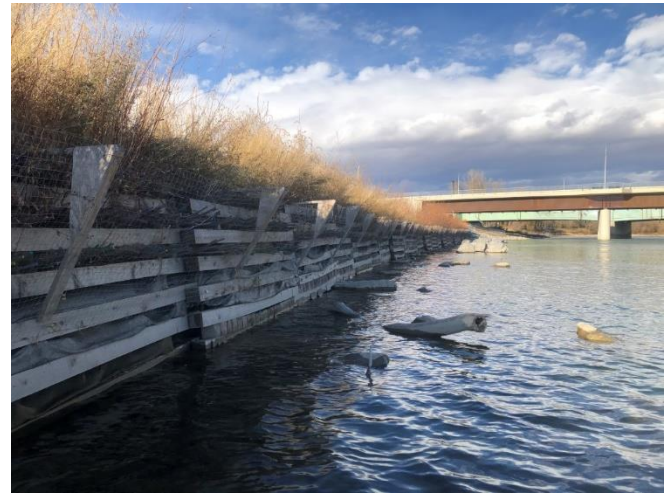
Photo 5-6: Fish shelters, fish habitat boulders and large woody debris (rodent protection fencing attached to face of crib wall) (October 25, 2019)

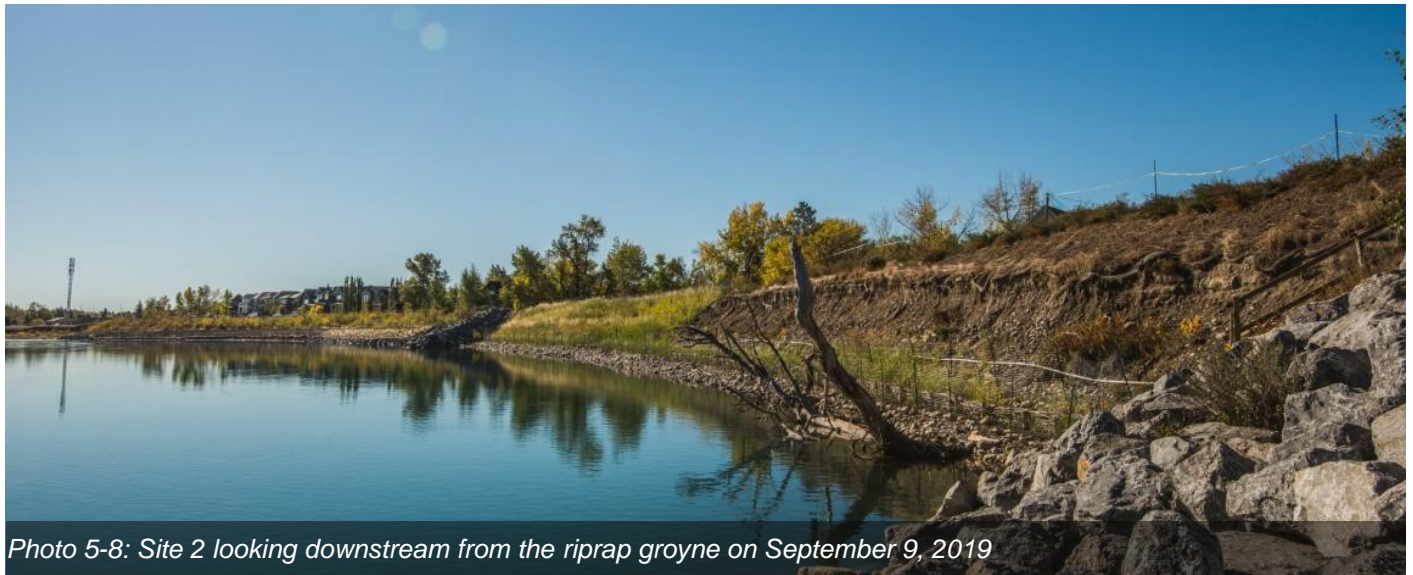
Photo 5-8: Site 2 looking downstream from the riprap groyne on September 9, 2019

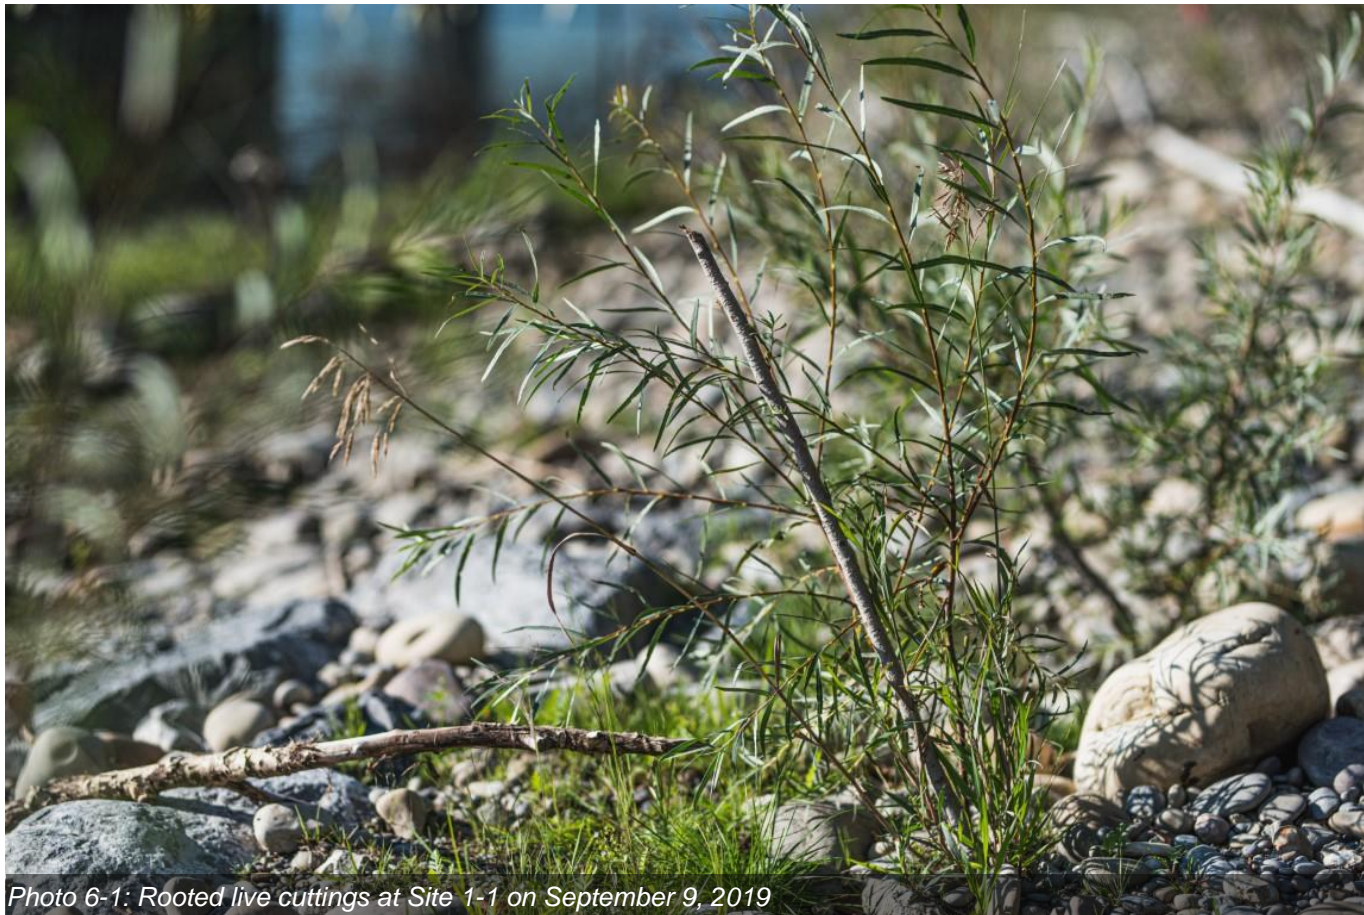
Photo 6-1: Rooted live cuttings at Site 1-1 on September 9, 2019
