# 2019 Annual Summary Report

## The City of Calgary Riparian Monitoring Program

July 14, 2020

Report prepared for:  
The City of Calgary - Water Resources

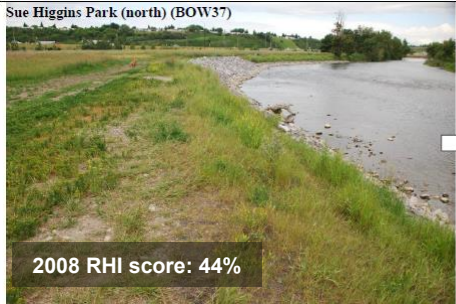
<p>Sue Higgins Park (north) (BOW37)</p> <p>2008 RHI score: 44%</p>

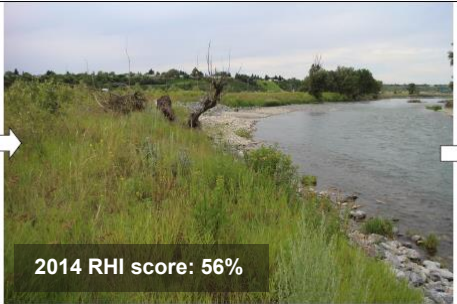
<p>2014 RHI score: 56%</p>

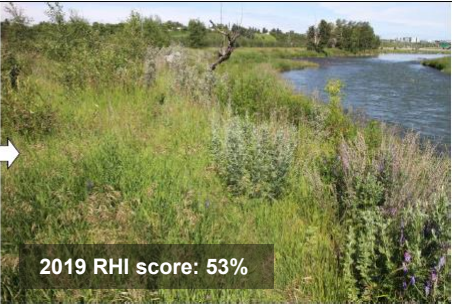
<p>2019 RHI score: 53%</p>
High recreational use in the floodplain has created areas of human-caused bare ground (view upstream). Riprap bank stabilization was done here to repair flood damage after the 2005 flood at the B2B stormwater outfall.	Exclusion fencing was installed here in 2009/2010 to restrict recreational access. Poplar plantings were also installed. Beneficial natural recovery and infilling of vegetation has occurred. Minimal erosion resulted here from the 2013 flood.	Natural regeneration of balsam poplars is progressing here in addition to continued growth of planted trees/shrubs, improving riverbank health; however, weedy and disturbance-caused plants continue to be prevalent.

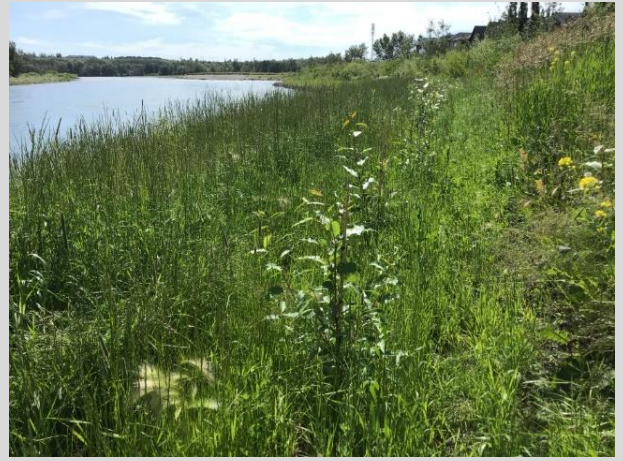
*Photo 3-1: BE-BOW-46E1 (Bioengineering Demonstration and Education Project Site 4-1) looking downstream*

At site BE-BOW-46E1 (Bioengineering Demonstration and Education Project Site 4-1), the existing riprap was covered with soil and planted with container shrubs. The plantings were handled, stored, and installed according to best practices, including using soil amendments and fencing the site for protection from wildlife. The biodegradable erosion control matting contributed to good seed mix establishment. The site was also constructed according to an appropriate schedule by an experienced contractor. Following best practices yielded excellent survivorship (97%), plant health, and overall structure success. This site received a rating of 89/100.

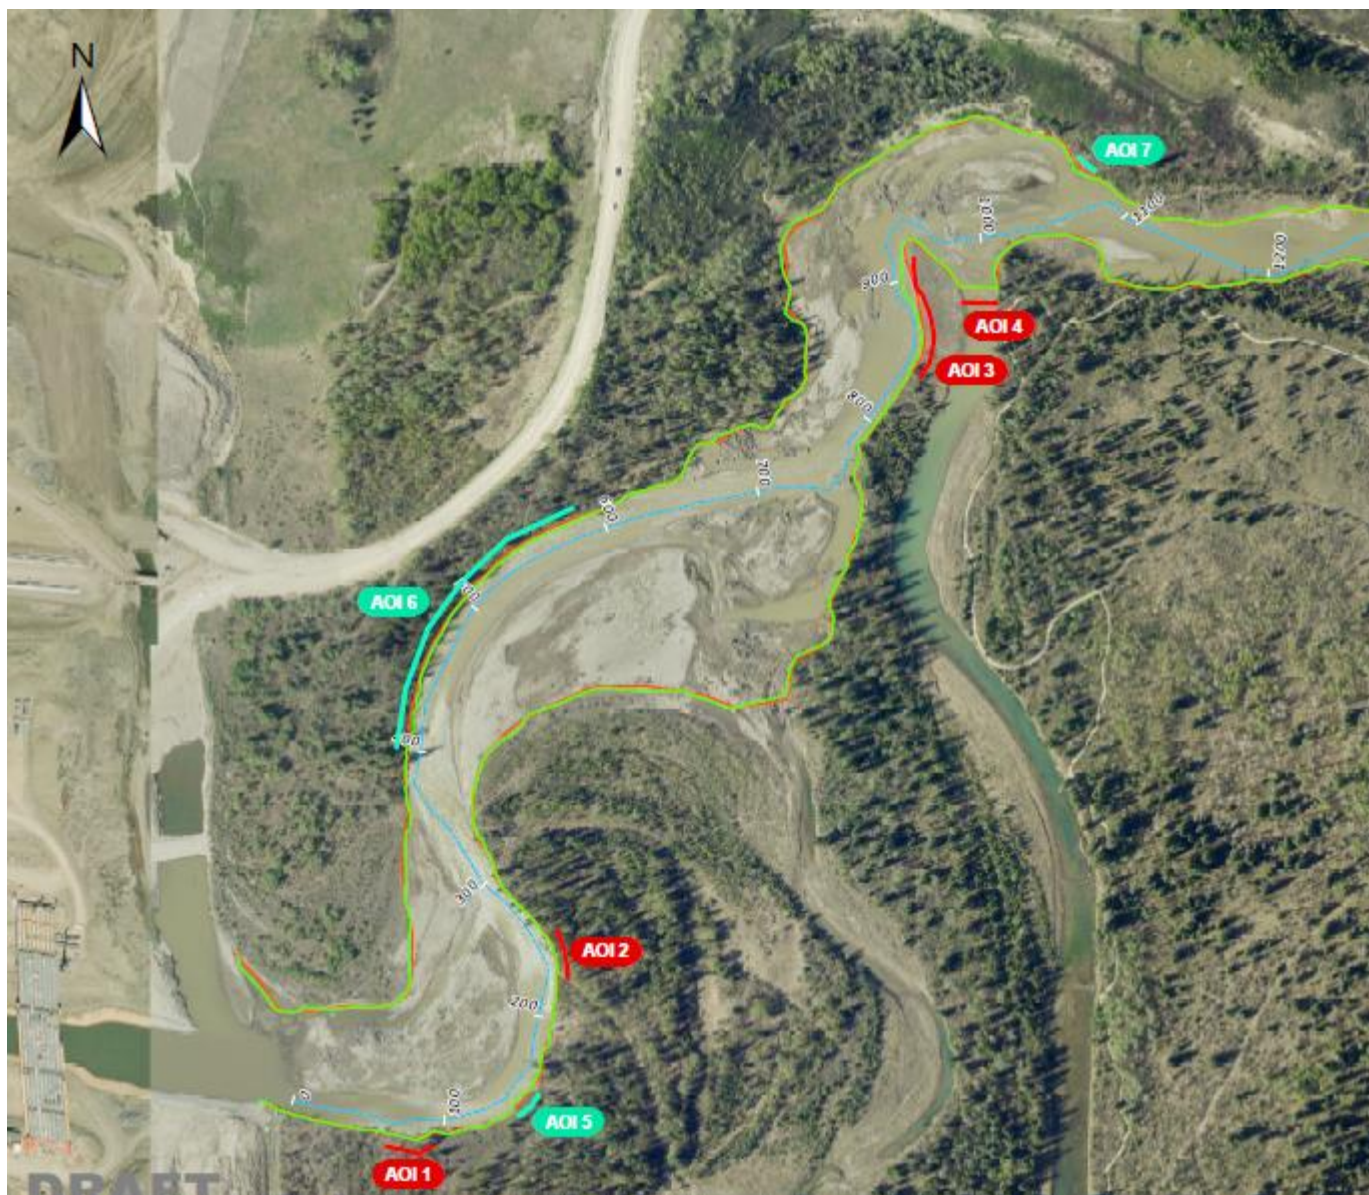
Figure 6-1: 2018 and 2019 Areas of Interest (AOI)

- While bank erosion was observed at Area of Interest (AOI) #1 and AOI #2 between 2016 and 2018, no notable changes were observed at these locations between 2018 and 2019 (pre-freshet) (Figure 6-1).

- Geomorphic changes at AOI #3 were consistent for both monitoring years (2018 and 2019), with notable erosion observed along the right bank (Figure 6-1).

- The mid channel sediment bar at AOI #4 has undergone significant planform changes each year (Figure 6-1). It is suspected that local hydraulics that relate to the meander cut-off that was initiated in 2006 is likely governing the changes observed here.

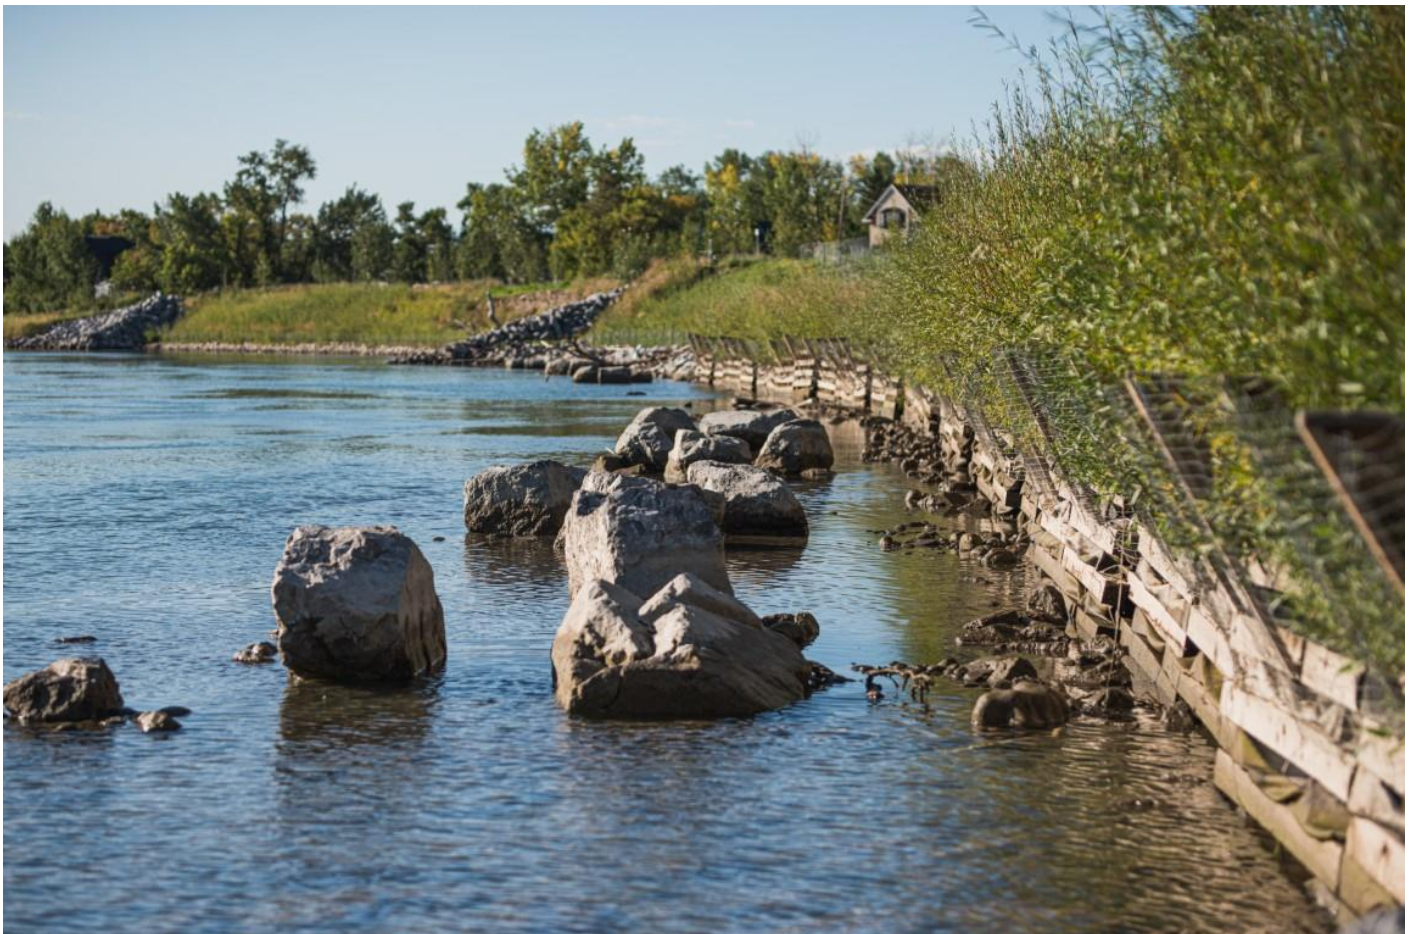
- The fish shelters were observed to have some fine sediment deposited along the bottom but were otherwise clear and providing good fish habitat. No significant change in the condition of the timber crib wall was observed from as-constructed conditions, and there was no observed change in the deflection of the spanning members that are supported by the steel supports. It is recommended to monitor the timber for long-term durability and to use structural quality timber of larger size for the spanning members should this technique be used again.

*Photo 7-1: Timber crib wall and fish habitat enhancement boulders at BDEP.*
