Bioengineering Demonstration and Education Project - 2020 Monitoring Report

The City of Calgary Riparian Monitoring Program

June 23, 2021

Report prepared for:
The City of Calgary - Water Resources

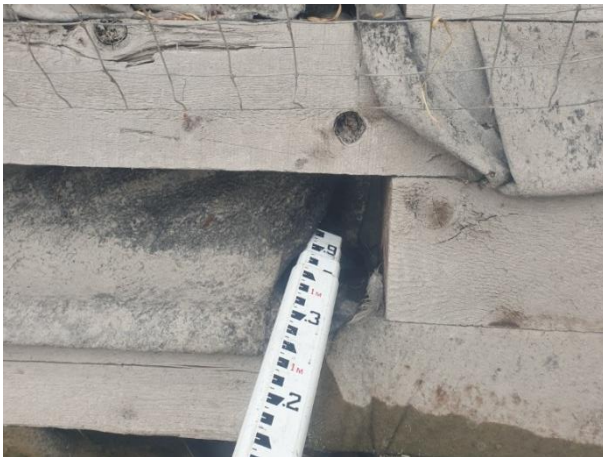
*Photo 5-1: Gaps in non-woven geotextile used for material containment in the timber crib wall at Site 1
Credit: Terra Erosion Control Ltd.*

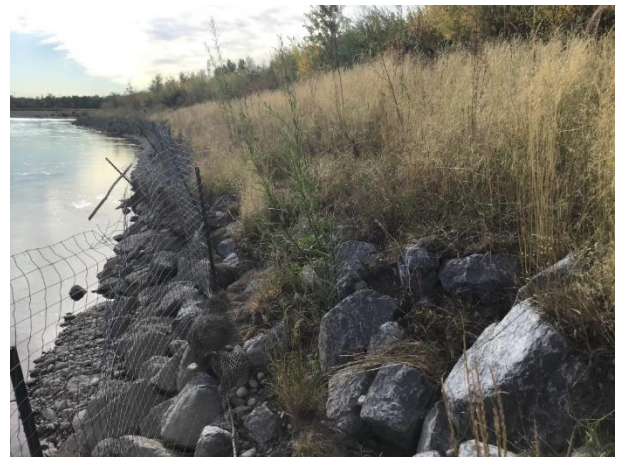
Photo 5-4: Degraded curlex log at Site 4 (Sept 25, 2020)

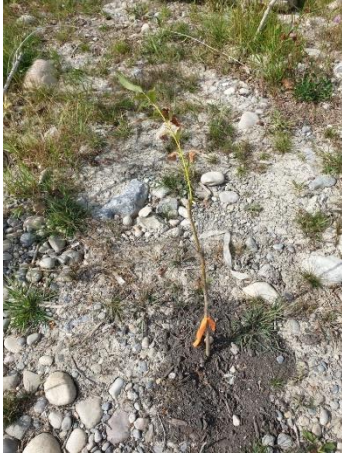
Photo 5-9: Replanted cuttings in the upstream end of Site 1 (September 23, 2020) Credit: Terra Erosion Control Ltd.

- The contractor should carefully consider the impact of early removal of irrigation at the Site since live cuttings replanted in the timber crib wall in 2020 mostly died due to early irrigation removal. It is recommended to replace the dead replanted live cuttings in 2021 and provide on-going irrigation throughout the summer.

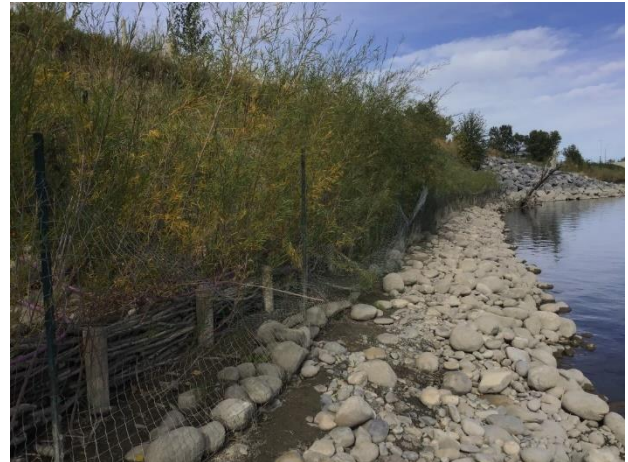
Photo E-26: Site 2 box fascine toe –no toe erosion observed (looking upstream)

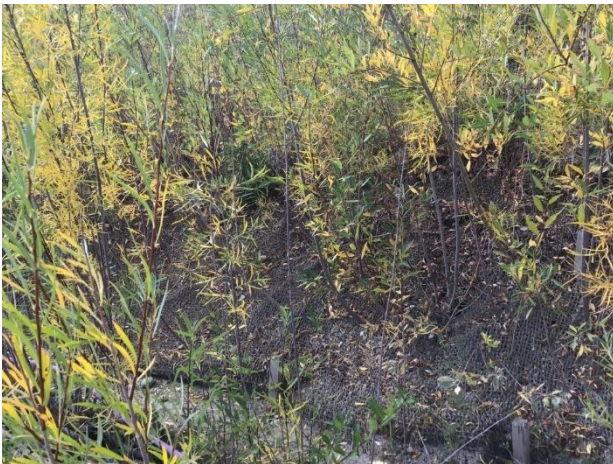
Photo E-27: Site 2 biodegradable coir geogrid in good condition

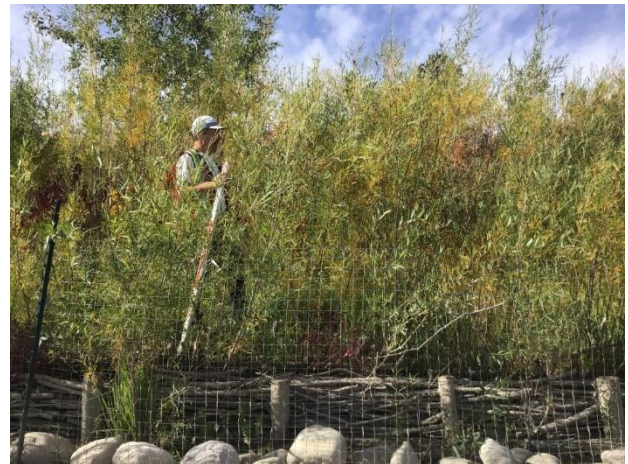
Photo E-28: Site 2 hedge brush layer and box fascine with good establishment (looking west)

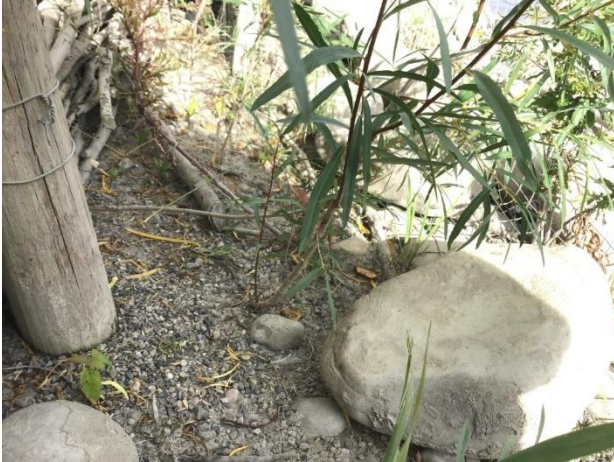
Photo E-29: Site 2 brush layer under box fascine establishment – also note good condition of wood posts and steel wire

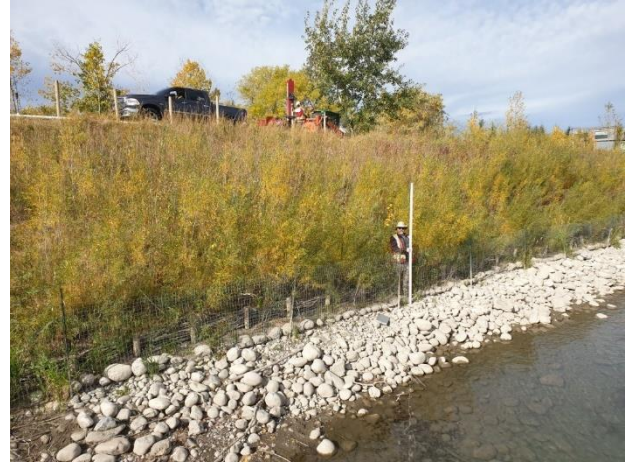
Photo E-30: Site 2 hedge brush layer establishment and no toe erosion observed

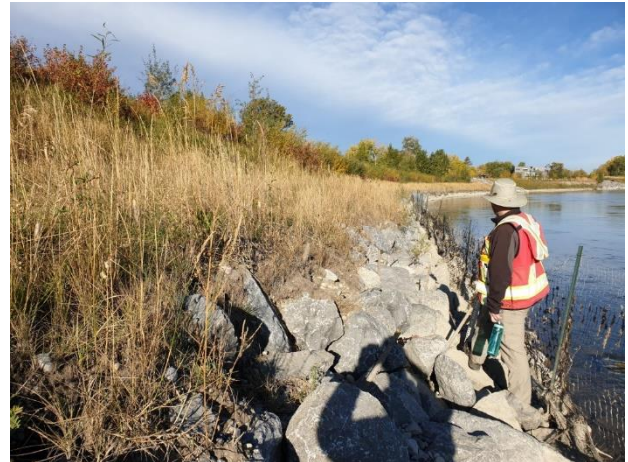
Photo E-38: Site 4 – note erosion of placed toe fill material – observed to be no further erosion in 2020 (looking upstream)

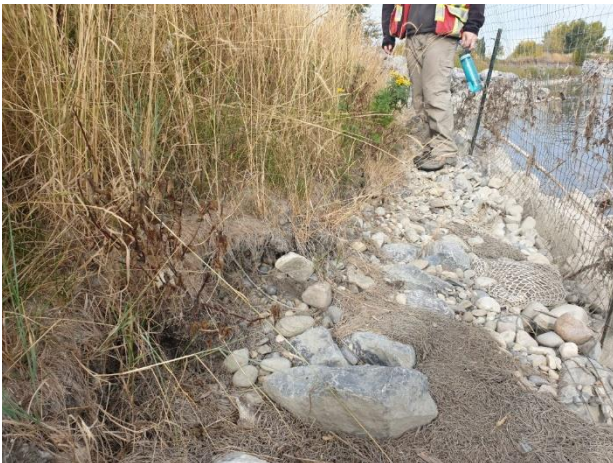
Photo E-39: Site 4 condition of curlex log (looking upstream)

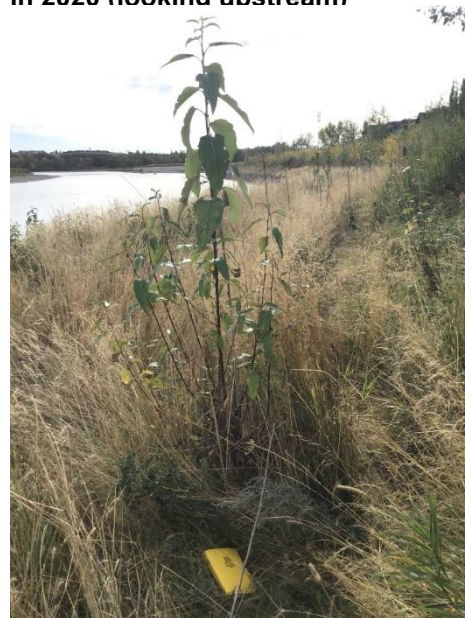
Photo E-40: Site 4 good Balsam poplar establishment (looking downstream)

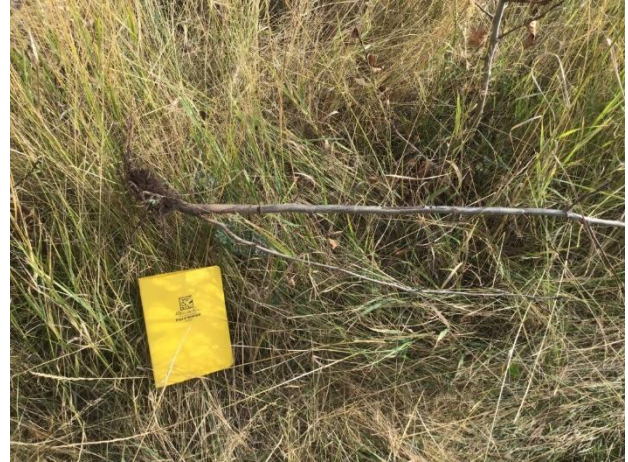
Photo E-42: Site 4 condition of root of desiccated Balsam poplar
