Bioengineering Demonstration and Education Project - 2021 Monitoring Report – Revision 1

The City of Calgary Riparian Monitoring Program

Report prepared for:
The City of Calgary - Water Resources
August 11, 2022

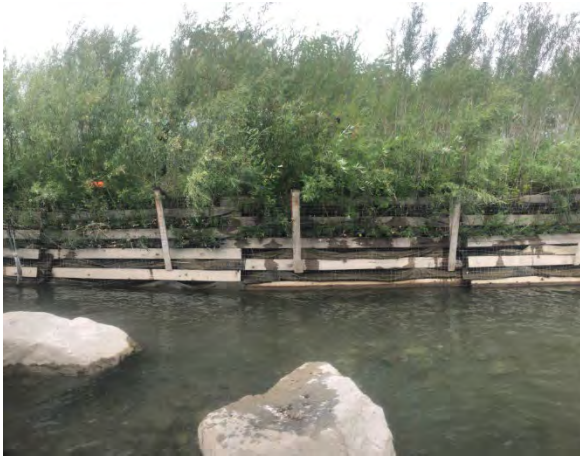
- The fish shelters were observed to have 0.05 m more fine sediment deposited along the bottom compared to 2020 results but were otherwise clear and providing good fish habitat. No significant change in the condition of the timber crib wall was observed from as-constructed conditions, and there was no observed change in the deflection of the spanning members that are supported by the steel supports.

Photo 5-2: Timber crib wall, rock riprap (submerged), and fish boulders (July 21, 2021).

- If the timber crib wall with fish shelters technique is used in the future, it is recommended to construct the spanning members using structural timber that are sized appropriately.

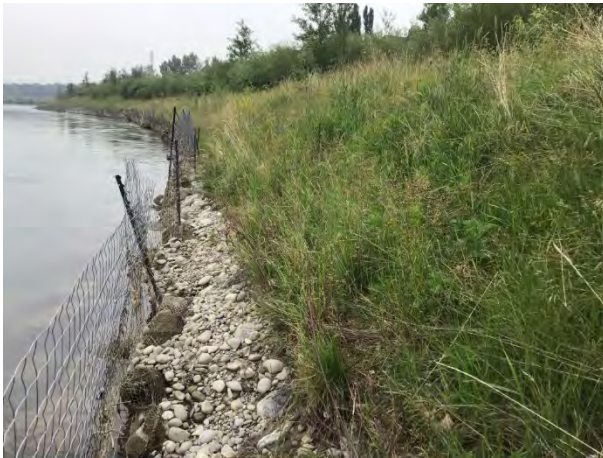
- Materials used in the construction of the BDEP include rock riprap, wood, erosion control matting and geogrids, concrete, and steel and were generally found to be in good to excellent condition. Curlex® Sediment Logs® were noted in 2021 to be in poor condition and missing in some places but they have served their purpose of providing temporary erosion and sediment control and can be either left in place or removed.

Photo 5-4: Degraded Curlex® Sediment Log® and temporary rodent fence at Site 4 (July 19, 2021)

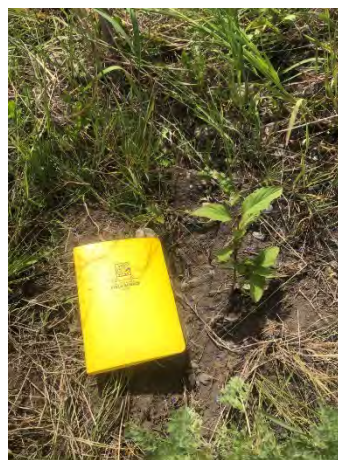
Although Site 1 and Site 2 have mostly shown consistent or sustained improvement since 2016, there has been a very slight riparian health decline since 2020 for Site 4. Some die-off of planted stakes and container plants is apparent in Site 4, likely in part due to drought conditions in Calgary in the summers of 2020-2021. This affected regeneration scores for both RHA and BRQI ratings for Site 4. Replacement plantings were installed in 2021 as a mitigation.

Photo 5-19: Replacement shrub plug plantings at Site 4 (June 18, 2021)

- Continue to monitor planting survival in Site 4 where replacement plantings were done in 2021.
 - Monitor the survival success of recent live stakes installed in Site 1-2 (between the Cushing and Bus Rapid Transit bridges) and replace or mitigate with an alternate bioengineering treatment as warranted.

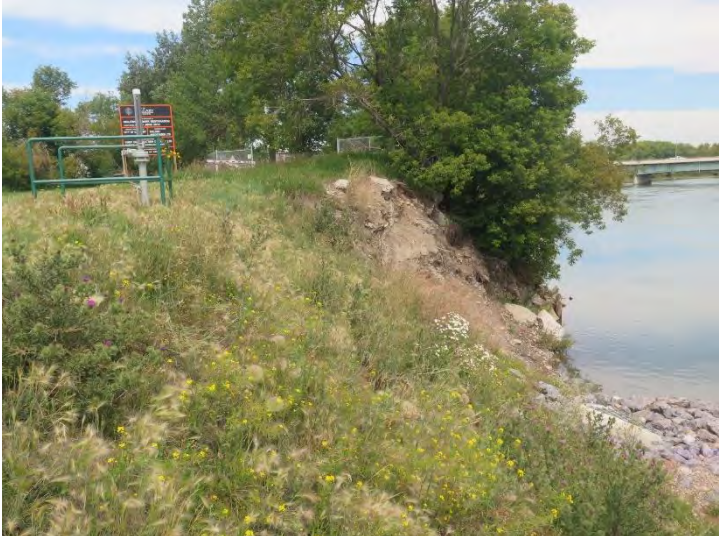
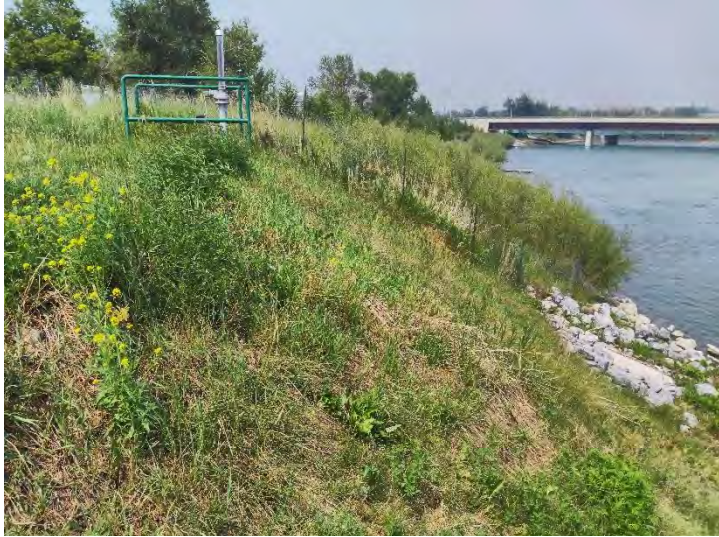
<p>RHIP95BOW021 (2016, Waypoint H) – A disturbed portion of steep, unstable bank at the B9 stormwater outfall. <i>(Photographer: M. Laing)</i></p>	<p>RHIP95BOW060 (2021, Retake of RHIP95BOW021) – Bioengineering slope treatments have been applied successfully immediately upstream from the B9 outfall in Site 1-4. <i>(Photographer: K. Hull)</i></p>

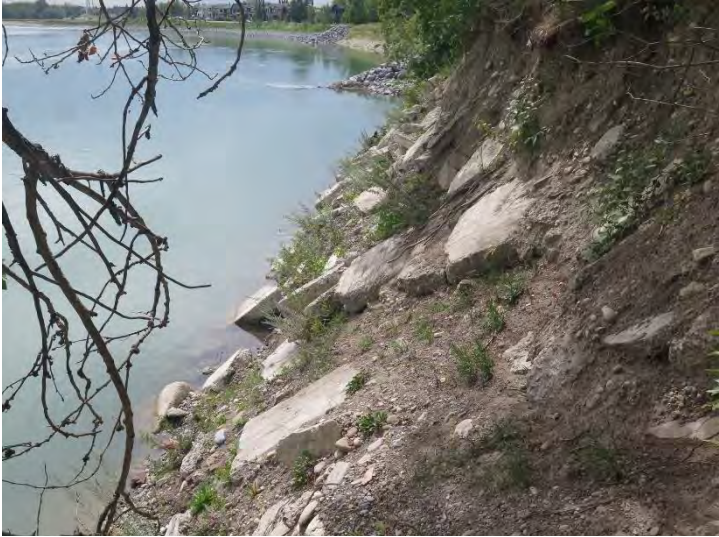
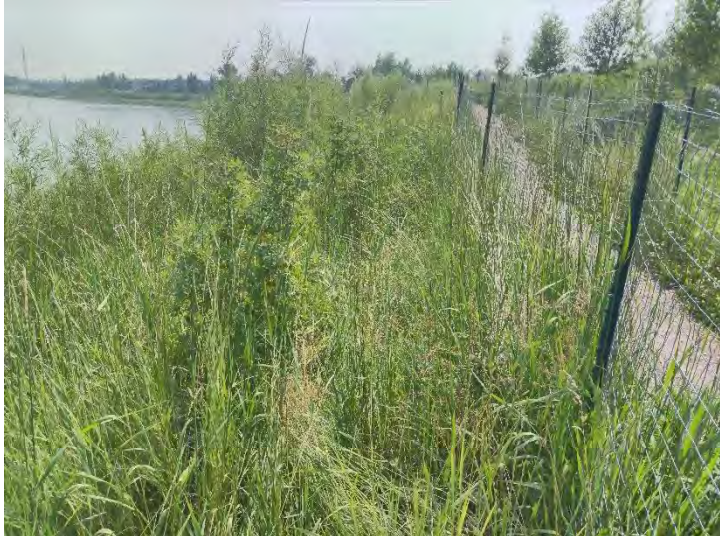
<p>RHIP95BOW023 (2016, Waypoint J) – Remnants of old concrete rubble and exposed rebar are indicative of historic bank disturbance in the upstream part of the site. <i>(Photographer: M. Laing)</i></p>	<p>RHIP95BOW064 (2021, Retake of RHIP95BOW023) – A large amount of concrete rubble was removed from the bank during bank reshaping. Bioengineering techniques successfully applied here (Site 1-4) included willow brush layers, brush mattresses and contour fascines. Dense seeded grass may be a limiting factor though in portions of Site 1. <i>(Photographer: K. Hull)</i></p>

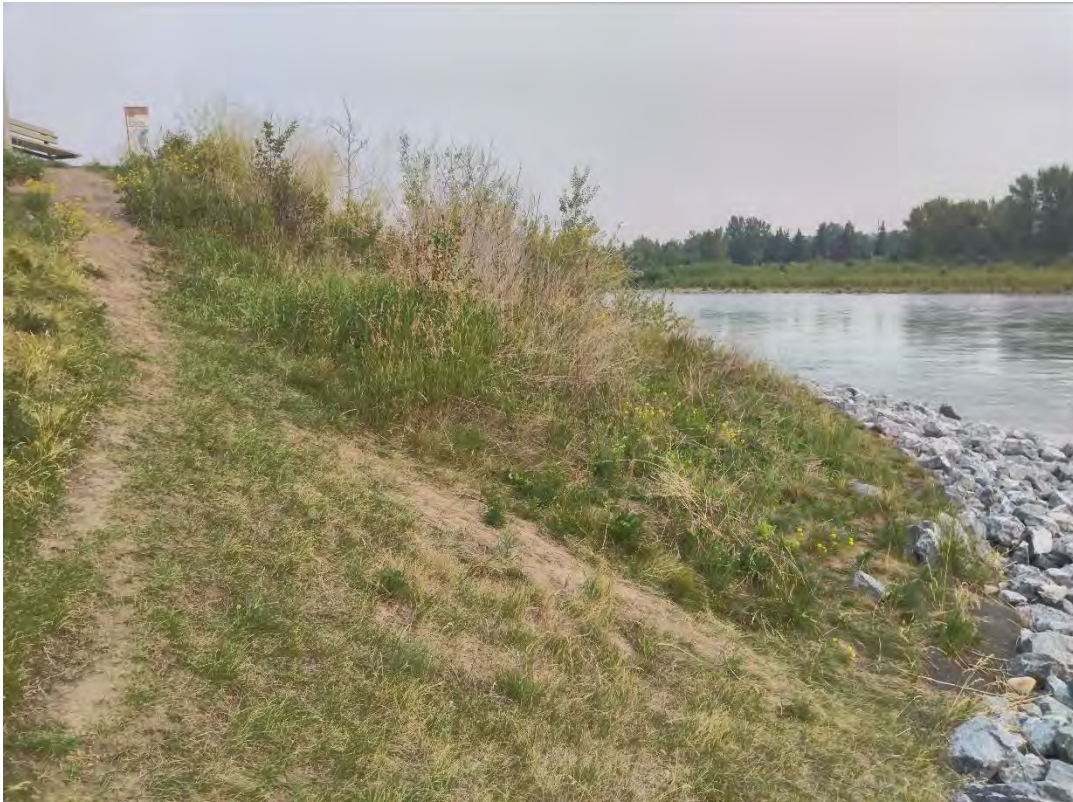
RHIP95BOW037 (2021, Waypoint L) – View upstream at the **downstream end** of the site, toward the unmodified ‘control’ site (**Site 4-4**). Some dead balsam poplar saplings need to be replaced here. This disturbed bank has residual scentless chamomile, ox-eye daisy and Canada thistle plants. Of note, wandering garter snakes were seen near here immediately downstream from the BOW95 site. (Photographer: K. Hull)

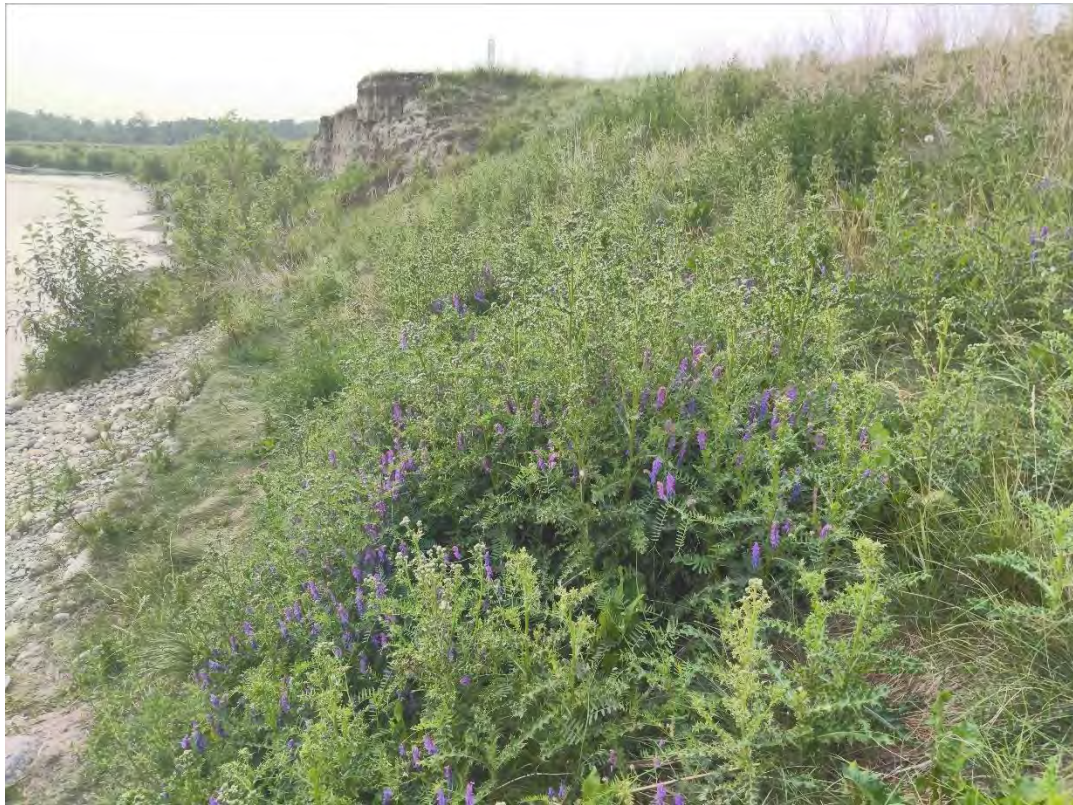
RHIP95BOW036 (2021, Waypoint BOW95 “OUT”) – A dense tufted vetch and Canada thistle infestation immediately downstream from the BDEP site, requiring management intervention. (Photographer: K. Hull)

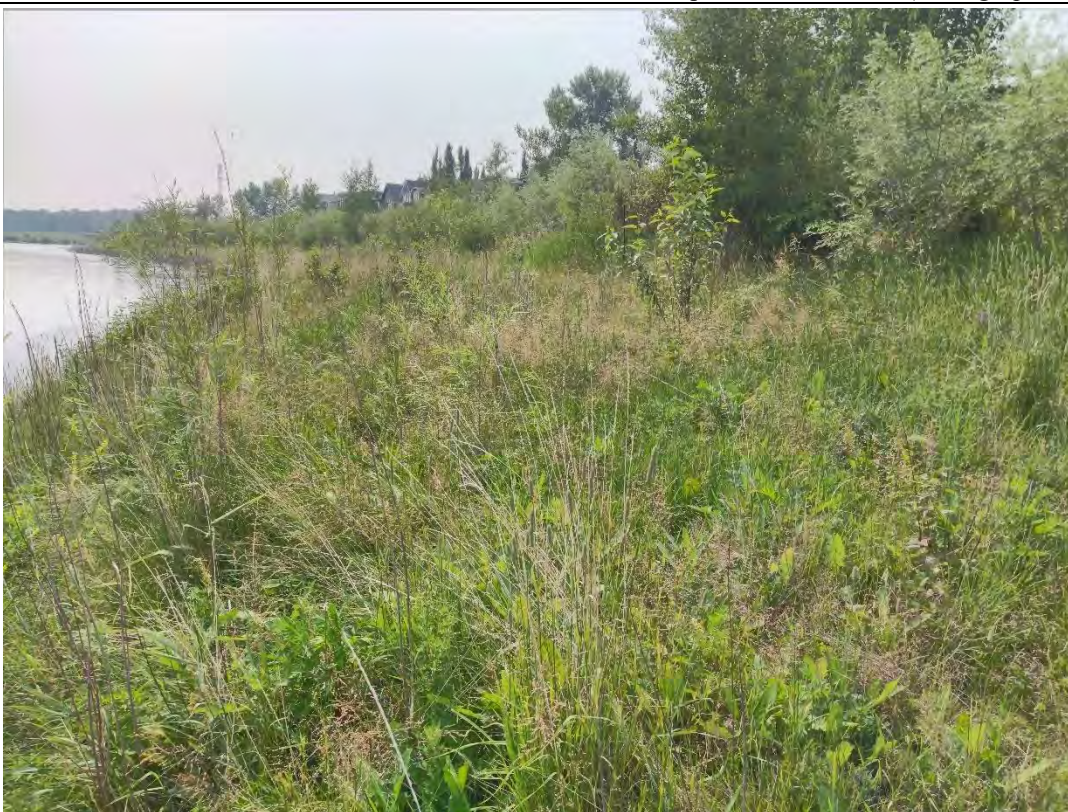
RHIP95BOW046 (2021, Waypoint 2A) – View downstream from the upper end of **Site 4** - successful vegetated rip-rap treatment. There has been excellent establishment of native trees and shrubs in Site 4, especially at mid to upper slope positions, although there are dead willow cuttings at the base. There is a consistent row of common tansy along the lower terrace within Site 4. (Photographer: K. Hull)

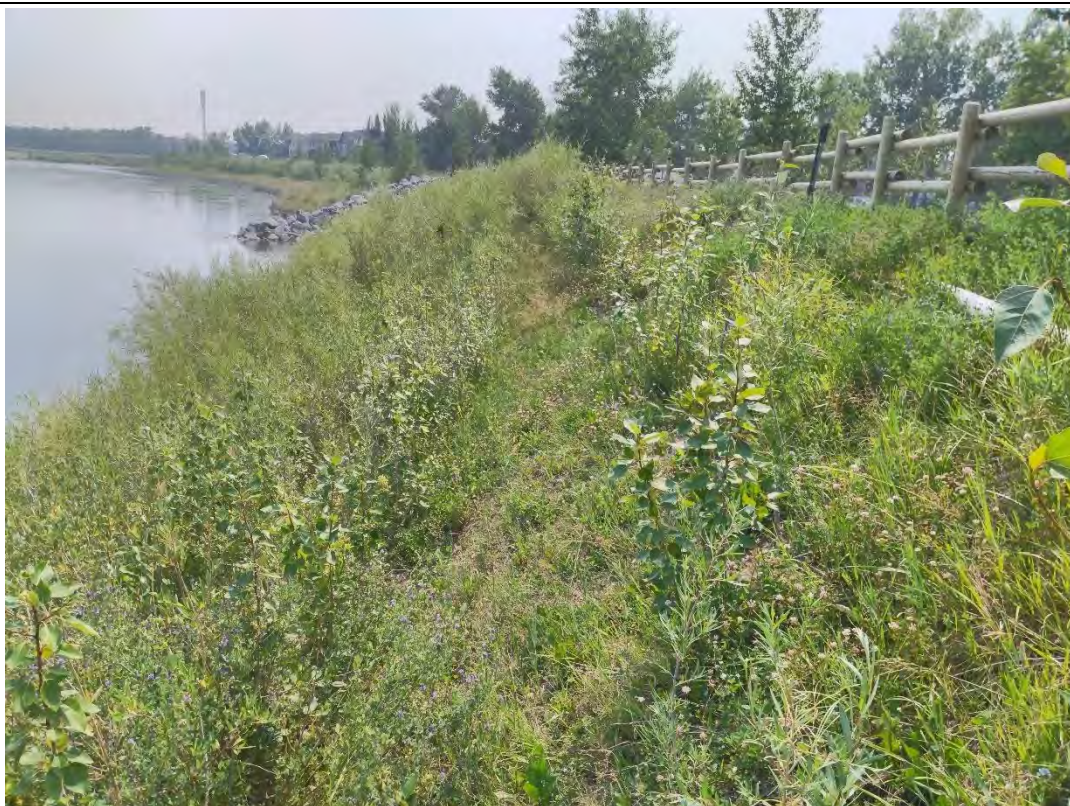
RHIP95BOW056 (2021, Waypoint 2C) – View downstream in **Site 2** – successful implementation of box fascine with brush layering and slope treatment. Wood rail fencing at the top of the bank should be retained to curtail recreational access to bank bioengineering treatments in the long-term. (Photographer: K. Hull)

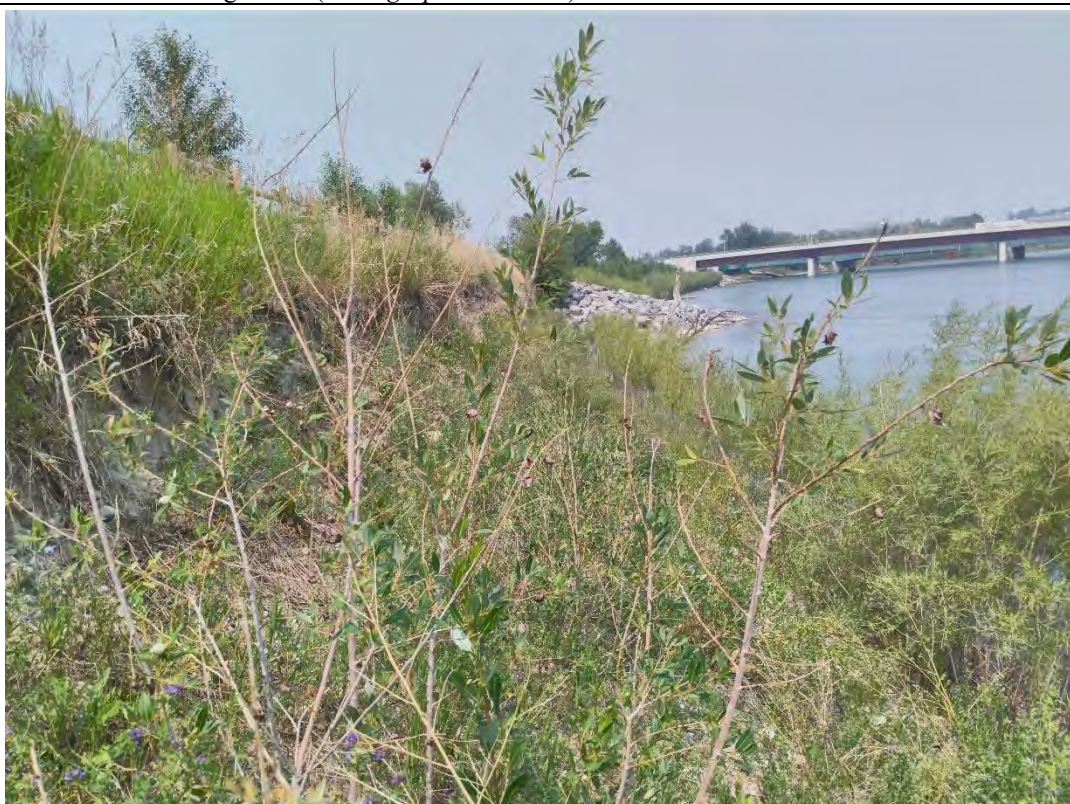
RHIP95BOW057 (2021, Waypoint 2C) – View upstream within Site 2 – successful box fascine at the toe, no slope treatment above due to steep exposed cutbank with swallow nests. (Photographer: K. Hull)

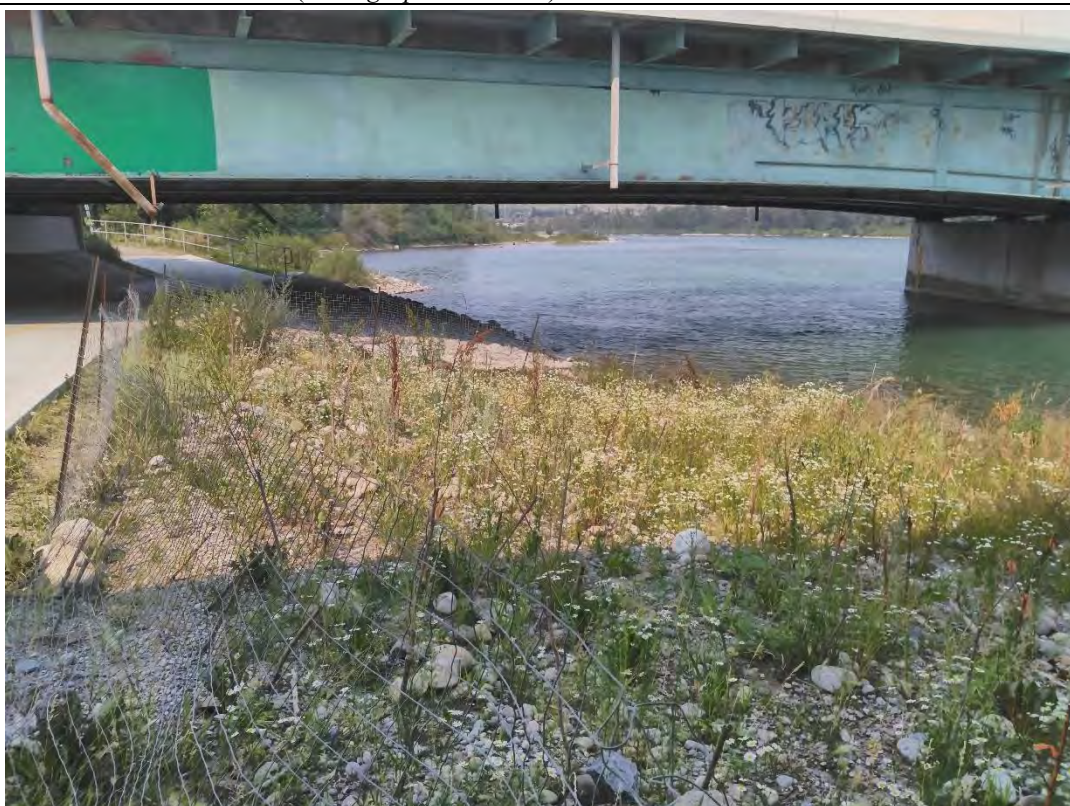
RHIP95BOW070 (2021, Waypoint 2G) – View upstream to the Cushing Bridge in **Site 1-2**. This disturbed area requires ongoing monitoring and maintenance to ensure survival success targets are reached for willow cuttings and to remove scentless chamomile infestations. *(Photographer: K. Hull)*

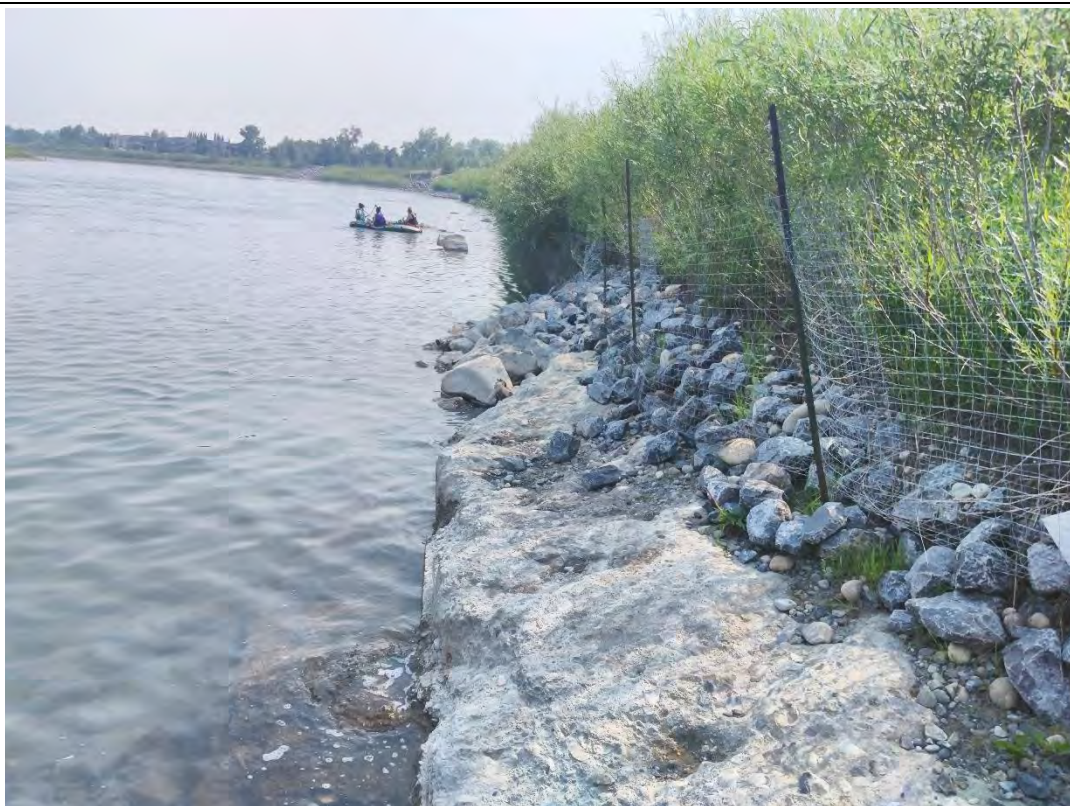
RHIP95BOW071 (2021, Waypoint 2H) – View downstream at the upper end of Site 1-3 – showing excellent establishment of sandbar willows within the timber crib wall. Fencing in the foreground at the base of the bank has been built to exclude beaver access. (Photographer: K. Hull)

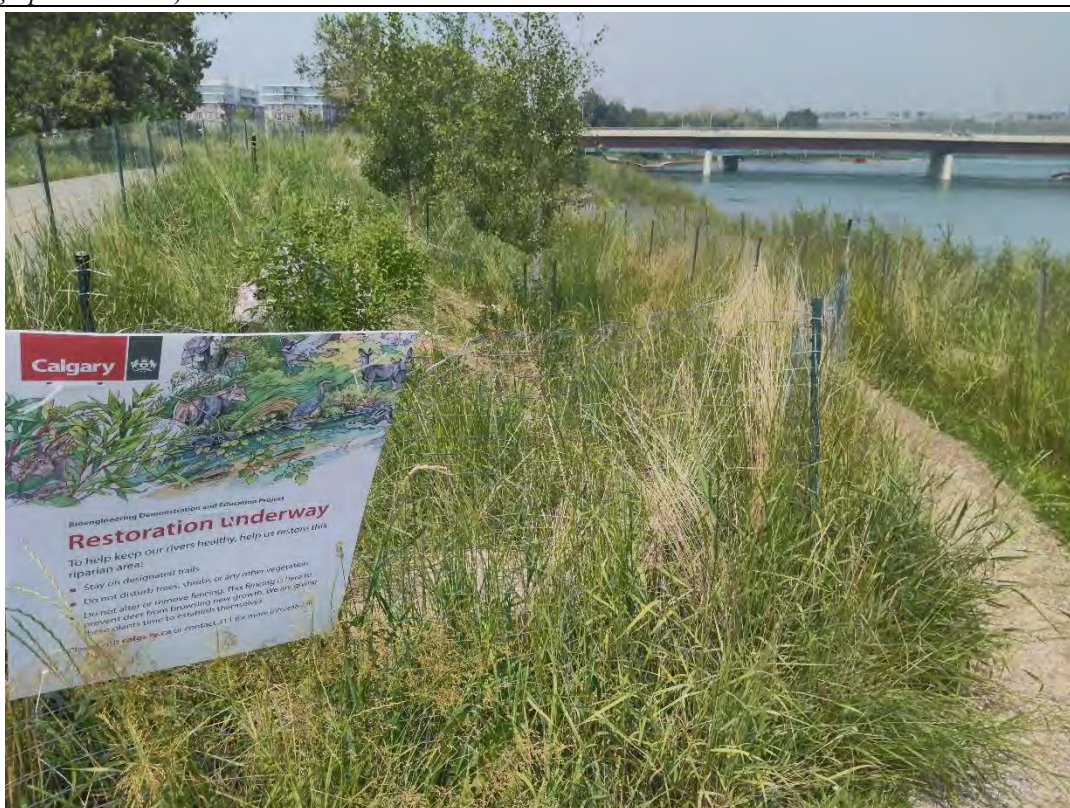
RHIP95BOW063 (2021, Waypoint I) – View upstream to the Cushing and BRT bridges from the lower end of Site 1-4. This portion of bank was reshaped to accommodate a wildlife corridor and lower riparian terrace. Dense cover from seeded grasses may be limiting to riparian plantings here. (Photographer: K. Hull)
