# BIOENGINEERING DEMONSTRATION AND EDUCATION PROJECT

## Site Assessment Technical Report

File: 1873-004.01  
September 2016

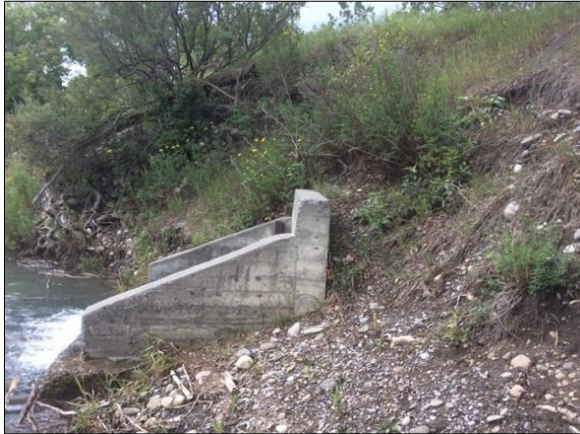
**Photo 1:** Outfall B-10 located within 100 m downstream of Cushing Bridge on right downstream bank.

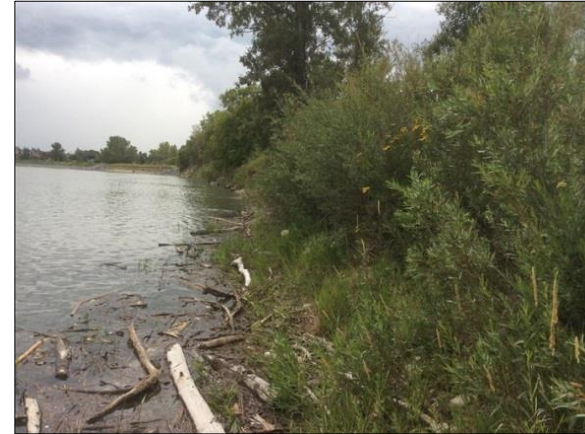
**Photo 2:** Looking downstream from outfall B-10.

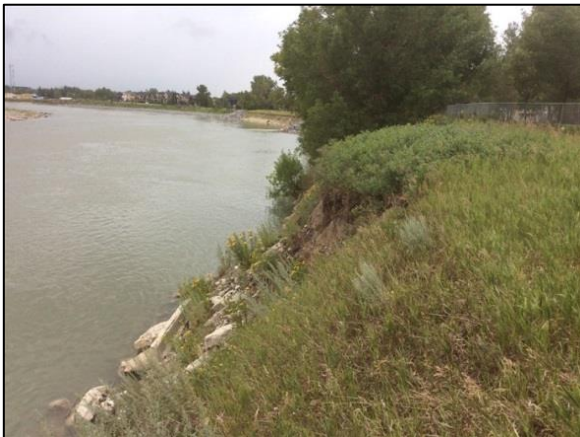
**Photo 3:** View looking downstream from middle of Site 1. View of historic broken concrete remediation and steep slope.

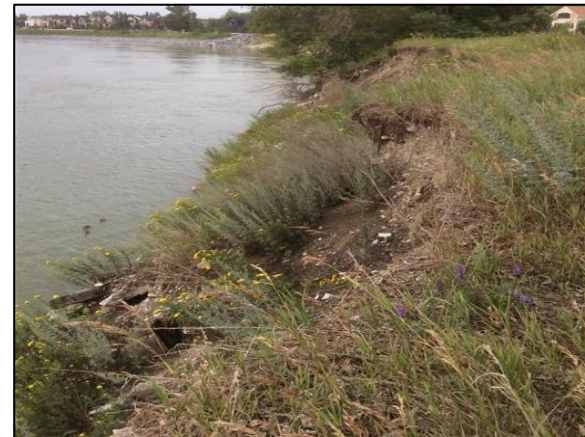
**Photo 4:** Looking towards downstream end of Site 1. Localized bank slump.

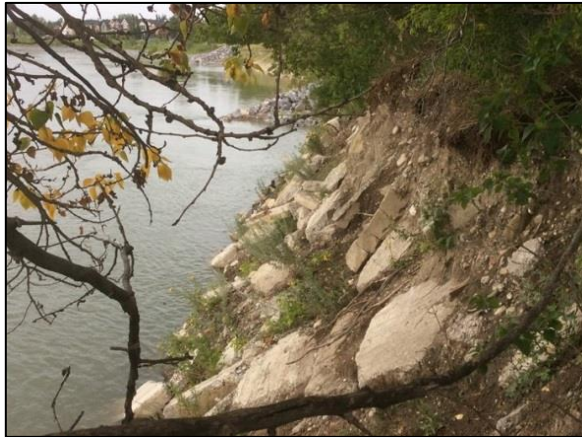
**Photo 5:** View at downstream end of Site 1. Steep slope with historic broken concrete remediation.

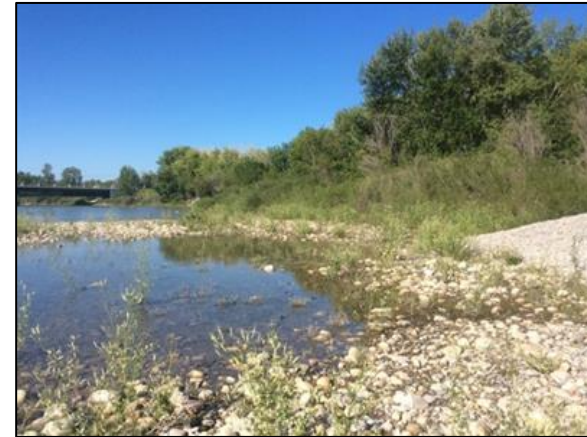
**Photo 6:** Right downstream bank area upstream of Cushing Bridge looking downstream towards the bridge.

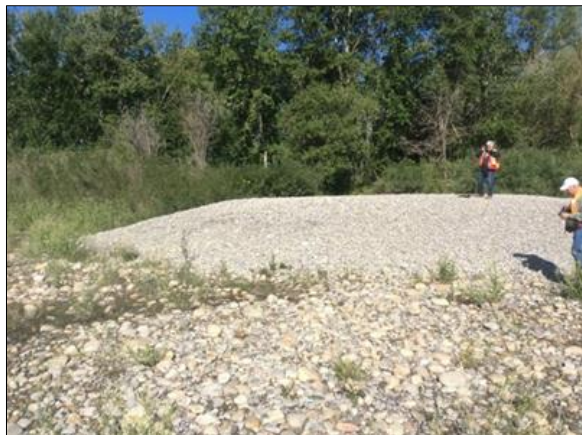
**Photo 7:** View towards right bank deposition area immediately downstream of the Harvie passage site.

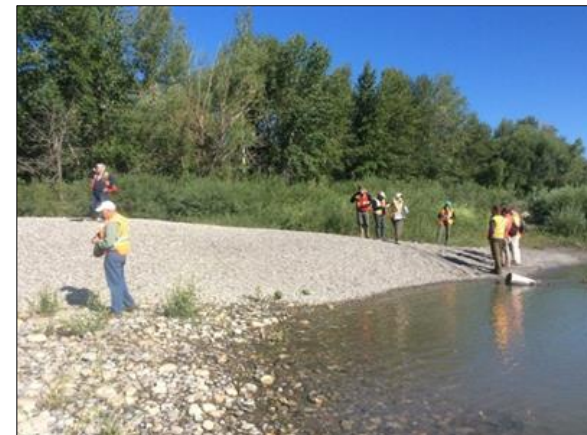
**Photo 8:** View towards right bank deposition area looking upstream immediately downstream of the Harvie passage site.

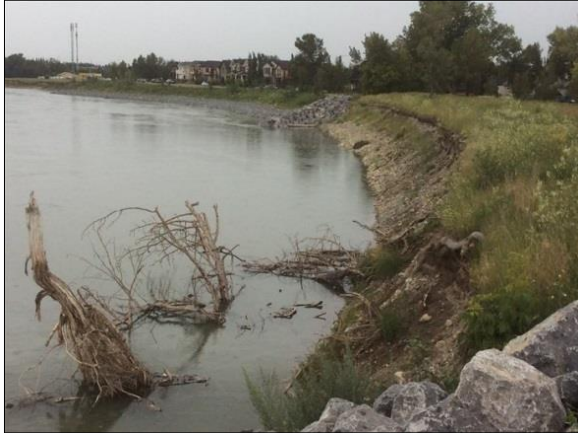
**Photo 1:** View looking downstream along Site 2 right bank from rock groyne and outfall at the upstream boundary of Site 2. Large woody debris in foreground.

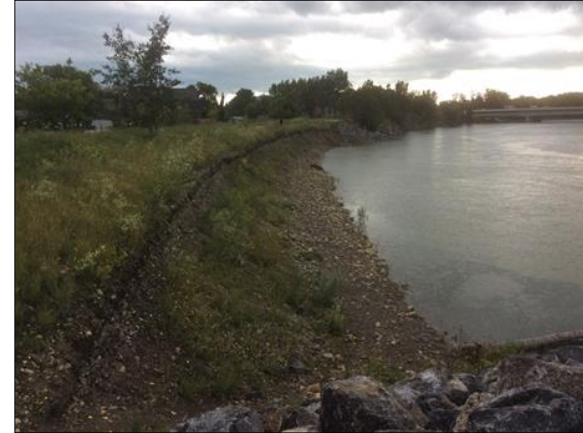
**Photo 2:** View looking upstream towards Site 2 from downstream rock groyne at upstream boundary of Site 4.

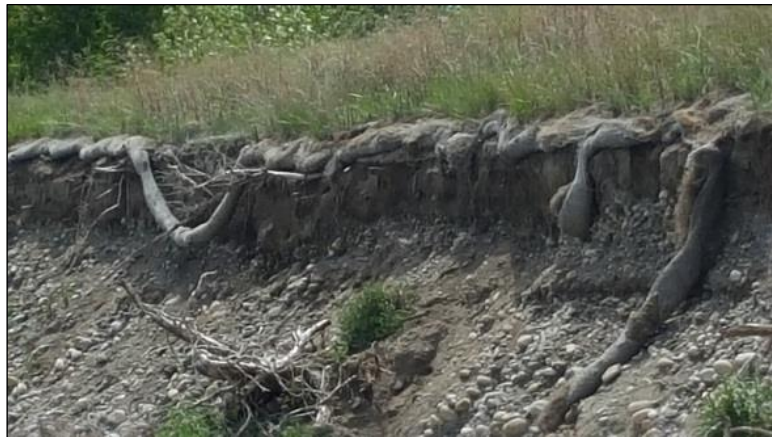
**Photo 3:** Bank swallow habitat along vertical section of exposed soil below coir erosion and sediment control. View southwest.

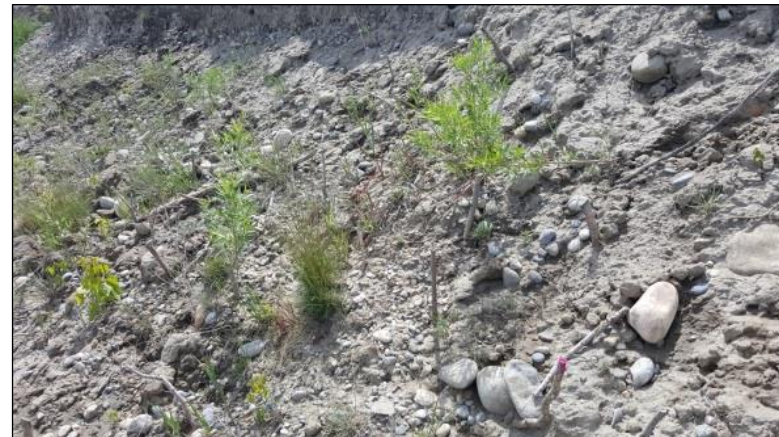
**Photo 4:** View of historic live staking in eroded bank.

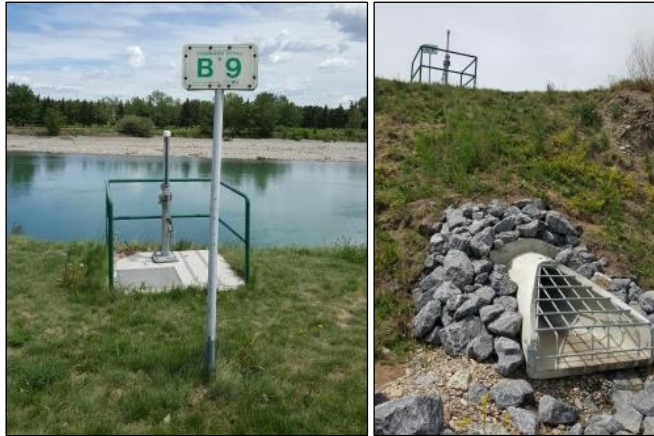
**Photo 5:** Opposing photo directions of Storm Outfall B-9. View across the river looking East to Site 3.

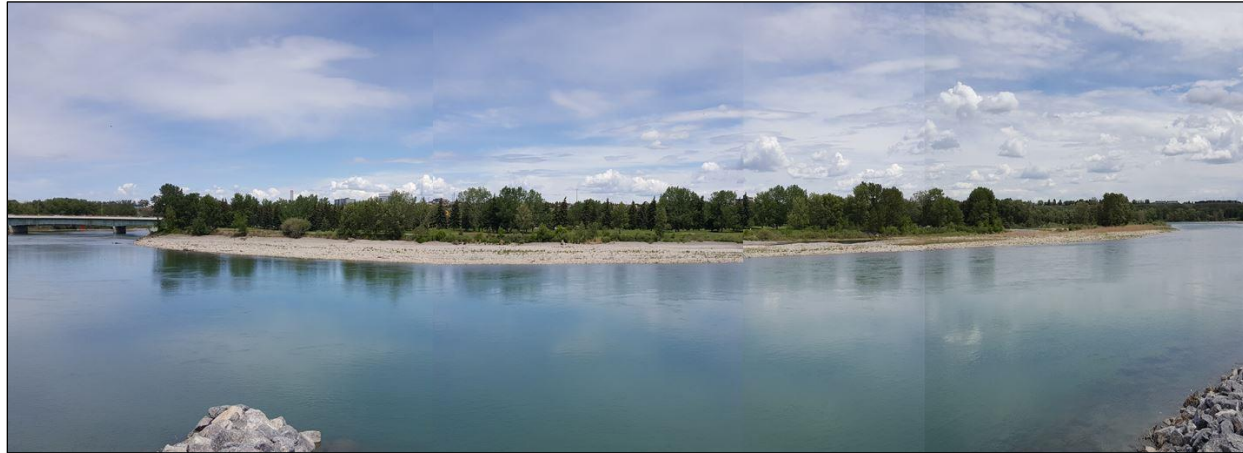
**Photo 1:** June 2, 2016. Pan view upstream to downstream toward Site 3 from Site 2.

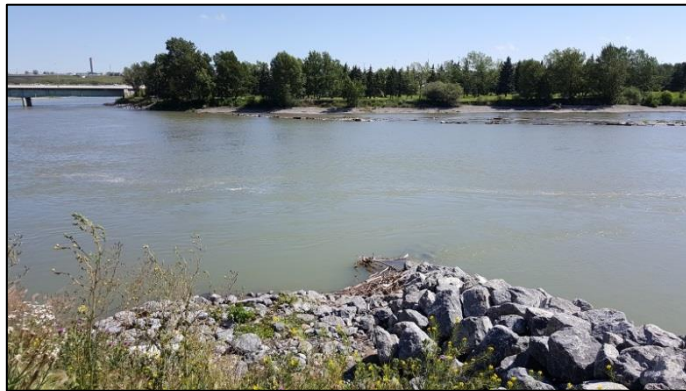
**Photo 2:** July 18, 2016. View looking across to upper Site 3 from downstream groyne at downstream boundary of Site 1.

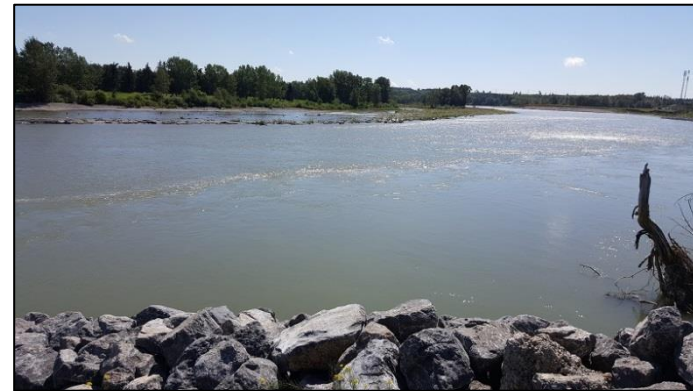
**Photo 3:** July 18, 2016. View looking across to middle of Site 3 from downstream groyne at downstream boundary of Site 1.

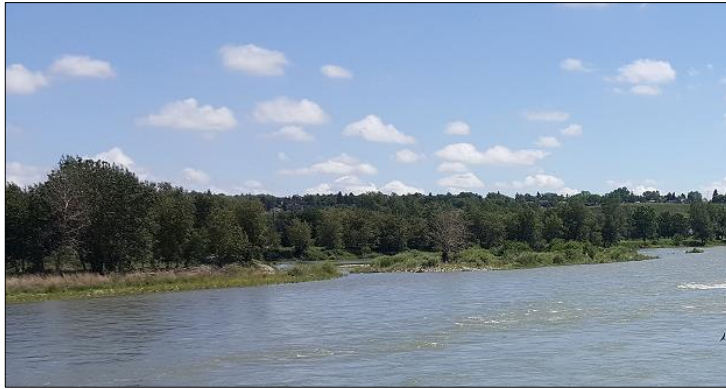
**Photo 4:** July 18, 2016. View looking across to downstream end of Site 3 from Site 4.

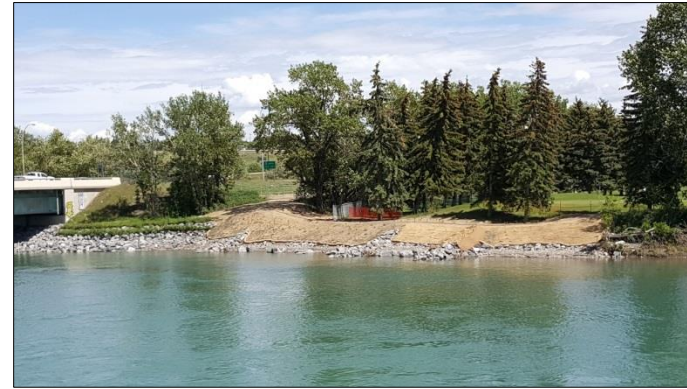
**Photo 5:** June 2, 2016 – Completed City of Calgary Bioengineering project upstream of Site 3 on the left bank immediately downstream of Cushing Bridge.

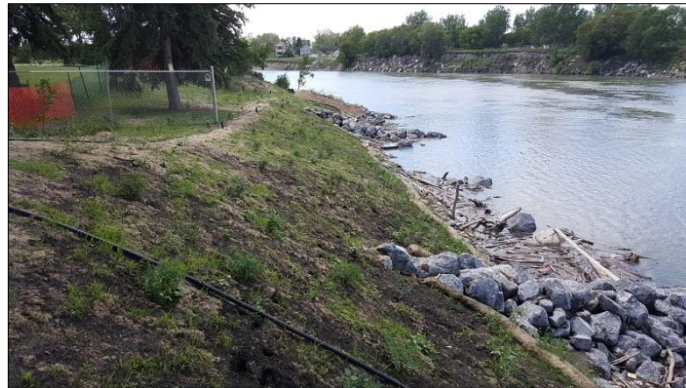
**Photo 6:** July 18, 2016. Close-up view of completed City of Calgary bioengineering project from upstream end of project.

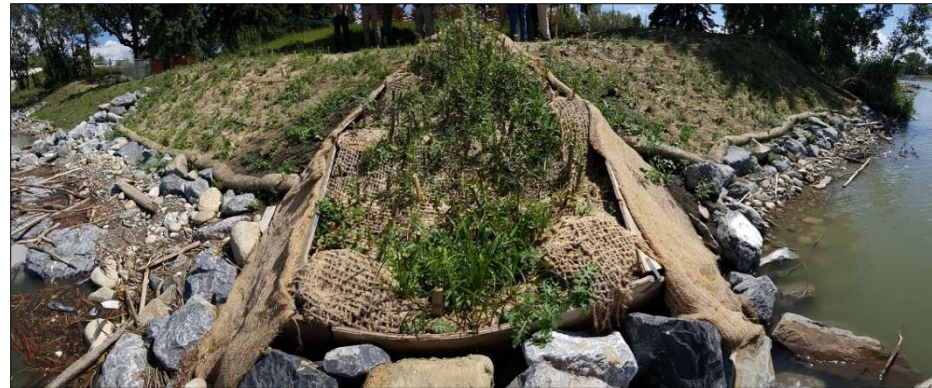
**Photo 7:** July 18, 2016. View of live groyne component above rip rap for the City of Calgary Bioengineering project.

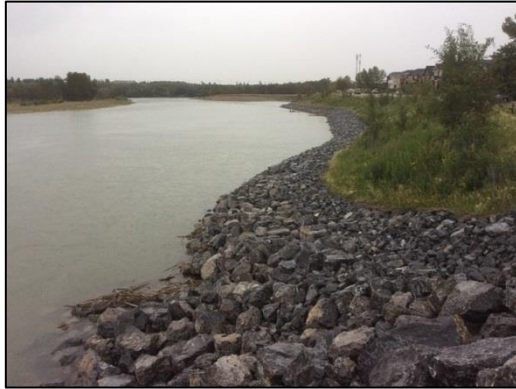
**Photo 1:** Looking downstream at Site 4 from Site 2 downstream boundary.

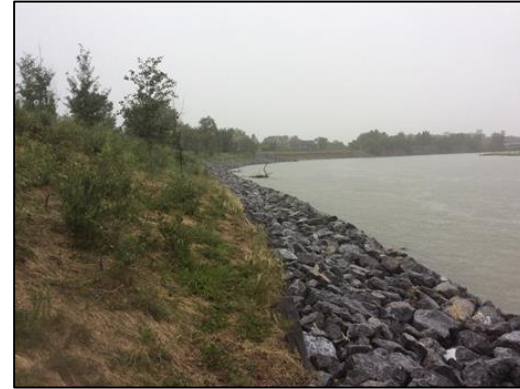
**Photo 2:** Looking upstream at Site 4 from Site 5 upstream boundary.

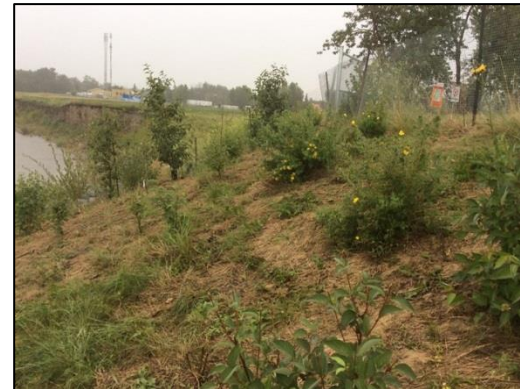
**Photo 4:** Close-up of Site 4 post-flood bank reconstruction with riparian planting above riprap.

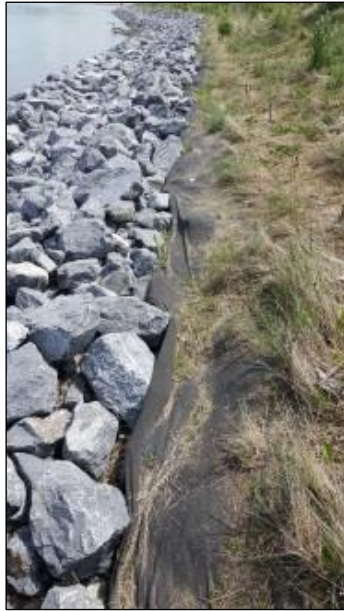
**Photo 5:** June 2, 2016 – Exposed filter material shows extent and use of synthetic materials in construction at transition from rip rap to riparian planting area.

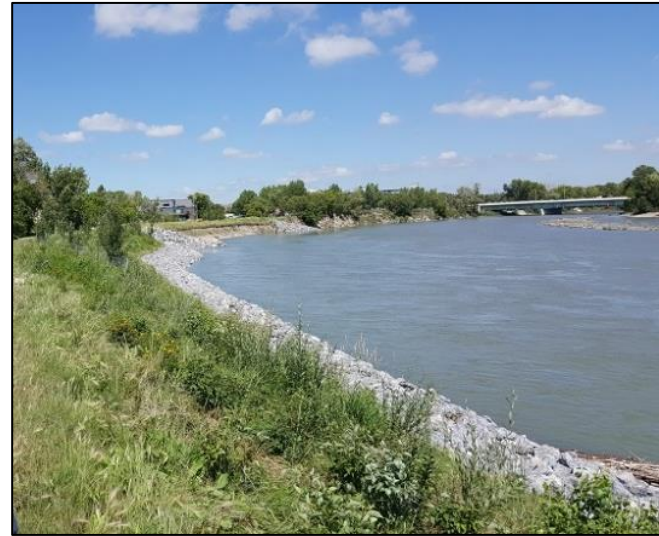
**Photo 6:** Looking upstream at Site 4 rip rap and riparian planted area from top of bank.

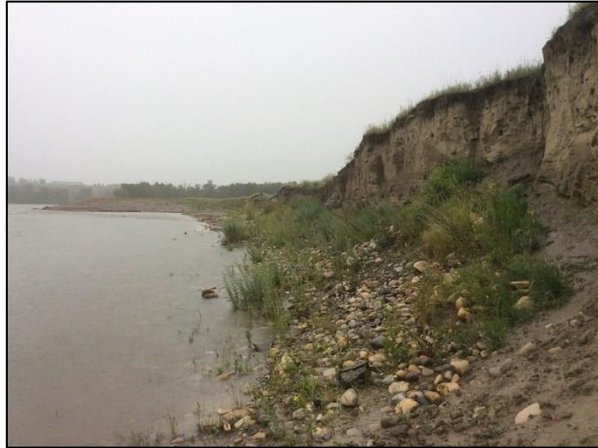
**Photo 1:** Site 5 looking downstream at active bank swallow colony.

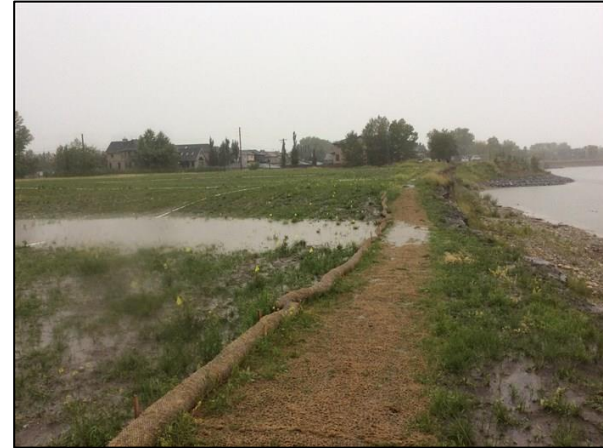
**Photo 2:** Note runoff through swale on riparian bench flowing toward river.

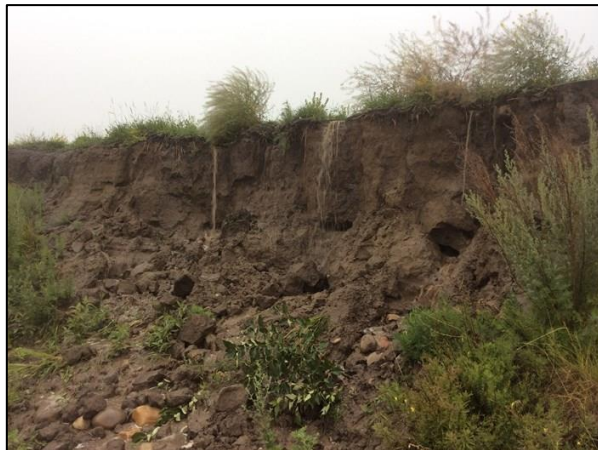
**Photo 3:** Close-up of overflow from swale from riparian bench above.

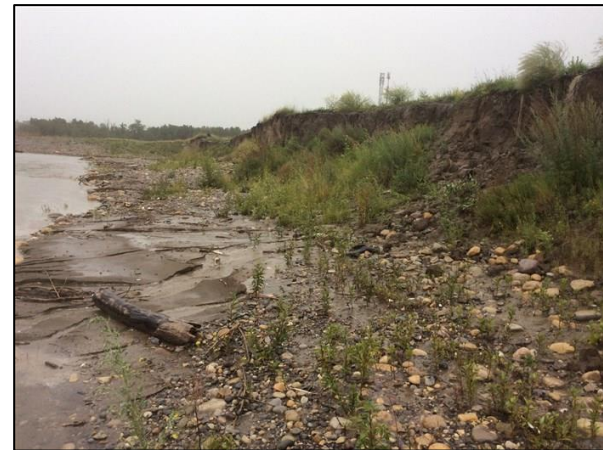
**Photo 4:** Note sediment accumulation caused by drainage from swale on riparian bench above.

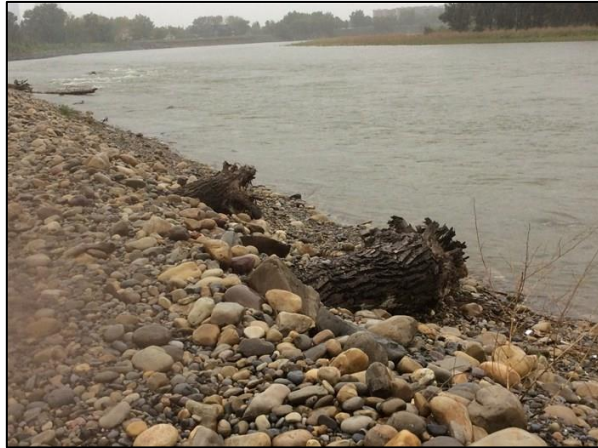
**Photo 5:** View taken from constructed gravel bar on Site 5 noting large woody debris buried as part of previous post-flood reclamation activities.

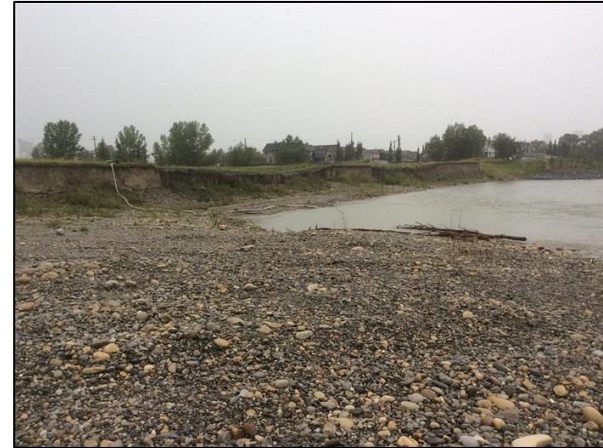
**Photo 6:** View taken from constructed gravel bar on Site 5 towards near vertical bank and bank swallow colony.

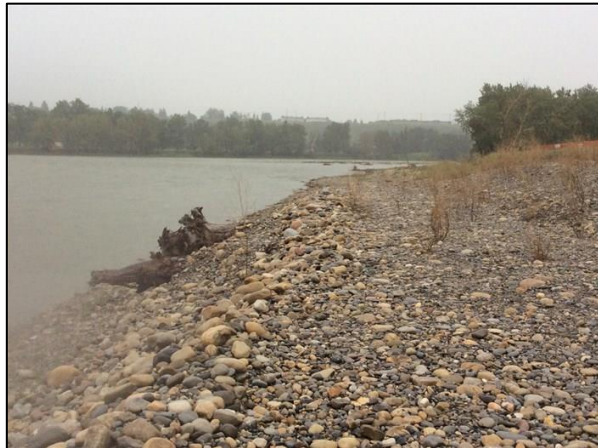
**Photo 7:** View taken from constructed gravel bar. Gravel re-located from Site 3 during post-flood reclamation activities.

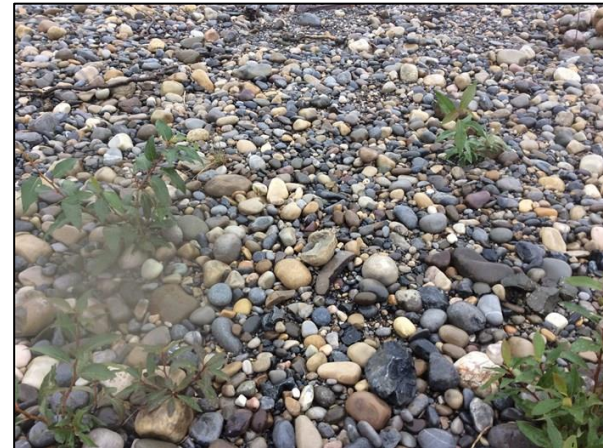
**Photo 8:** Balsam poplar seedlings colonizing the constructed gravel bar on Site 5.

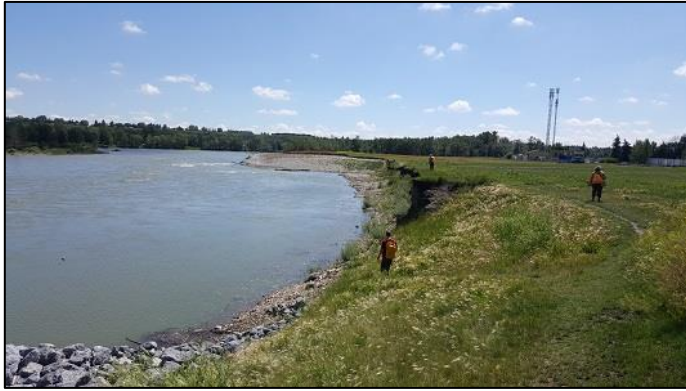
**Photo 9:** Overview of Site 5 looking downstream. Active bank swallow colony near middle of Site.

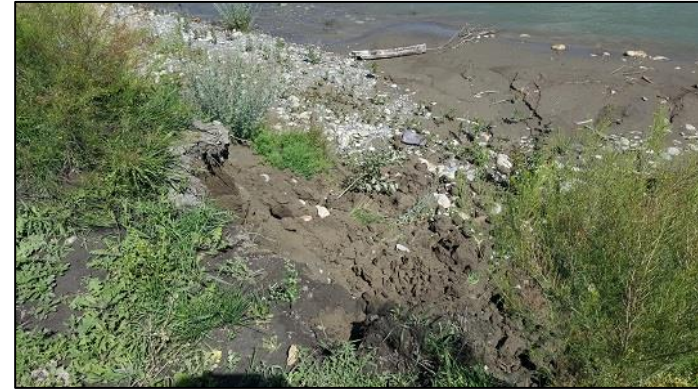
**Photo 10:** Post rainfall runoff deposition of eroded sediments via swales constructed in the re-contoured and reclaimed riparian bench.

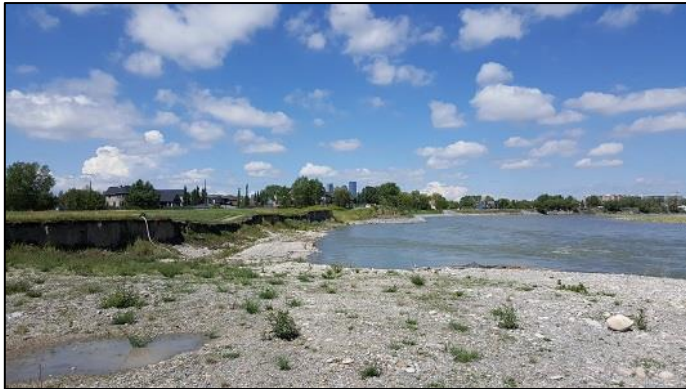
**Photo 11:** View looking upstream from placed constructed gravel bar toward Site 4 /5 boundary and active bank swallow colony.

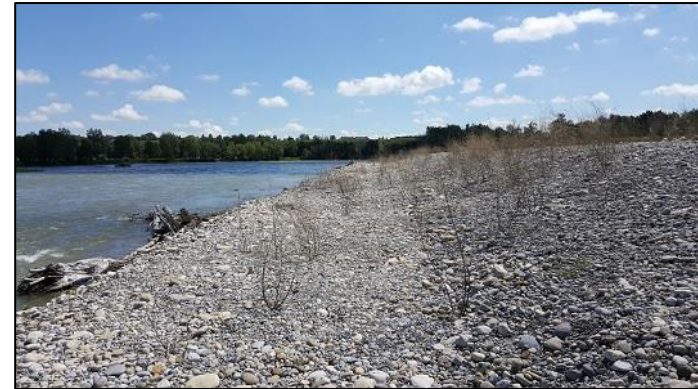
**Photo 12:** Dried and desiccated vegetation on constructed gravel bar placed from Site 3. Note the lower bench available for active mobilization.

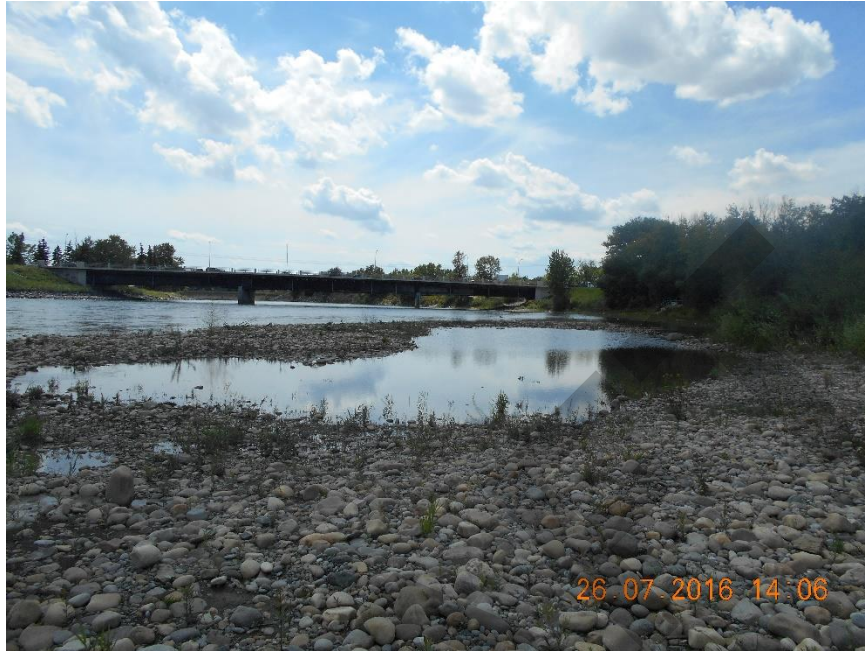
Photo 1. Looking southwest. Gravel bar comprising coarse fluvial channel deposits located in northern portion of Site 1.

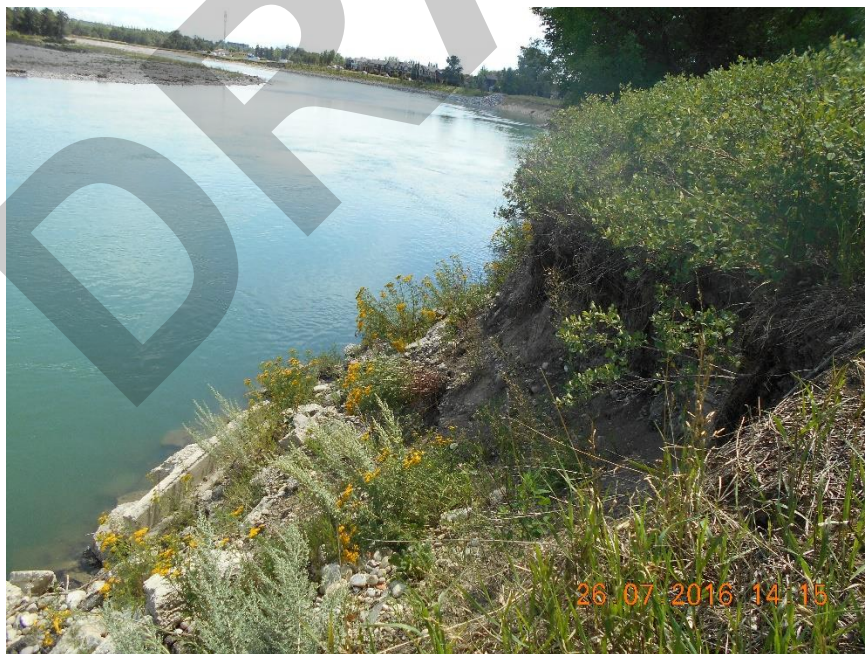
Photo 2. Looking south. River bank erosion in near top of bank of Site 1. Concrete debris is visible at the river water level.

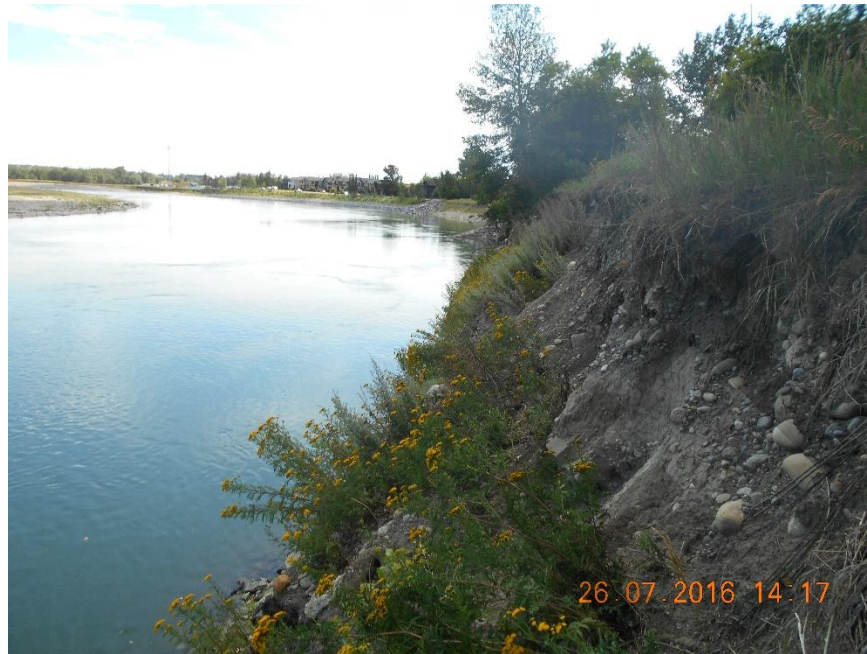
Photo 3. Looking south. River bank erosion near top of bank of Site 1 and exposed soil stratigraphy.

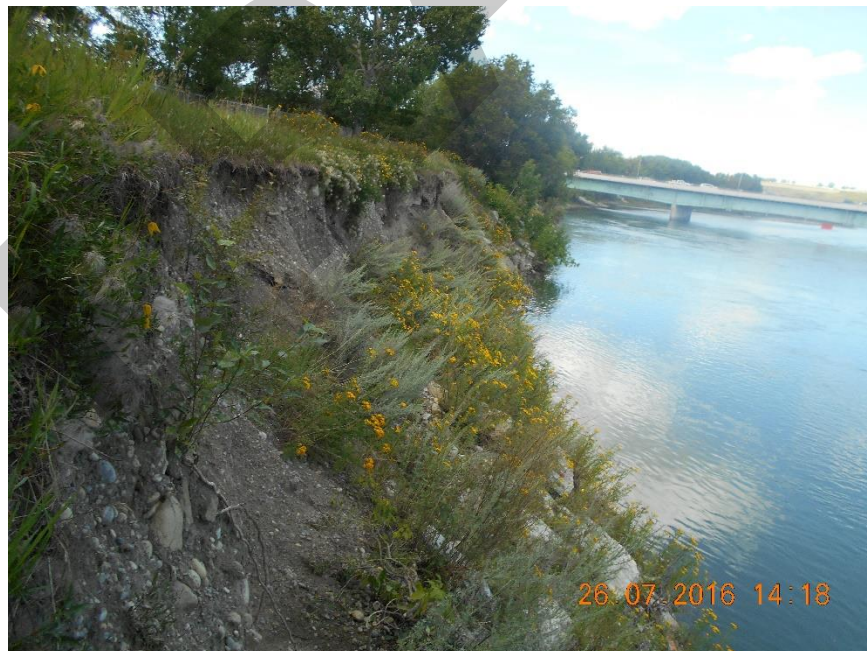
Photo 4. Looking north. River bank erosion of Site 1 and exposed soil stratigraphy. Concrete debris is noted near the river water level.

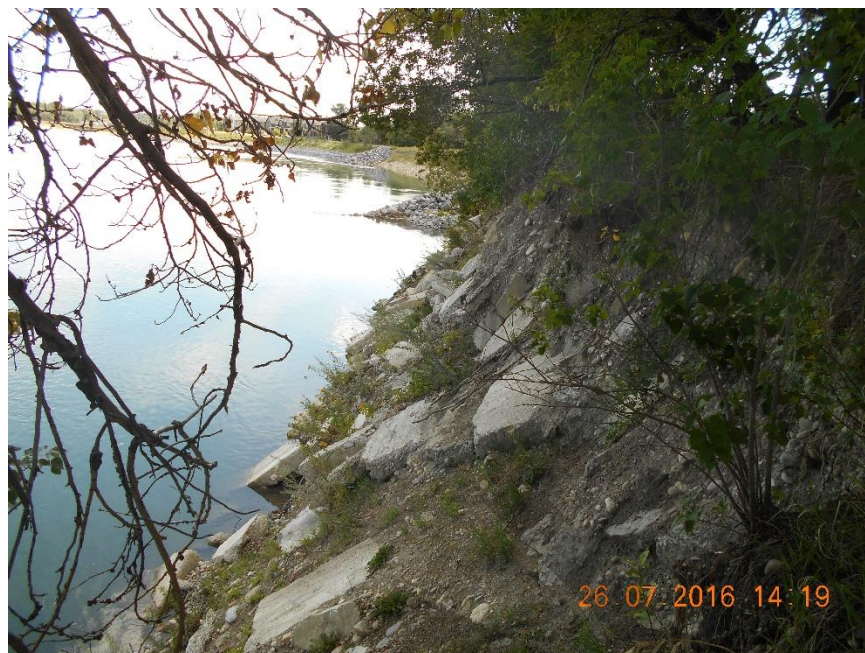
Photo 5. Looking south. Eroded river bank of Site 1 and concrete debris.

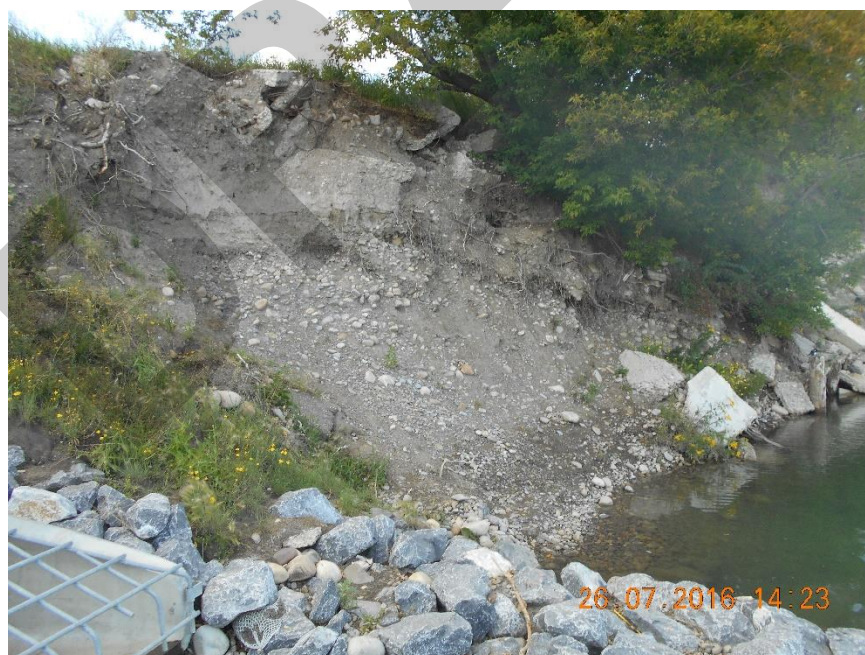
Photo 6. Looking northwest. Eroded river bank and exposed soil stratigraphy in southern portion of Site 1, just north of an existing outfall. Concrete debris is also noted along the river bank.

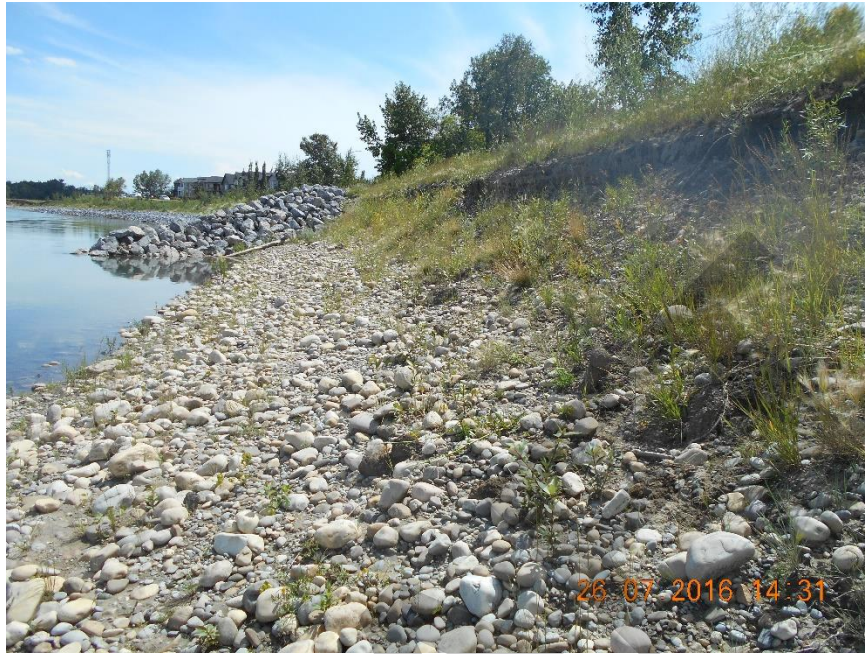
Photo 7. Looking south. River bank of Site 2. Coarse fluvial channel deposits were noted.

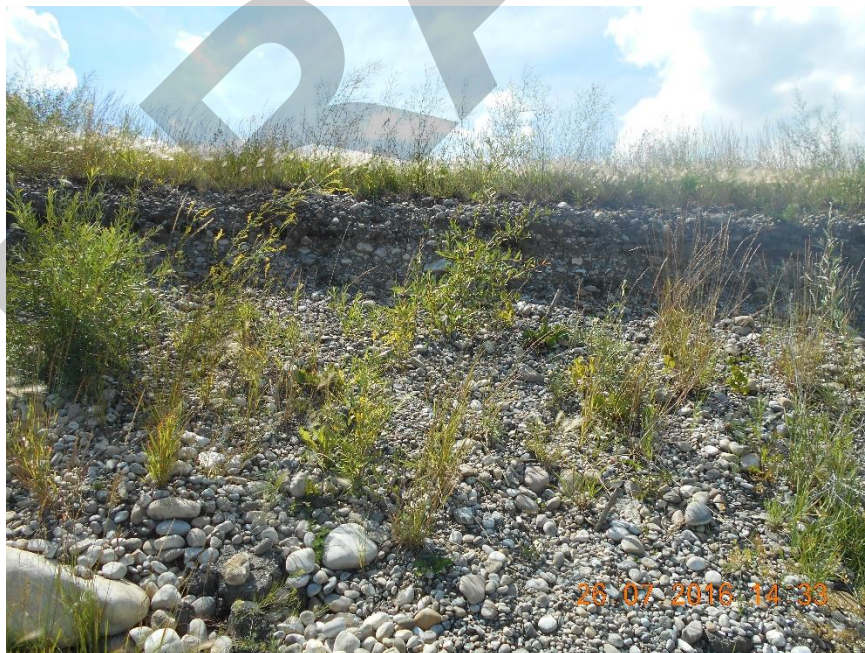
Photo 8. Looking west. River bank of Site 2. Apparent live planter steaks were noted.

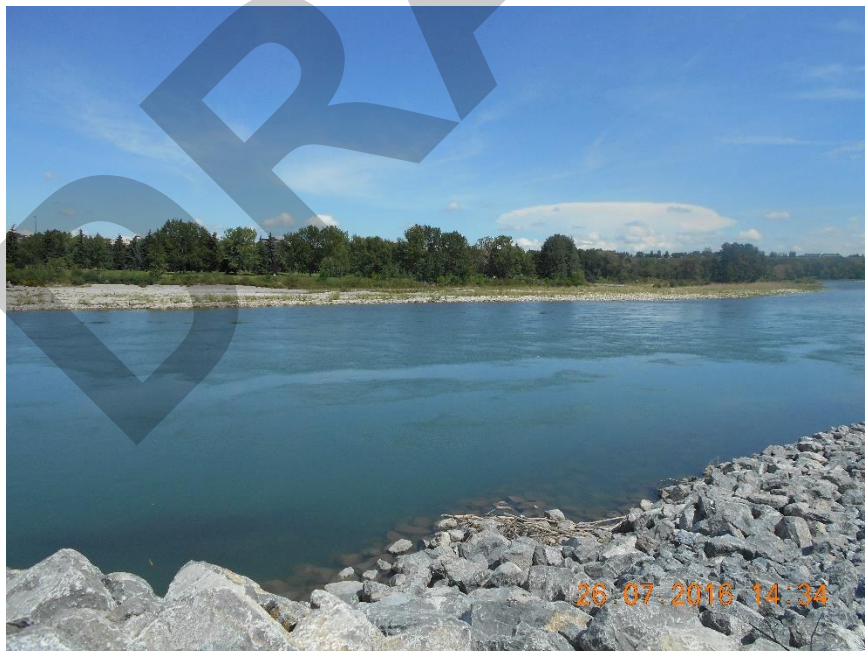
Photo 10. Looking east. Gravel bar comprising coarse fluvial channel deposits in central portion of Site 3.

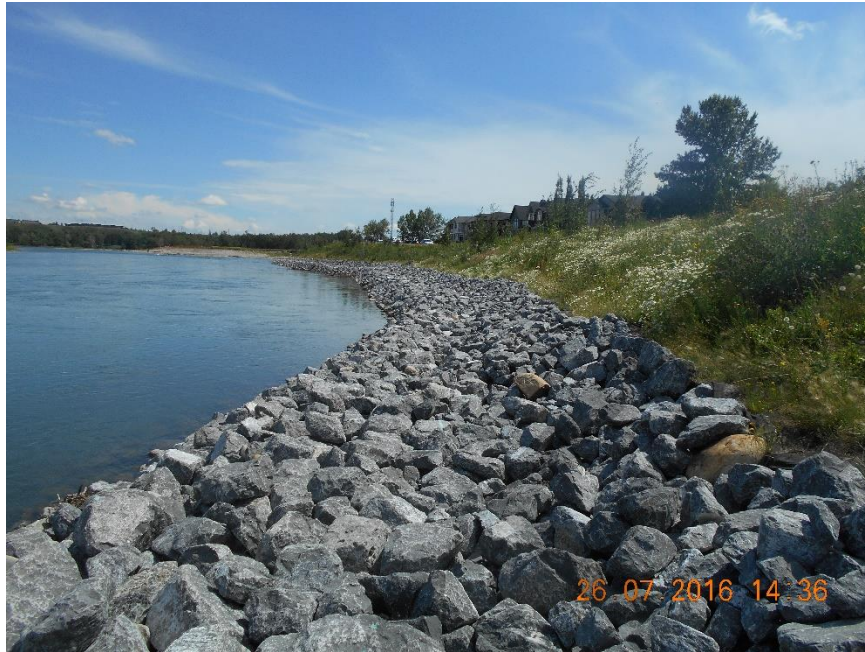
Photo 11. Looking southeast. Riprap along the river bank of Site 4.

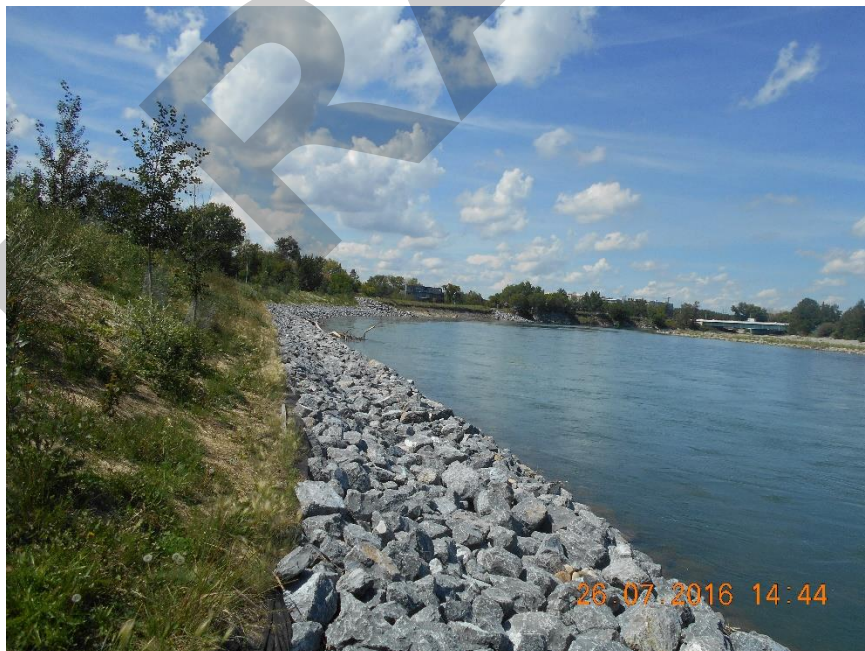
Photo 12. Looking northwest. Riprap along the river bank of Site 4.

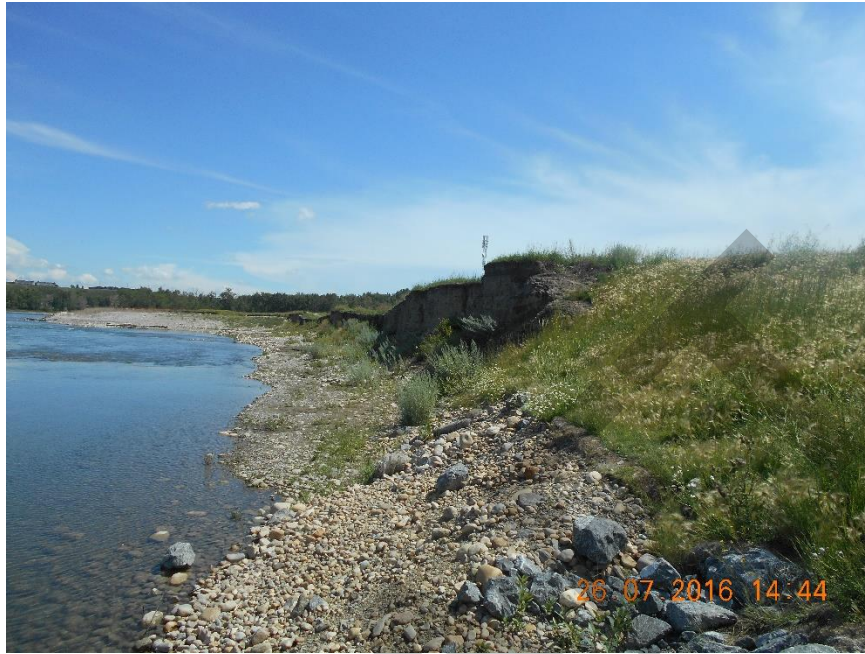
Photo 13. Looking southeast. Northern portion of the river bank of Site 5 and an exposed eroded river bank.

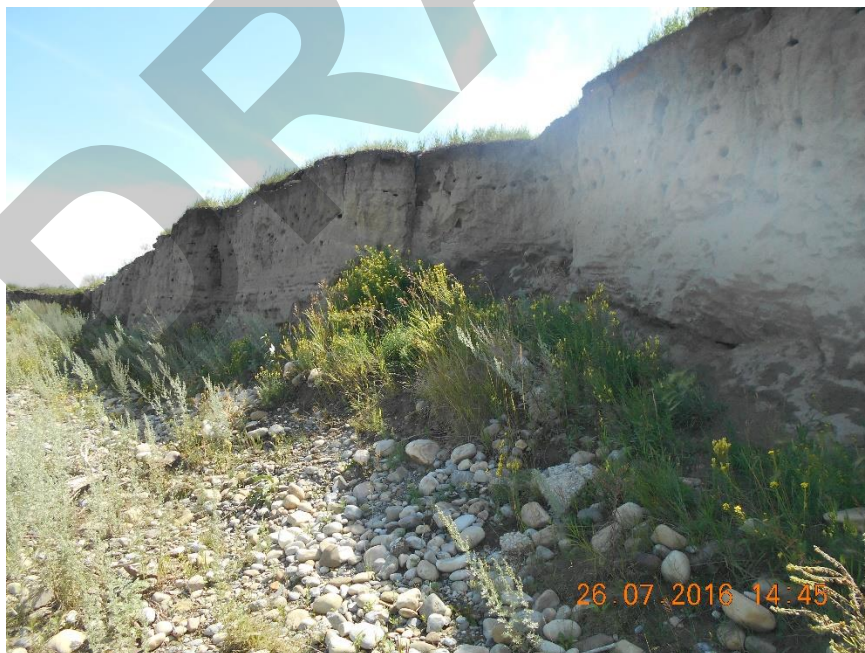
Photo 14. Looking south. Erosion near top of bank of Site 5 and exposed soil stratigraphy.

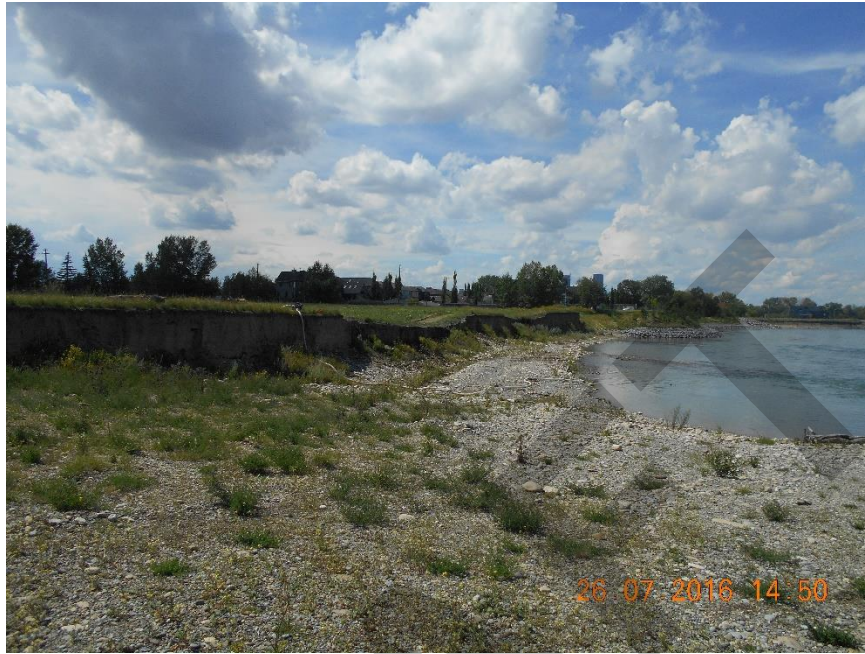
Photo 15. Looking east. Gravel bar comprising coarse fluvial channel deposits and river bank of Site 5.

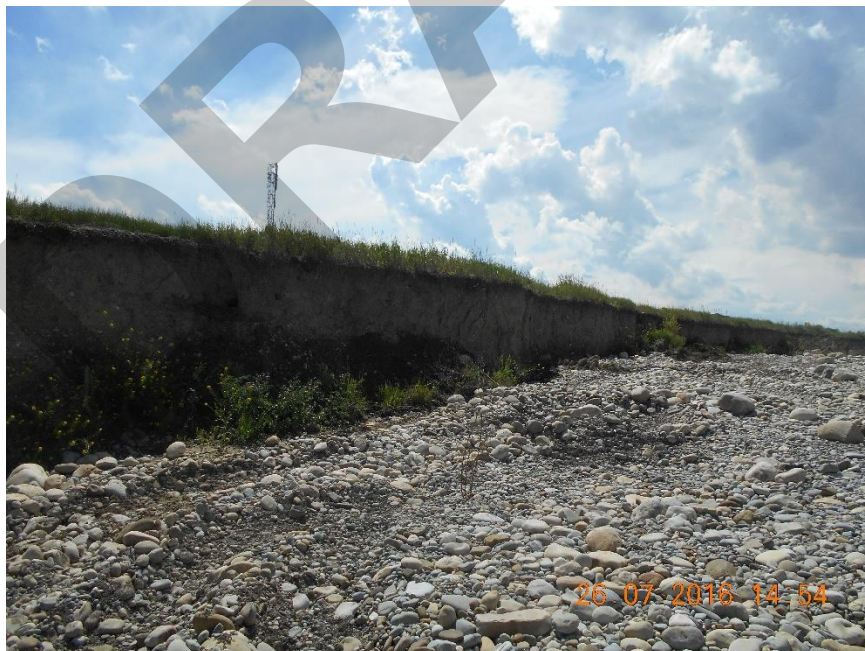
Photo 16. Looking southwest. Gravel bar and river bank of Site 5.

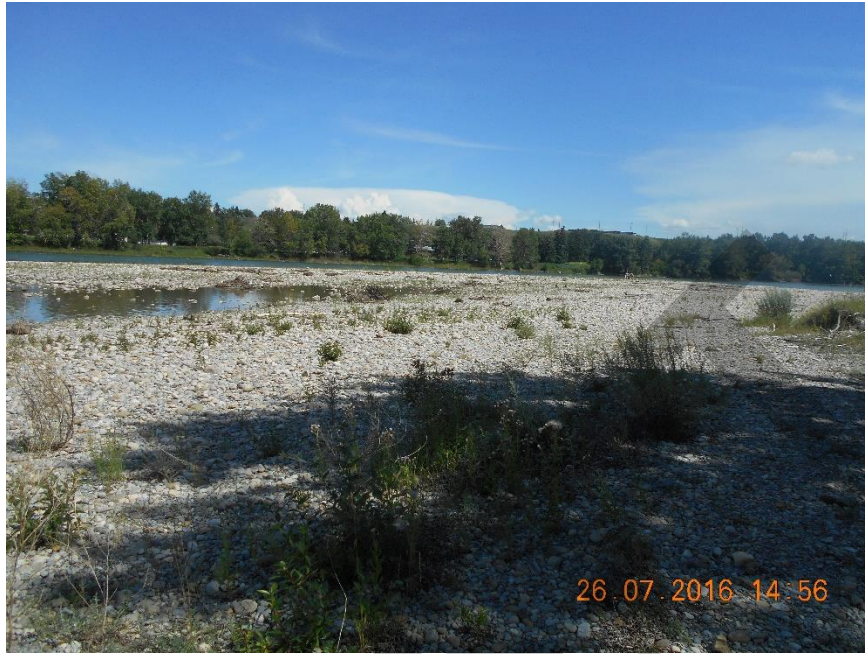
Photo 17. Looking east. Gravel bar in southern portion of Site 5.
