Glenmore Trail East Interchanges Functional Planning Study

Appendix H - Road Safety Audit Report

Glenmore Trail: 100 Street SE to Rainbow Road Road Safety Audit

Glenmore Trail - 100 Street SE to Rainbow Road Interchange Functional Plan Road Safety Audit

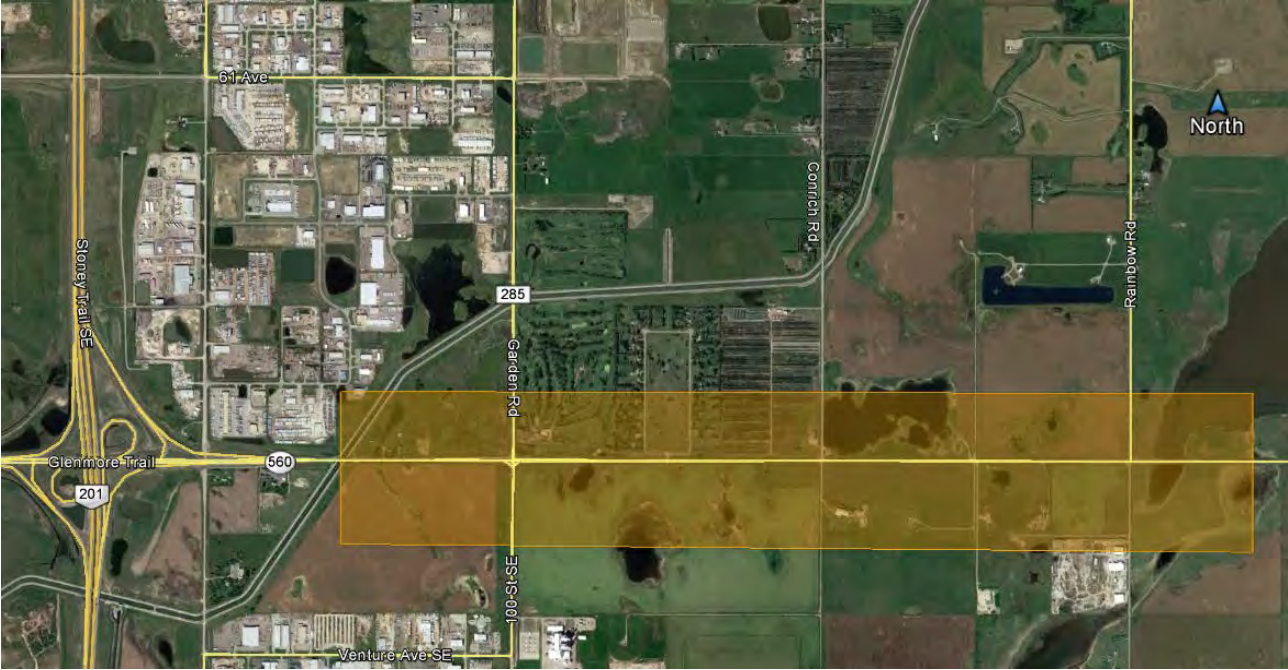
Figure 1: Study Area

The study area, as shown in Figure 1, includes proposed interchanges on Glenmore Trail at 100 Street SE (Garden Road), Conrich Road (Range Road 284), and Rainbow Road (Range Road 283).

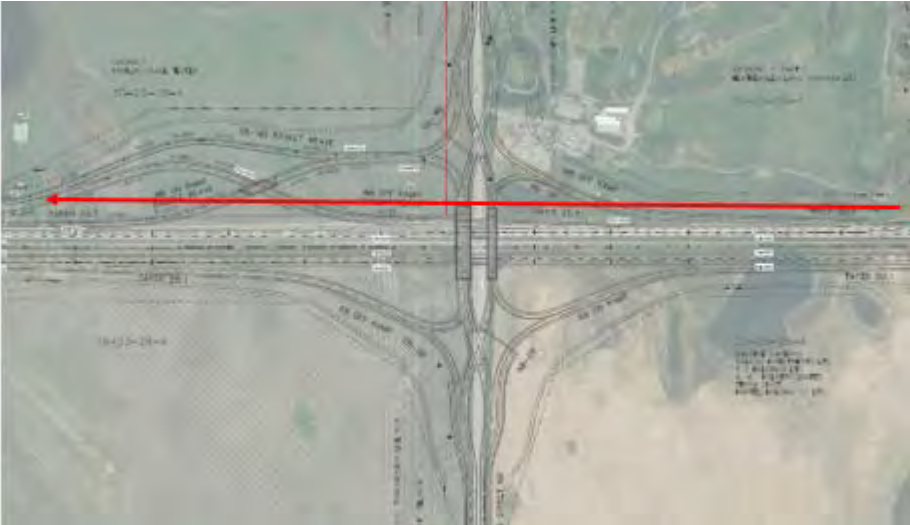
Issue 1	Lane Balance on WB Glenmore Trail	
Description	On WB Glenmore Trail there are numerous lane drops and additions due to added lanes, exit lanes and lane drops. The number of lanes on WB Glenmore Trail transitions from 5 > 4 > 3 > 5 > 4 > 3 > 5 > 4 > 3. This could result in numerous lane changes in the right lanes, creating turbulence and the potential for sideswipe and rear-end collisions.	
Location(s)	WB Glenmore Trail.	
Drawing(s)

<p>Plans: RP1, PP2, Conrich Interchange, Rainbow Road Interchange</p>	
Risk Assessment	Expected Severity:	Property Damage Only - Minor Injury
	Expected Frequency:	> 5 per year
	Risk Rating:	C- D
Mitigation Suggestions	Merging the on-ramps upstream of Glenmore Trail such that there is one added lane instead of two at each interchange could result in four core lanes along Glenmore Trail and reduce the amount of lane changing taking place.

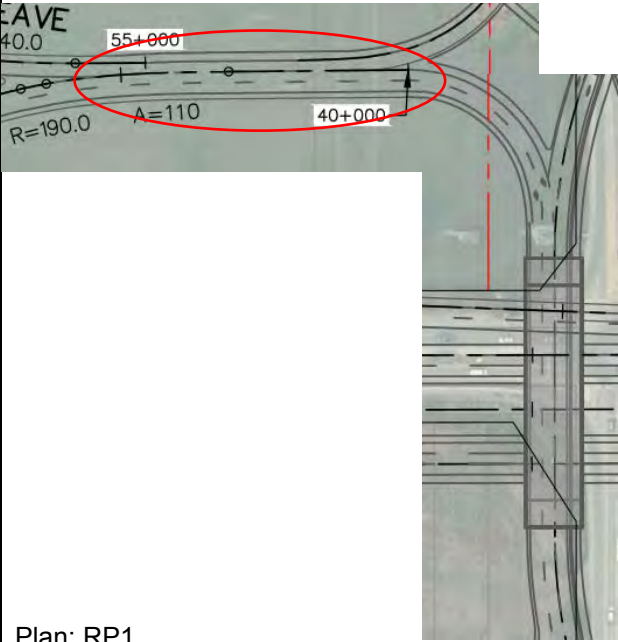
Issue 2	Inadequate Weave and Decision Sight Distance	
Description	<p>For the basket weave option at 100 Street SE, there is a very short weave for SB-WB and NB to Stoney Trail traffic. The short weaving distance may result in sideswipe and rear-end collisions. The risk is amplified by the likely high traffic volumes (particularly trucks) and limited sight distance due to the horizontal curves on both approaches. Furthermore, there is not adequate distance to provide guidance (through guide signs) to motorists at the fork due to the close proximity to 100 Street SE.</p>	
Location(s)	<p>Weaving section in northwest quadrant of 100 Street SE interchange.</p>

<p>Plan: RP1</p>	
Risk Assessment	<p>Expected Severity:</p>	<p>PDO – Minor Injury</p>
	<p>Expected Frequency:</p>	<p>> 5 per year</p>
	<p>Risk Rating:</p>	<p>C - D</p>
Mitigation Suggestions	<ul style="list-style-type: none"> • Increase the length of the weaving section • Relocate the weave further west of intersection • Consider alternate basket weave or interchange configuration

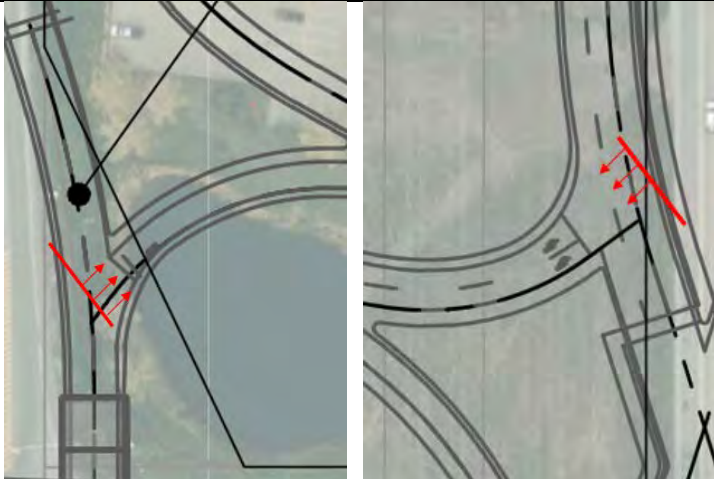
Issue 3	Visibility of Traffic Lights at Terminal Intersections	
<p>Description</p>	<p>It is assumed that the ramp terminal intersections are signalized for the left-turns onto the cross-streets. The positioning of the signal heads may introduce driver confusion if the signals are visible to motorists travelling NB and SB. This may result in NB or SB traffic stopping when not required to do so, which could result in rear-end collisions.</p> <p>Due to the curvature of the ramp approaches, the signals may be difficult to see further in advance of the signal, which increases the risk that motorists will not see the signal (potential red light running) or will see the signal at the last second (sudden braking).</p>	
<p>Location(s)</p>	<p>All off-ramp terminal intersections.</p>	
<p>Drawing(s)</p>

<p>Plans: RP1, PP2, Conrich Interchange, Rainbow Road Interchange</p>	
<p>Risk Assessment</p>	<p>Expected Severity:</p>	<p>Minor Injury – Major Injury</p>

<p>Expected Frequency:</p>	<p>1 – 4 per year</p>
	<p>Risk Rating:</p>	<p>C - D</p>
<p>Mitigation Suggestions</p>	<ul style="list-style-type: none"> • Optimize the angle of the traffic signal heads to maximize the sight distance for the vehicles on the ramp, while minimizing the visibility of the signal for through traffic. • Provide lane designation signs over the signal heads. • Provide a secondary signal that is visible further upstream on the ramps.

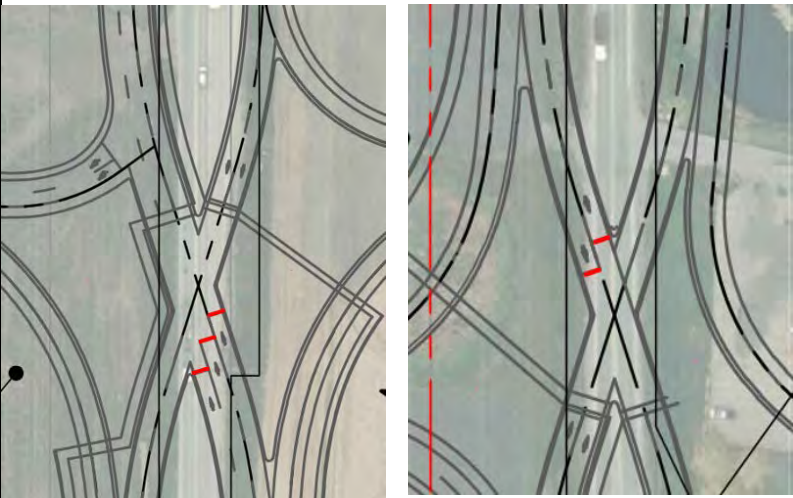
Issue 4		Offset Stop Lines	
Description	<p>The stop bars at the cross-over intersections at the 100 Street SE interchange appear to have significant offsets. This, may result in motorists in the left-hand lanes encroaching into the opposing through lanes if they align with adjacent vehicles rather than the stop bar, particularly if the stop bar is deteriorated or covered in snow. It is noted that pavement markings are not developed at this stage and may not be the intended location for the stop bars, but the comment is still provided for consideration.</p>		
Location(s)	<p>Stop bars at the cross-over intersections at 100 Street SE</p>

<p>Plans: RP1, PP2</p>		
Risk Assessment	Expected Severity:	Major Injury - Fatal	
	Expected Frequency:	<p>< 1 per year, > 1 per 5 years</p>	
	Risk Rating:	C - D	
Mitigation Suggestions	<ul style="list-style-type: none"> Align stop bars with the stop bar furthest from the intersection. Ensure signal timings and clearance provide sufficient yellow and red times to clear the intersection.

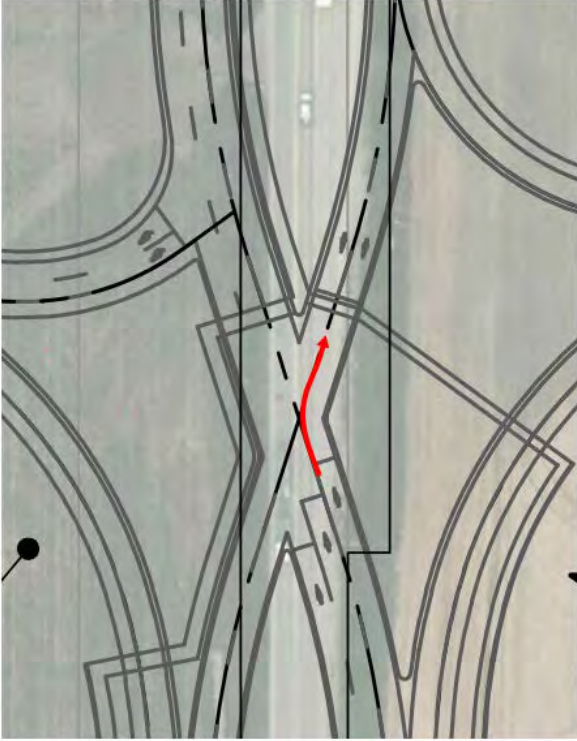
Issue 5	Potential for Wrong-Way Movements	
<p>Description</p>	<p>The geometry of the cross-over intersections is such that opposing traffic lanes align closely with approach lanes at the intersections. This may result in driver confusion with lane designation and the potential for motorists to travel into oncoming traffic lanes. This risk is increased given that driver expectations typically involve travelling on the right-hand side of the road. As such, driver confusion at the cross-over intersections may result in erratic maneuvers, abrupt stopping and traffic blockages, or potentially head-on collisions.</p>	
<p>Location(s)</p>	<p>Cross-over intersections at all interchanges.</p>	
<p>Drawing(s)</p>

<p>Plans: RP1, PP2, Conrich Interchange, Rainbow Road Interchange</p>	
<p>Risk Assessment</p>	<p>Expected Severity:</p>	<p>Major Injury</p>
	<p>Expected Frequency:</p>	<p>< 1 per year, > 1 per 5 years</p>

<p>Risk Rating:</p>	<p>C</p>
<p>Mitigation Suggestions</p>	<p>This risk is common with diverging diamonds, particularly in areas unfamiliar with the configuration. The risk of wrong-way movements can be mitigated during future design stages through clear pavement markings (potentially including leader lines) and signage, including “Do Not Enter” and “Turns Prohibited” signs.</p>

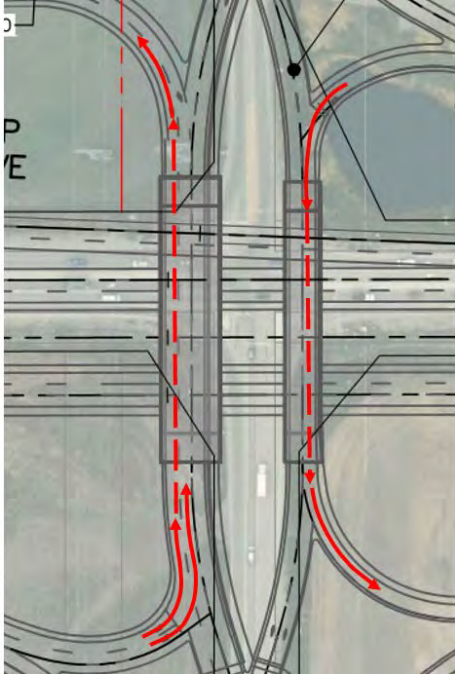
Issue 6	Left-Turns Entering Exit Lane	
<p>Description</p>	<p>At all three interchanges, the eastbound dual left-turn lanes enter three northbound lanes, the left-most of which becomes an exit lane to westbound Glenmore Trail. Motorists are typically required to turn into the lane nearest the left side of the road. This would result in EB-NB motorists in the left-hand lane entering the exit lane. This may result in erratic maneuvers braking as motorists attempt to change lanes into the northbound through lane prior to the exit. As a result, there may be an increased risk of rear-end and sideswipe collisions. A similar issue exists with WB to SB left-turn traffic entering the SB to EB exit lane.</p>	
<p>Location(s)</p>	<p>EB to NB and WB to SB left-turn lanes.</p>	
<p>Drawing(s)</p>

<p>Plans: RP1, PP2, Conrich Interchange, Rainbow Road Interchange</p>	
<p>Risk Assessment</p>	<p>Expected Severity:</p>	<p>Property Damage Only</p>

<p>Expected Frequency:</p>	<p>> 5 per year</p>
	<p>Risk Rating:</p>	<p>C</p>
<p>Mitigation Suggestions</p>	<p>The addition of leader line pavement markings and appropriate overhead guide signage may improve lane delineation and help guide motorists to turn into the appropriate travel lanes.</p>

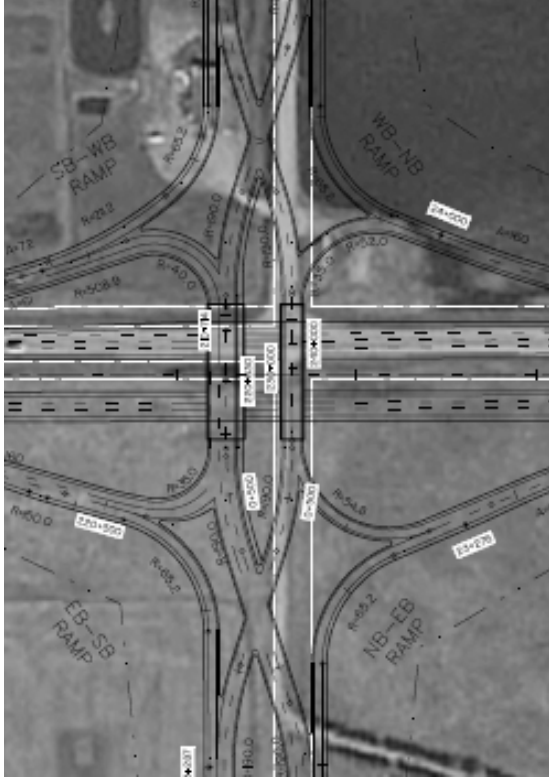
Issue 7	Lack of Pedestrian Facilities	
Description	<p>The drawings provided do not indicate any pedestrian or bicycle facilities at the Conrich Road or Rainbow Road interchanges. Although the interchanges will be in a predominantly industrial area, there still may be desire lines for crossing Glenmore Trail. Failure to provide facilities could result in pedestrians crossing or walking along Glenmore Trail or the cross-streets. Due to the vulnerability of pedestrians, any collisions have the potential to be severe.</p>	
Location(s)	Conrich Road and Garden Road Interchanges

<p>Plans: Conrich Interchange, Rainbow Road Interchange</p>	
Risk Assessment	Expected Severity:	Fatal
	Expected Frequency:	< 1 per 5 years
	Risk Rating:	C
Mitigation Suggestions	<ul style="list-style-type: none"> • Provide pedestrian (and potentially bicycle) facilities on Conrich Road and Rainbow Road; or, • Provide multi-use trail overpasses over Glenmore Trail.

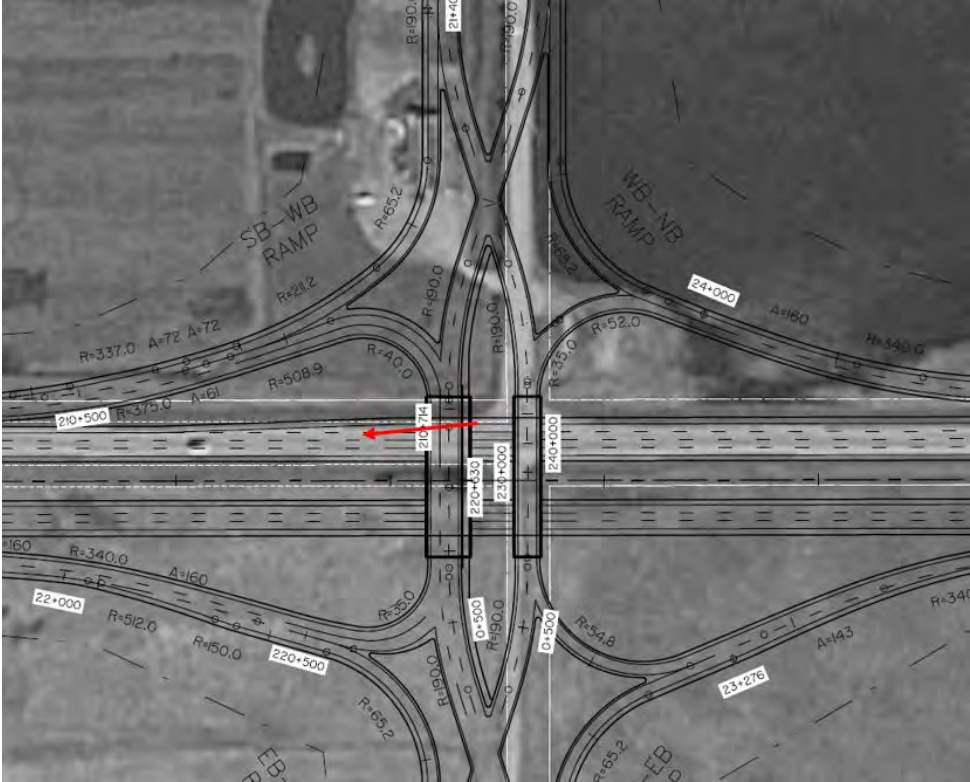
Issue 8	Lane Drops Obscured by Bridge	
Description	<p>On westbound Glenmore Trail, there are lane drops under the Conrich Road and Rainbow Road interchanges. Due to the location of the lane drops under the bridge, they may be difficult for motorists to identify due to obstructions from the bridge, including shadows and poor illumination. The bridge abutment may also make it difficult to sign the location of the lane drop and could pose a hazard in the event of a run-off-road incident. Lane drops under bridges are atypical and may not be anticipated by motorists. Motorists that are not aware of the lane drop might make an erratic lane change or run-off-road.</p>	
Location(s)	<p>WB Glenmore Trail under Conrich Road and Rainbow Road</p>

<p>Plans: Conrich Interchange, Rainbow Road Interchange</p>	
Risk Assessment	<p>Expected Severity:</p>	<p>Minor Injury</p>
	<p>Expected Frequency:</p>	<p>< 1 per year, > 1 per 5 years</p>
	<p>Risk Rating:</p>	<p>B</p>
Mitigation Suggestions	<ul style="list-style-type: none"> Relocate lane drop east of bridge structure See Issue 1 regarding suggestions for WB Glenmore laning

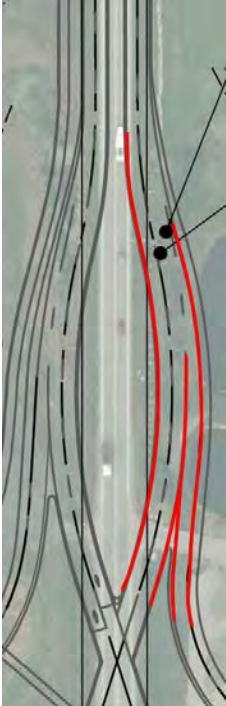
Issue 9	Merge on a Horizontal Curve	
Description	<p>The right-turn from WB Glenmore Trail to NB 100 Street SE merges with NB traffic on a horizontal curve. WB-NB traffic must negotiate a series of reverse curves to complete the movement while at the same time trying to assess gaps in traffic and adjust their speed. Tracking the road alignment and gaps in traffic could be difficult and result in lane departures (sideswipe and run-off-road collision potential).</p>	
Location(s)	WB Glenmore Trail to NB 100 Street SE

<p>Plan: RP1, PP2</p>	
Risk Assessment	Expected Severity:	Property Damage Only
	Expected Frequency:	1 – 4 per year
	Risk Rating:	B
Mitigation Suggestions	<p>Consideration should be given to extending the merge lane to enter 100 Street SE on a tangent section north of the reverse curve to improve the visibility of the ending lane and vehicles in adjacent lanes.</p>

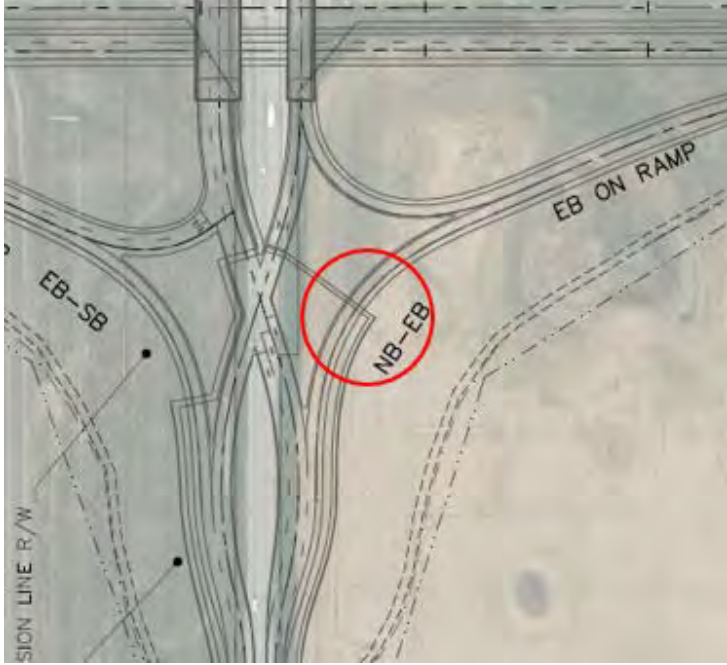
Issue 10 Pedestrian Crosswalks on High Speed Ramps							
Description	<p>The pedestrian cross-walks on the NB to EB and SB to WB ramps at the 100 Street interchange are located mid way down the ramps. At this location, motorists may already be accelerating as they approach the mainline. Furthermore, they may not anticipate pedestrians so far down the ramp. Both of these factors may reduce motorists' ability to stop in the event of a pedestrian crossing.</p>						
Location(s)	<p>NB to EB and SB to WB ramps at the 100 Street interchange.</p>						
Drawing(s)

<p>Plans: RP1, PP2</p>						
Risk Assessment

<table><tr> <td data-bbox="483 1276 1052 1335">Expected Severity:</td> <td data-bbox="1052 1276 1466 1335">Major Injury</td> </tr><tr> <td data-bbox="483 1335 1052 1402">Expected Frequency:</td> <td data-bbox="1052 1335 1466 1402">< 1 per 5 years</td> </tr><tr> <td data-bbox="483 1402 1052 1472">Risk Rating:</td> <td data-bbox="1052 1402 1466 1472">B</td> </tr></table>

Expected Severity:	Major Injury	Expected Frequency:	< 1 per 5 years	Risk Rating:	B
Expected Severity:	Major Injury						
Expected Frequency:	< 1 per 5 years						
Risk Rating:	B						
Mitigation Suggestions	<p>Consider relocating the pedestrian crosswalks further upstream, closer to the slower speed cross-street, where operating speeds are likely lower and motorists are more likely to anticipate pedestrians.</p>

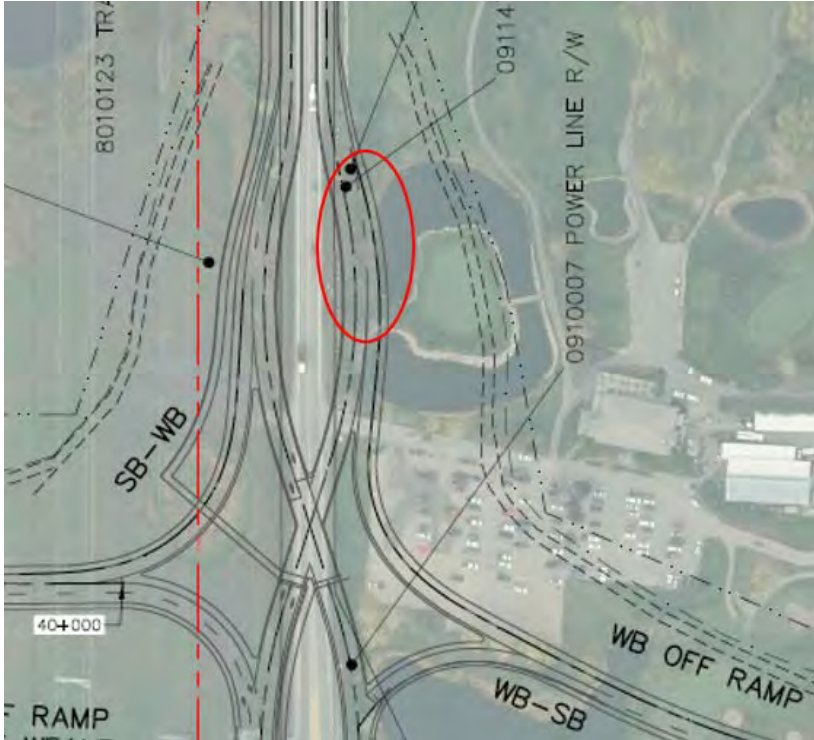
Issue 11 Short Merge Lengths on Glenmore On-Ramps		
Description	<p>At each interchange, the merge of the right-turn with the left-turn exit is relatively short considering the added complexities of the curved approach for the left-turn exit, free-flow left-turns and curvature of the road at the merge location. These factors result in a high workload for motorists who may not have time to adjust their speed and merge accordingly, increasing the risk of rear-end and sideswipe collisions.</p>	
Location(s)	<p>All Glenmore Trail on-ramps</p>

<p>Plans: RP1, PP2, Conrich Interchange, Rainbow Road Interchange</p>	
Risk Assessment	<p>Expected Severity:</p>	<p>Property Damage Only</p>
	<p>Expected Frequency:</p>	<p>1 - 4 per year</p>
	<p>Risk Rating:</p>	<p>B</p>
Mitigation Suggestions	<ul style="list-style-type: none"> Extend the parallel section of the right-turn lanes where they merge with the left-hand exit

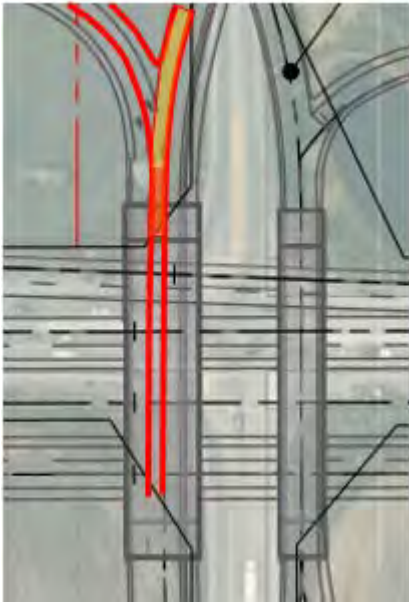
Issue 12	Limited Through Lane Storage Space	
Description	<p>There is limited storage space available for NB through traffic on 100 Street at the north intersection. If the left-hand lane queue was to extend approximately 40m, it would block access to the right-hand NB-WB left-turn lane. In addition to operational issues, there is an increased risk for rear-end collisions for the back of the queue. Left-turn traffic in the middle lane may also make erratic lane changes to avoid the lane blockage, which could result in sideswipe collisions. This issue is not as pronounced in the SB direction or at the other two intersections, but it applies to both options at the 100 Street interchange.</p>	
Location(s)	NB on 100 Street SE at the left-turn exit

<p>Plans: RP1, PP2</p>	
Risk Assessment	Expected Severity:	Property Damage Only
	Expected Frequency:	1 – 4 per year
	Risk Rating:	B
Mitigation Suggestions	<ul style="list-style-type: none"> • Advance overhead signage could encourage through traffic to use the right-most lane. • Review traffic model for likelihood of queue spillback. Consider timing revisions to minimize blockage. • Consider storage extension if feasible.

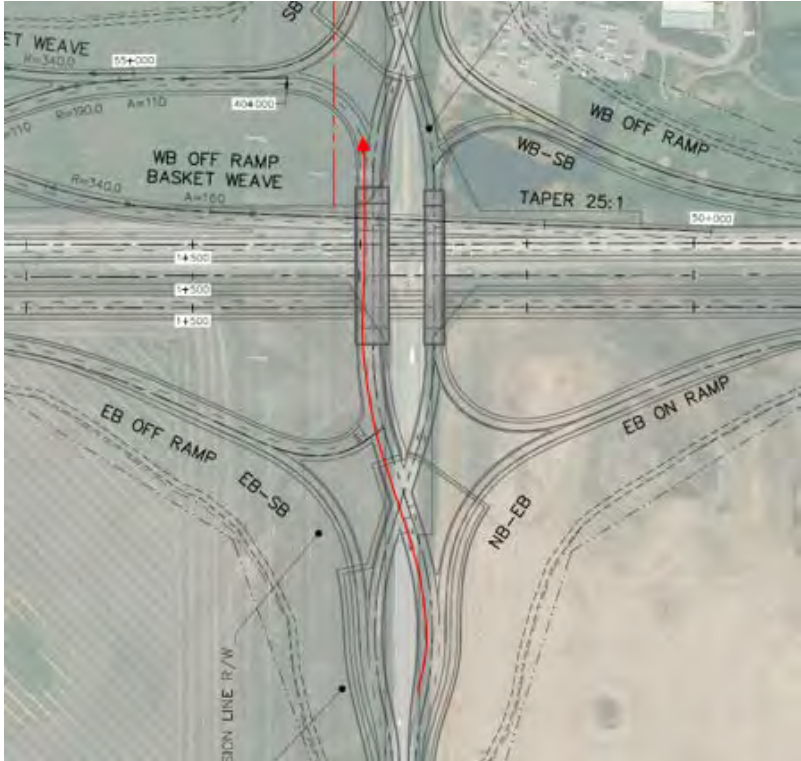
Issue 14	Through Traffic May Enter Long Left-Turn Lanes	
<p>Description</p>	<p>An additional left-turn lane is added on the northbound approaches of all three interchanges. The additional lane provides capacity for traffic headed to westbound Glenmore Trail. The start of the left-turn lane begins upstream of the preceding intersection. Given the distance from the exit, through traffic may mistake the lane as an additional through lane, only to discover they need to get back to the right-hand lanes. This could result in sudden or erratic lane changes or braking.</p>	
<p>Location(s)</p>	<p>NB approach at 100 Street, Conrich Road, and Rainbow Road interchanges</p>	
<p>Drawing(s)</p>

<p>The drawing is a technical plan view of a highway interchange. It shows a central north-south corridor with several east-west ramps. Key features include: <ul style="list-style-type: none"> WB OFF RAMP BASKET WEAVE: A weaving section for westbound off-ramp traffic with a radius of R=340.0 and a taper of A=100. WB OFF RAMP: A ramp for westbound off-ramp traffic. WB-SB: A section for westbound-southbound traffic with a taper of 25:1. EB OFF RAMP: A ramp for eastbound off-ramp traffic. EB-SB: A section for eastbound-southbound traffic. NB-EB: A section for northbound-eastbound traffic. EB ON RAMP: A ramp for eastbound on-ramp traffic. ST WEAVE: A weaving section for southbound traffic with a radius of R=340.0. SB: Southbound mainline. NB: Northbound mainline. EB: Eastbound mainline. WB: Westbound mainline. 50+000 and 40+000: Stationing markers. 1+500, 1+300, 1+100: Vertical curve markers. SEION LINE R/W: Right-of-way line. </p> <p>Plans: RP1, PP2, Conrich Interchange, Rainbow Road Interchange</p>

<p>Risk Assessment</p>	<p>Expected Severity:</p>	<p>Property Damage Only</p>
	<p>Expected Frequency:</p>	<p>1 – 4 per year</p>
	<p>Risk Rating:</p>	<p>B</p>
<p>Mitigation Suggestions</p>	<p>Guide signs could be used to inform motorists of the lane designation. However, consideration should be given to where those signs can be placed as the curvilinear alignments could make it difficult for motorists to see the signs on the approach.</p>
