# Bow River 10 Street Gravel Bar Habitat Restoration Vision

Prepared for The City of Calgary by O2 Planning and Design Inc.

2025-08-29

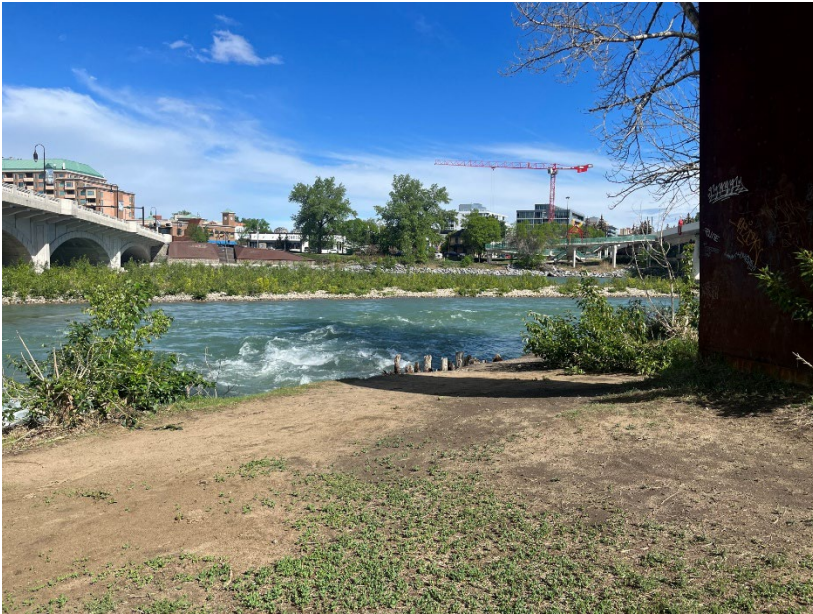
Photo 1. Compacted and bare ground on the south bank east of 10 Street.

The Alberta Riparian Habitat Management Society (Cows and Fish) Riparian Health Inventory assessed the riparian area to be in an unhealthy condition (ARHMS 2020). Vegetation is impacted by human and pet activities as well as river scouring (Photo 1 and Photo 2).

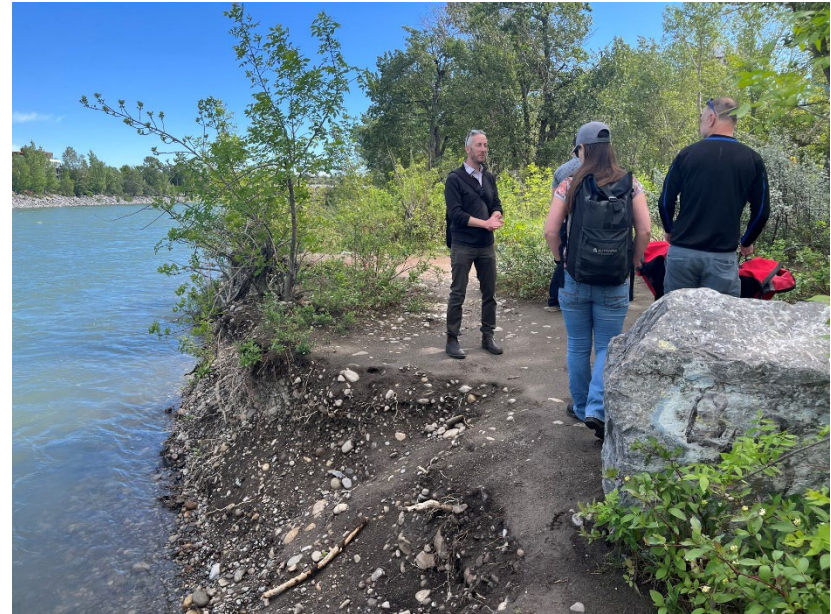
Photo 2. Eroded and compacted riverbank on the south bank east of 10 Street.

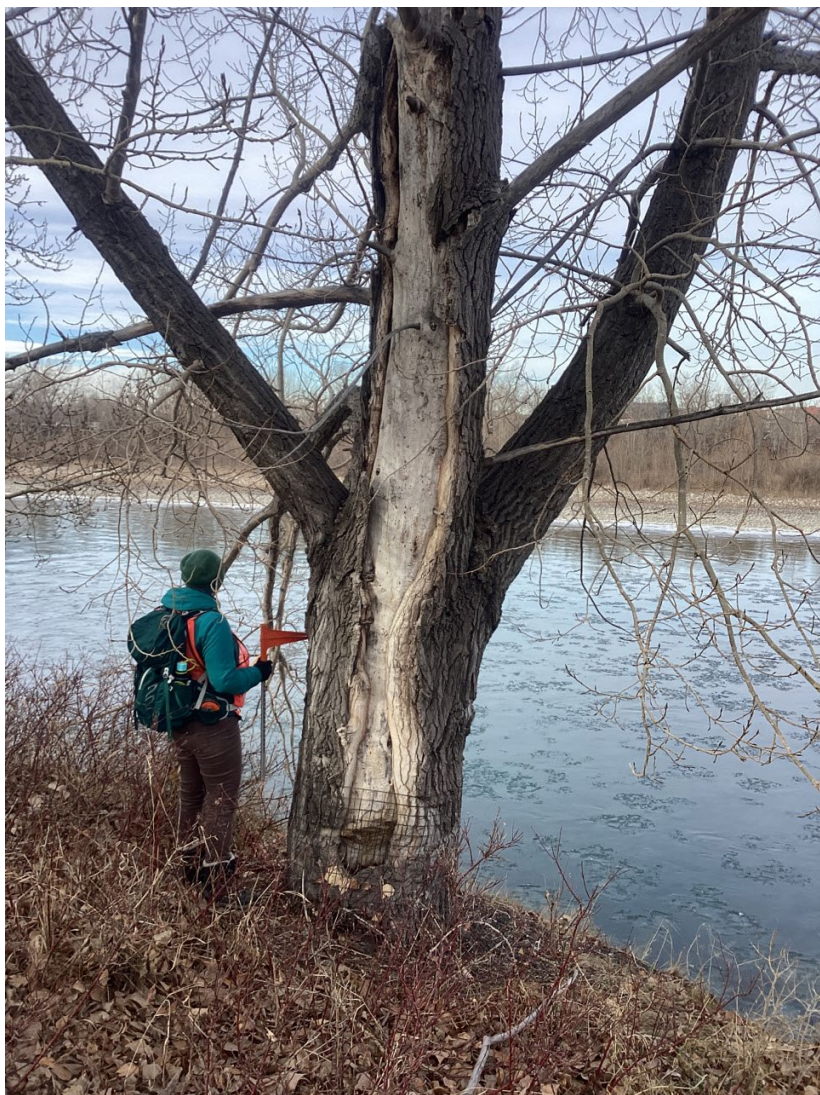
*Photo 3. Large balsam poplar tree inventoried; main stem dead.*

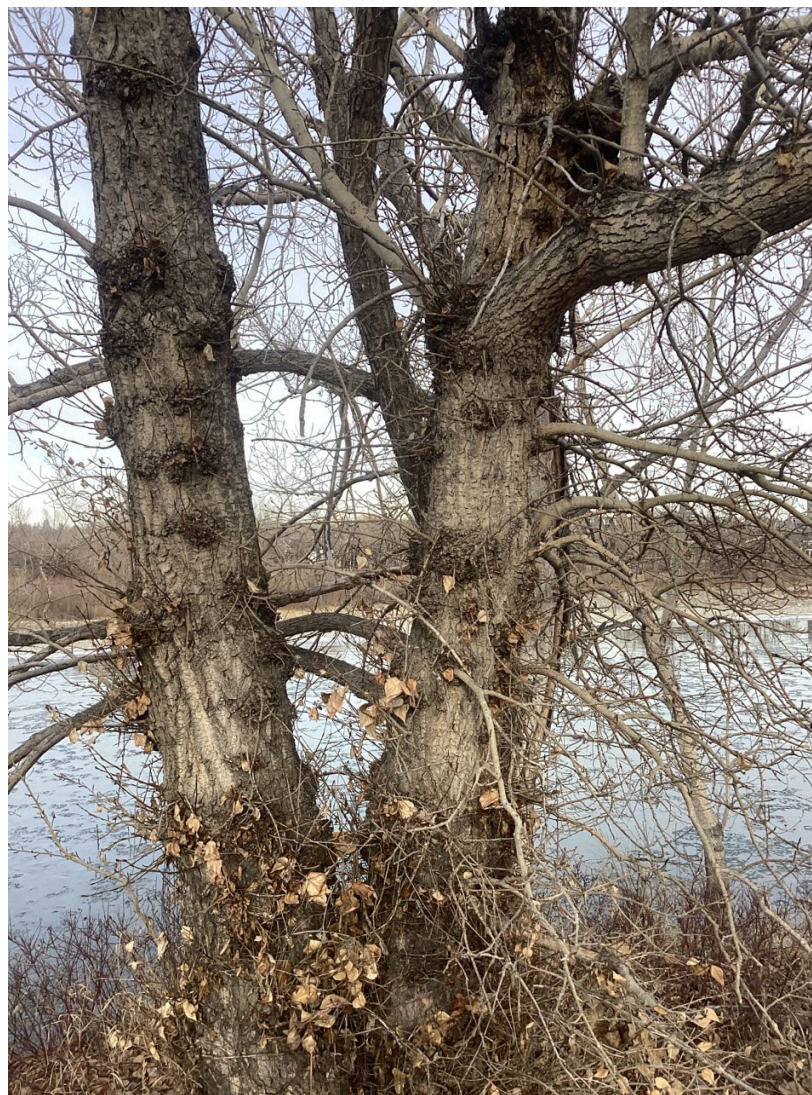
*Photo 4. Large balsam poplar inventoried, main stem split at base.*

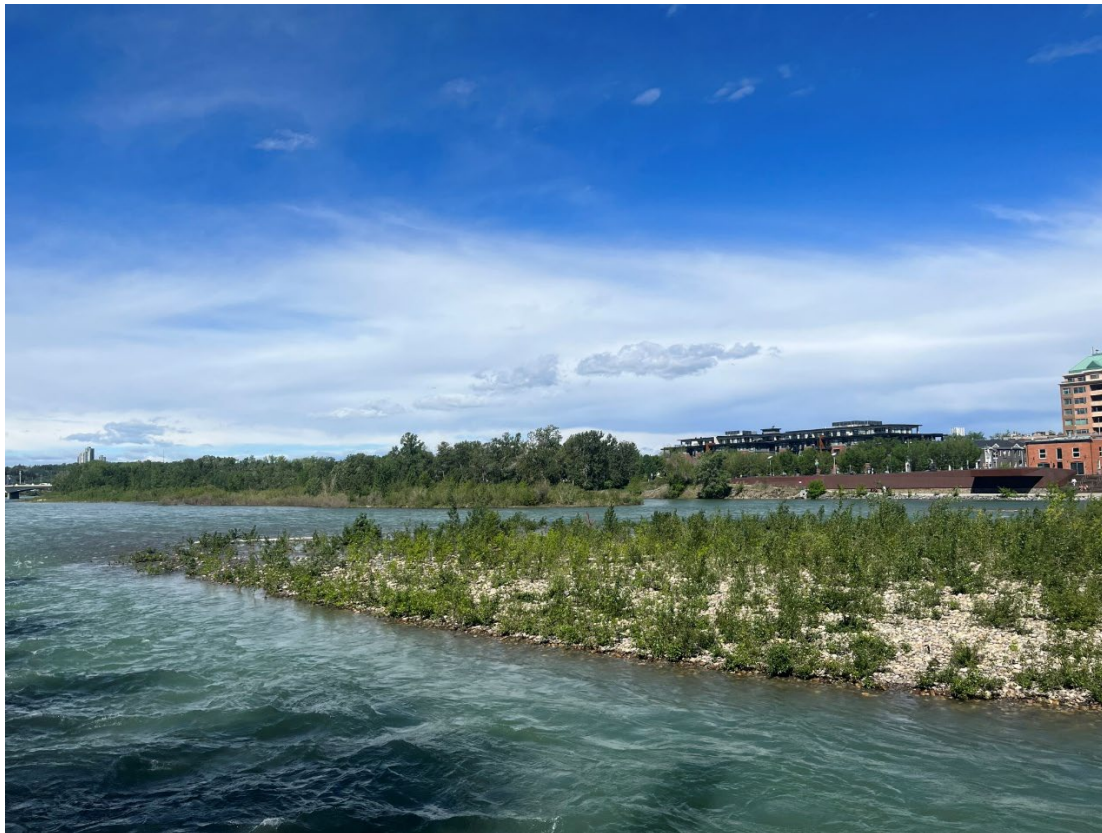
Photo 8. Sandbar willow community type on the 10 Street gravel bar.

The Sandbar Willow community type occurs on moist alluvial deposits subject to frequent annual flooding, ditches, and lakeshores (Photo 8). It is an early seral (pioneer) primary successional stage on newly deposited sediments and commonly occurs in open stands of balsam poplar (*Populus balsamifera*), narrow-leaf cottonwood (*Populus angustifolia*), or plains cottonwood (*Populus deltoides*). Sandbar willow is the major shrub species of this community type and persists under repeated flooding events, sometimes accompanied by red-osier dogwood (*Cornus sericea*), rose species (*Rosa* spp.), and chokecherry (*Prunus virginiana*). Yellow willow (*Salix lutea*) may be present, indicating a possible successional trend toward communities dominated by that species. The herbaceous layer may include a wide variety of pioneering species.
