## **Physical Model Study of Gravel Bar Realignment Designs for the Bow River near Louise Bridge**

Report No.: NRC-OCRE-2024-TR-018

Prepared for: The City of Calgary

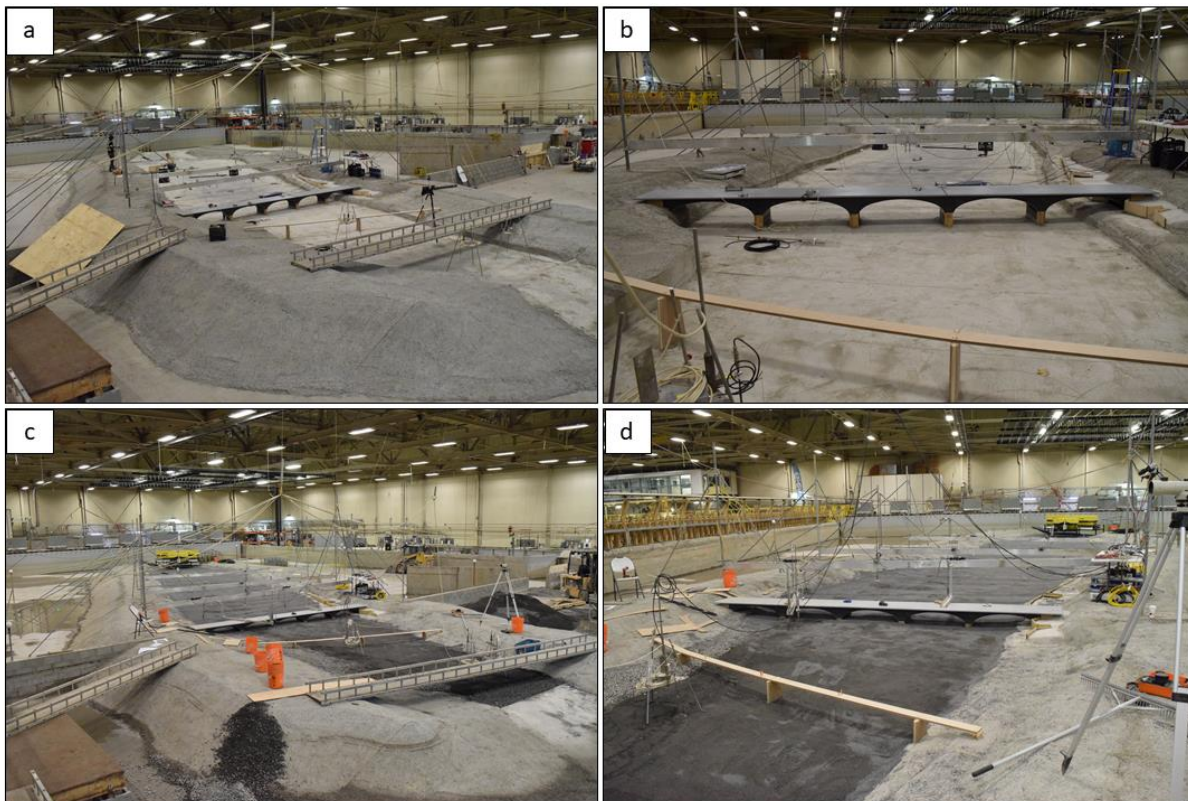
Figure 14. Photographs of the physical model after construction; a) and b) show the model without a mobile bed installed and c) and d) show the model with a mobile bed installed.

Figure 12 displays an overview of the model in NRC-OCRE's LAB, Figure 13 shows an example cross section of the model, and Figure 14 shows photographs of the physical model after construction with and without a mobile bed installed. When projected into real coordinates, the positive x direction shown in Figure 12 is 44.39° counterclockwise from east or 45.61° clockwise from north (i.e. flow velocity in the positive x direction in the model represents flow velocity 44.39° counterclockwise from east in reality).

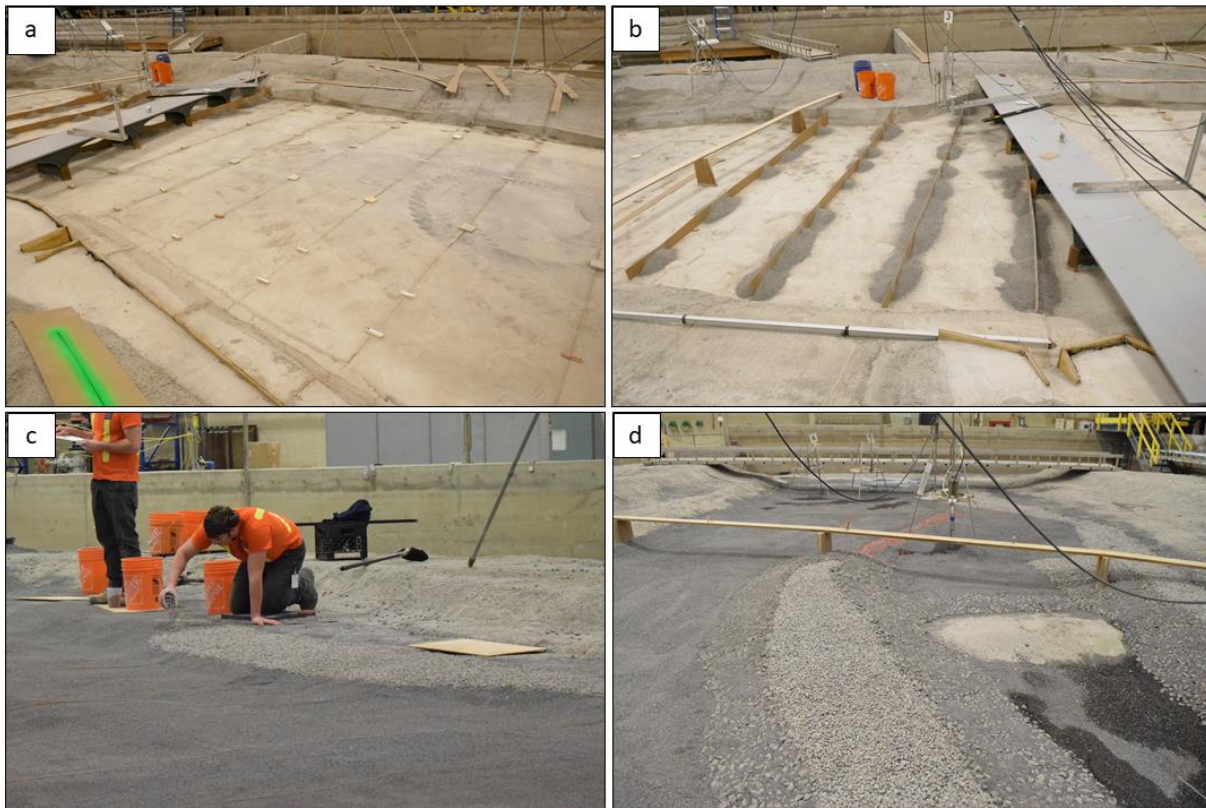
Figure 16. Various stages of the mobile bed construction; a) shows pads installed and levelled on top of the concrete bed, b) shows fiberboard templates installed on top of the levelled pads and prepared for backfilling, c) shows an example of bioengineering stone being installed by hand near Poppy Plaza, and d) shows a portion of the final mobile bed for conceptual design #2 looking downstream from Louise Bridge; riprap material (with voids filled with river sediment) is visible on the edges of the main bar, bioengineering stone is visible on top of the main bar, and transition cobble is visible behind the right (south) pier of the LRT bridge.

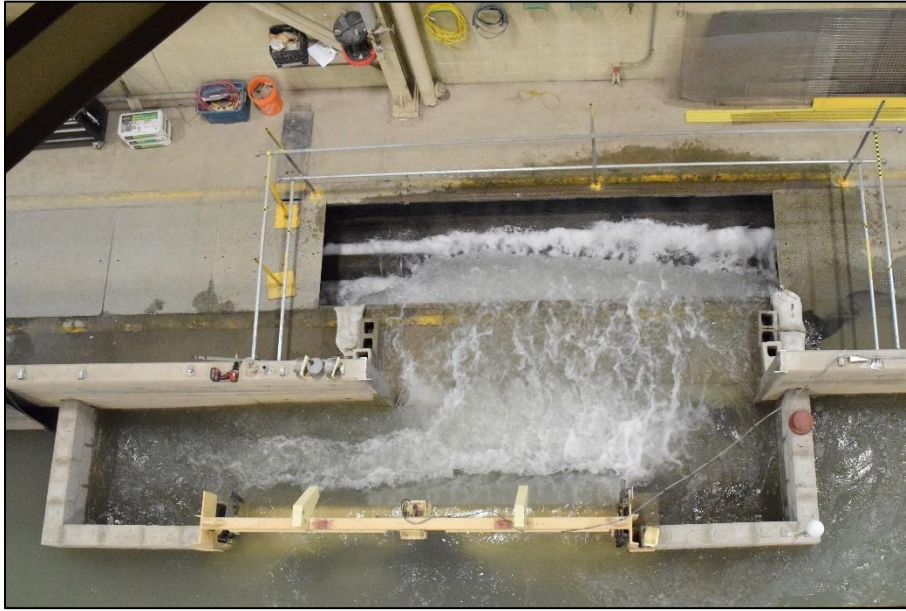
Figure 22. Flow spilling over the control weir into the reservoir sump (photo taken from above).

A schematic showing the flow through the model is shown in Figure 12. The flow was supplied from the underground water storage reservoir (sump) and pumped into the HDF using a variable pitch pump. The flow was controlled by adjusting the vane pitch on the pump control panel. The HDF was connected to the LAB. Masonry walls were constructed to route the inflow from the HDF through the Bow River model reach (i.e. so that flows would not bypass around the outside of the model reach). The flow from the HDF entered the LAB and flooded the area upstream of the model. Once the volume of water was high enough, the upstream end of the river began to flood and the flow travelled down through the model reach. Upon exiting the model reach, flow entered a settling pool before flowing over the control weir. The tailwater elevation (at the downstream end of the model reach) was controlled by adjusting the elevation of the weir. The control weir is shown in Figure 22. Flow spilling over the weir was returned to the water reservoir sump and recirculated back to the basin inflow via the HDF.

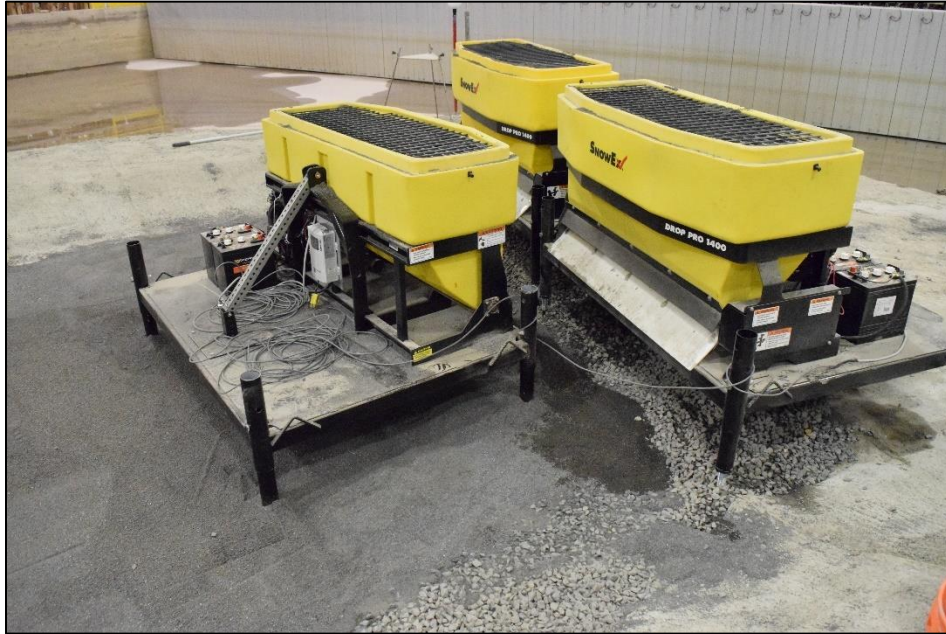
Figure 23 Sediment spreaders installed at the upstream boundary of the model.

Motorized spreaders were used to introduce sediment at the upstream boundary of the model in accordance with sediment loads estimated by the University of Ottawa (see Section 4.1). Three SnowEx SD-1400 spreaders were installed near the upstream boundary and filled with scaled river sediment material. The spreaders were mounted on steel support frames and powered by a custom-designed battery system. The physical properties of the scaled river sediment material were somewhat sensitive to moisture conditions, which could not be easily controlled in the laboratory. Consequently, a calibrated and reliable relationship could not be developed between the motor dial settings and the delivery rate of the river sediment. In lieu of calibrated dial settings, prescribed sediment loads were achieved by filling the spreaders with a known volume of river sediment before each test and carefully monitoring the spreaders to ensure that sediment was introduced into the flow in a consistent manner (i.e. ensure that 25% of the target sediment load was released after 25% of the test duration had passed, ensure that 50% of the target sediment load was released after 50% of the test duration had passed, and so on). Dial settings were adjusted, as needed, during each test and a built-in vibration feature was used occasionally. Lateral and temporal irregularity of sediment delivery may have introduced a model effect in the resulting bed morphology near the upstream boundary. Figure 23 shows the sediment spreaders positioned at the upstream boundary of the model reach. Sediment exiting the model reach at the downstream boundary was allowed to accumulate on the basin floor outside of the model reach (which was lower in elevation than the concrete floor of the model). The accumulated sediment on the basin floor did not appear to influence flows or water levels in the model reach. The accumulated sediment downstream of the model reach was cleared after each test.

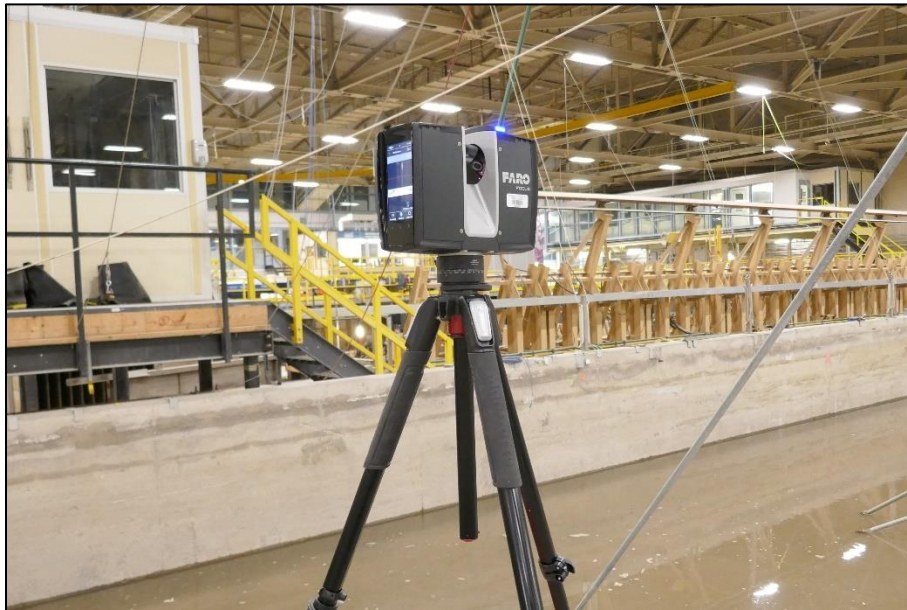
Figure 30. FARO Focus 3D laser scanner.

A FARO Focus 3D laser scanner (Figure 30) was used to survey the bathymetry of the model and record geomorphic change. For each test series, scans were taken before testing (i.e. the initial bed) and after each flow event, including scans of the final bed after all flow events had been run. For each bathymetry of interest, multiple scans were conducted at different locations around the model reach and were stitched together using SCENE software to compile a single, high-resolution point cloud. Each scan had a resolution (i.e. point spacing) of approximately 6.1 mm at 10 m from the scanner (MS). The point clouds were georeferenced and interpolated using Python programming to compile 1 m resolution (FS) digital elevation models (DEM). The resulting DEMs were used to interpret and analyze geomorphic change.

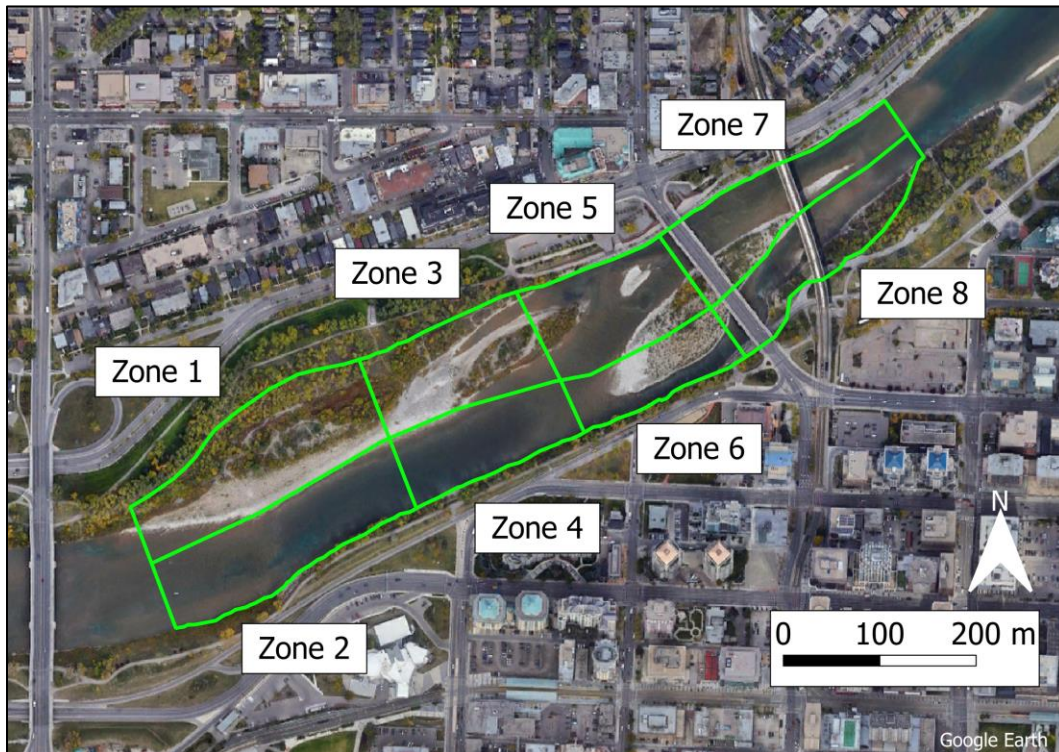
Figure 31. Zones used to assist with the interpretation of erosion and deposition, plotted over a post-flood satellite imagery basemap.

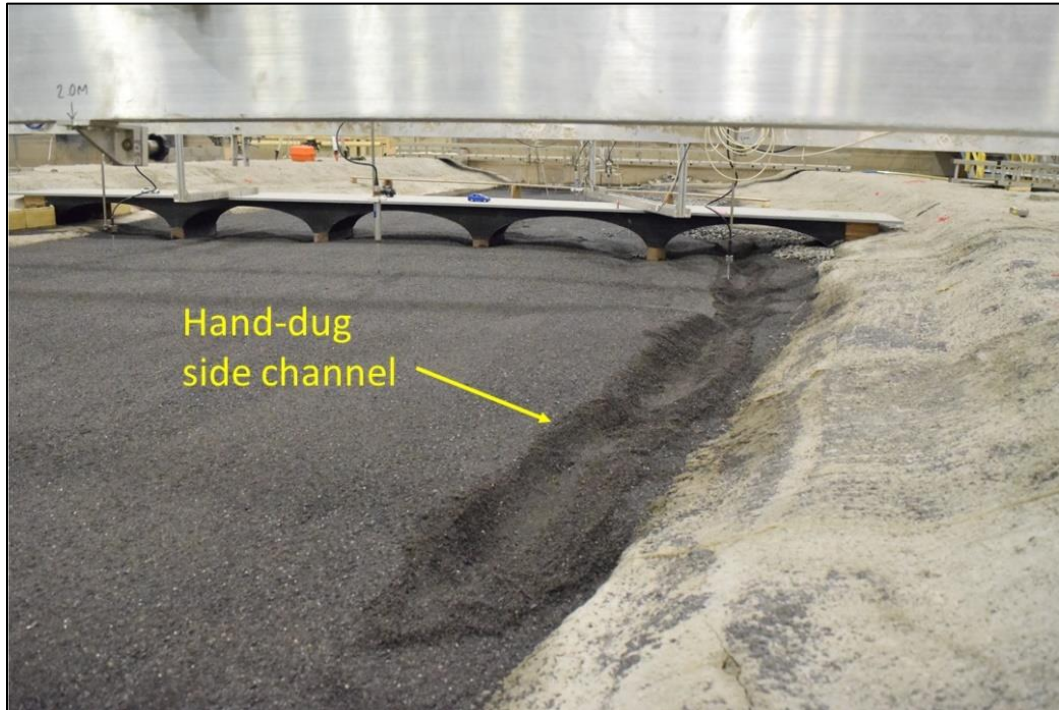
Figure 34. Bathymetry modification for the do-nothing test.

For the do-nothing test, it was determined that the resulting bathymetry from Calibration #2 (CAL2) was generally representative of the current-day bathymetry, providing an opportunity to understand how the existing study site might respond to a major flood event without any intervention to realign the gravel bars. Therefore, for the do-nothing test, the resulting bathymetry from Calibration #2 was modified slightly and then subjected to a 100-year flow condition for 30 hours (5.5 hours MS). The modification involved digging a side channel that was approximately 1.0 to 1.5 m deep and approximately 6 m wide along the south bank near Louise Bridge to better represent the actual bathymetry in this location (Figure 34). The length of the constructed side channel was approximately 180 m, beginning approximately 120 m upstream of Louise Bridge. The side channel extended downstream, underneath of Louise Bridge, toward the landing. This side channel, which is present in reality, was not naturally formed during Calibration #1 or Calibration #2. However, this discrepancy may be explained by potential interpolation errors present in the initial bathymetry. A detailed assessment of the discrepancy is provided in Section 5.1.

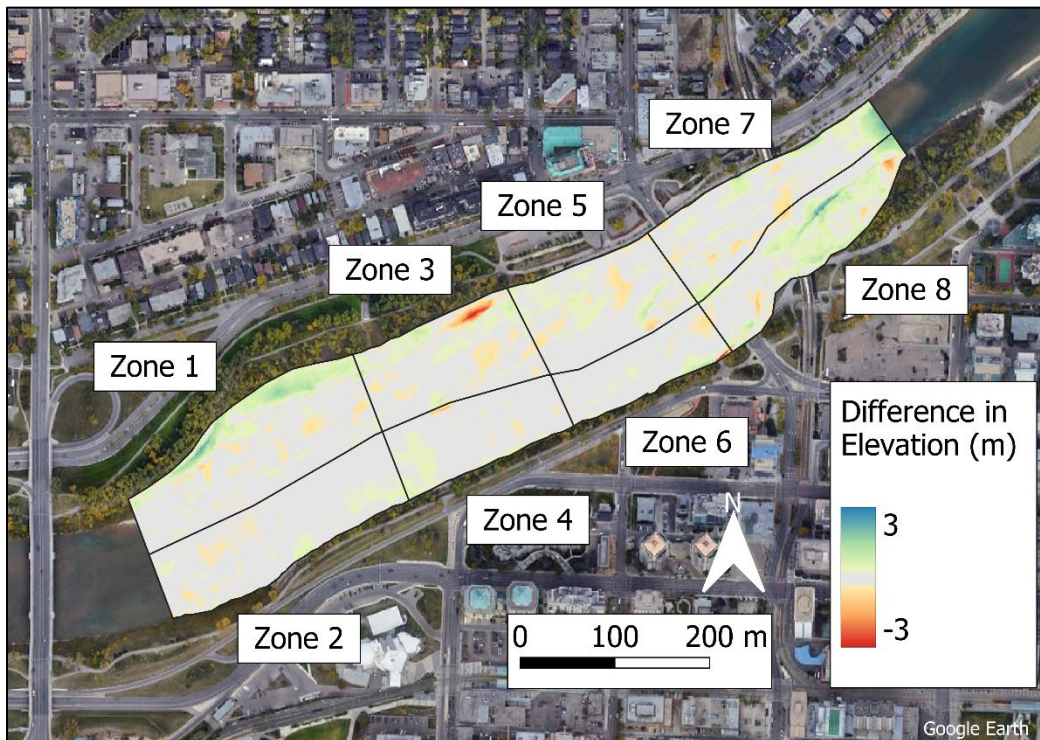
Figure 36. As-built initial bathymetry for CAL1 minus the target pre-flood bathymetry from Golder Associates (2011). Differences in elevation between -0.15 m and 0.15 m are shown in grey. Zone names conform to Table 10.

Figure 35 displays the as-built initial bathymetry for CAL1. Figure 36 displays the difference between the as-built initial bathymetry and the target pre-flood bathymetry from Golder Associates (2011). Figure 37 displays the model bathymetry after CAL1. Figure 38 displays the difference between the model bathymetry after CAL1 and the post-flood bathymetry from City of Calgary (2021). Figure 39 displays the change in the model bathymetry after CAL1 and can be compared directly to Figure 3 to further assess model skill. Computed error values are summarized in Table 10.

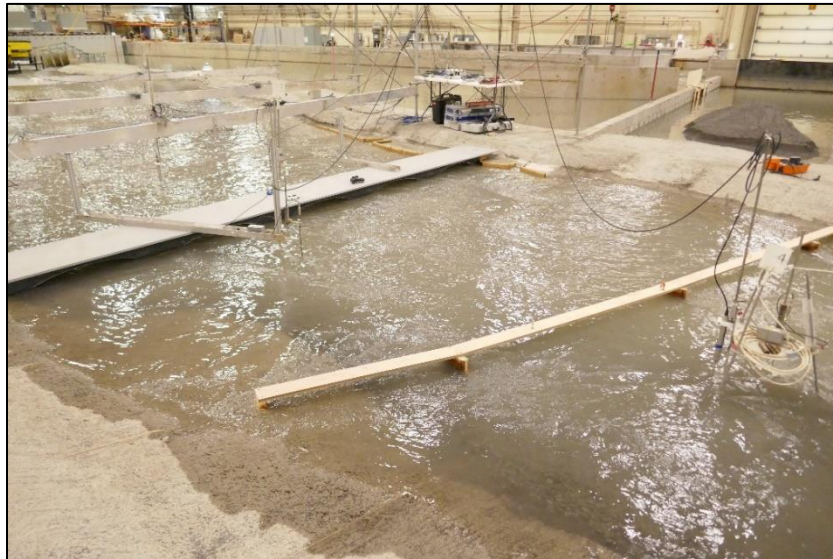
Figure 41. Photo during CAL1\_1750.

Figure 41 shows a photo of the model during the peak flow of CAL1 and Figure 42 shows select photos of the model after CAL1.

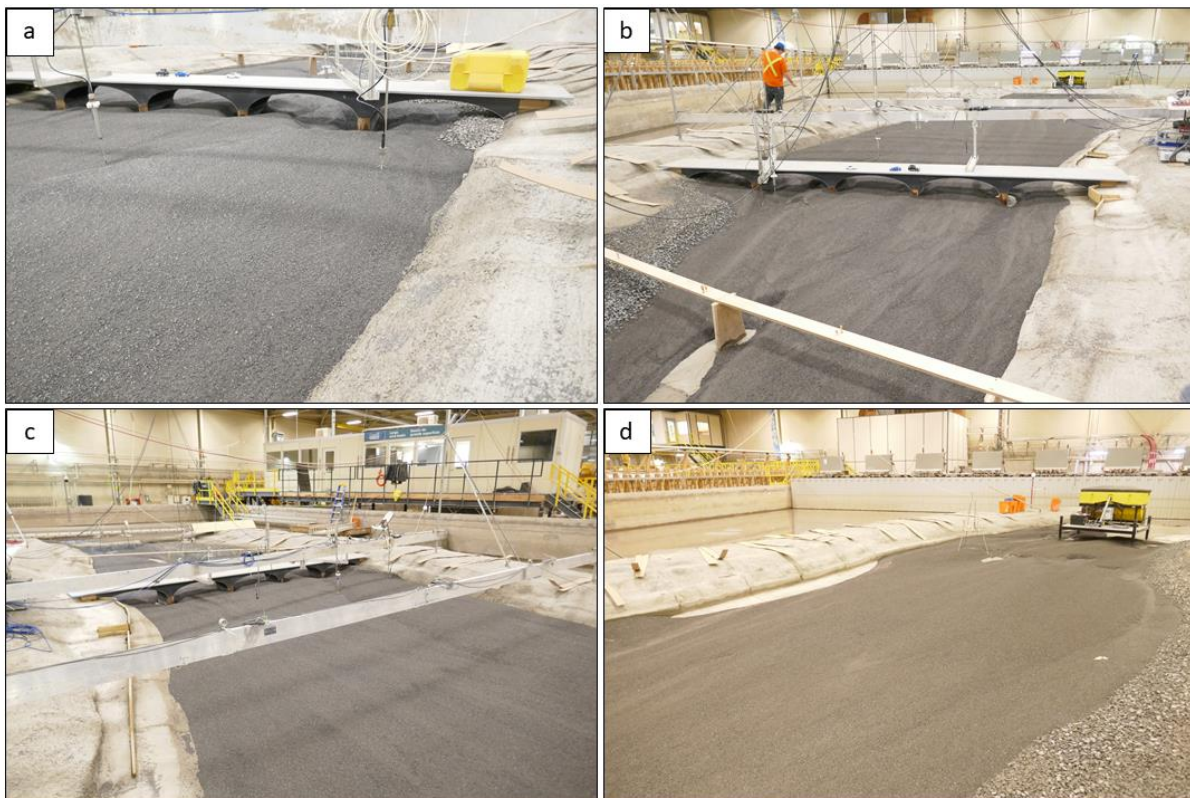
Figure 42. Photos of the model after CAL1; a) standing at the south embankment looking downstream, b) standing near the north abutment of the LRT bridge, looking upstream, c) standing at Poppy Plaza, looking downstream, and d) standing at Poppy Plaza, looking upstream.

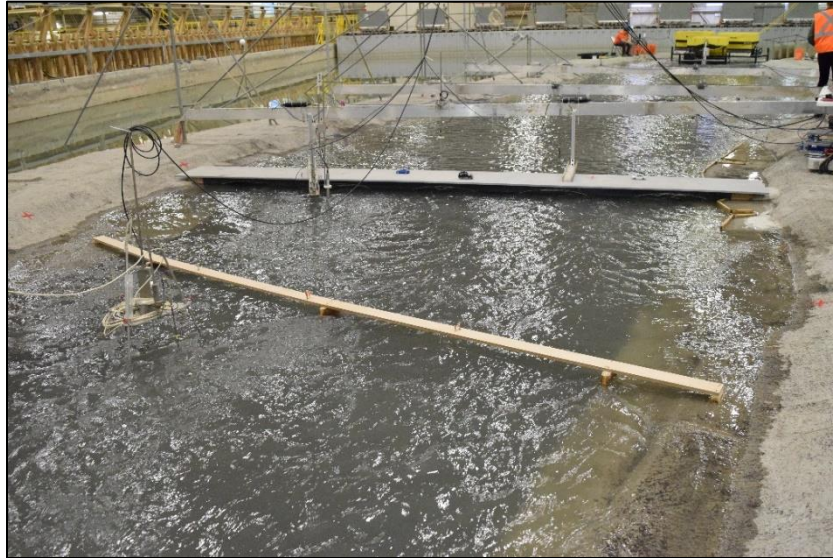
Figure 54. Photo of the model during the do-nothing test (standing near the north side of the downstream boundary, looking upstream).

Localized deposition was observed on the south side of the main bar upstream of Louise Bridge (zone 6), suggesting that the main bar would continue to grow towards the south bank during a 100-year flood if no action is taken to modify the site. This observation agrees with the findings from Yu et al. (2022) who concluded that deposition would continue to occur on the right (south) side of the gravel bar if no action is taken based on numerical modelling. Yu et al. (2022) also concluded that deposition would continue to occur near the nose of the main bar, and this was generally observed in the physical model as well (e.g. the deposition near the upstream portion of zones 5 and 6). Downstream of Louise Bridge, results from Yu et al. (2022) indicated that erosion would occur along the north side of the main bar and deposition would occur along the right side. The physical model results indicated a generally erosive environment downstream of Louise Bridge on both sides of the main bar, although some localized deposition was observed immediately south side of the main bar. The physical model results indicated that net deposition would occur on both the north and south side of the channel upstream of the main bar (zones 3 and 4). Figure 54 shows a photo of the model during the do-nothing test and Figure 55 shows select photos of the model after the do-nothing test.

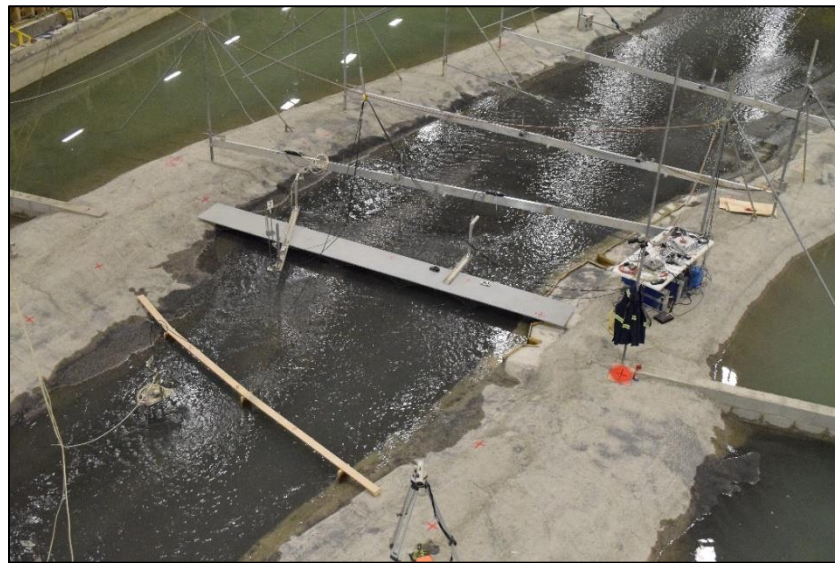
Figure 63. Photo of the model during TSA\_850.

The scan data indicated localized sediment deposition in the habitat channel, as well as deposition in the habitat channel crossover. Some localized erosion was observed along the north edge of the habitat channel. Net erosion was observed along a large portion of the south embankment, upstream of the main bar (zones 2 and 4). Deposition was generally observed north and south of the main bar upstream, and underneath, of Louise Bridge (zones 5 and 6, and the upstream portions of zones 7 and 8). Localized scour

was observed in the recreation channel downstream of Louise Bridge, adjacent to the landing. A localized area of increased flow turbulence was observed immediately downstream of the armoured main bar nose, creating surface water undulations, and potentially contributing to some of the erosion observed along the main bar. Sediment input at the upstream boundary was concentrated on the south side of the boundary. It is believed that this approach was, in part, responsible for the scour observed on the northern portion of the boundary and the deposition observed on the southern portion of the boundary. Sediment introduction was more evenly distributed across the length of the upstream boundary for subsequent tests. Figure 63 shows a photo of the model during TSA\_850, Figure 64 shows a close-up photo of the turbulence downstream of the armoured main bar nose, and Figure 65 shows select photos of the model after TSA\_850.

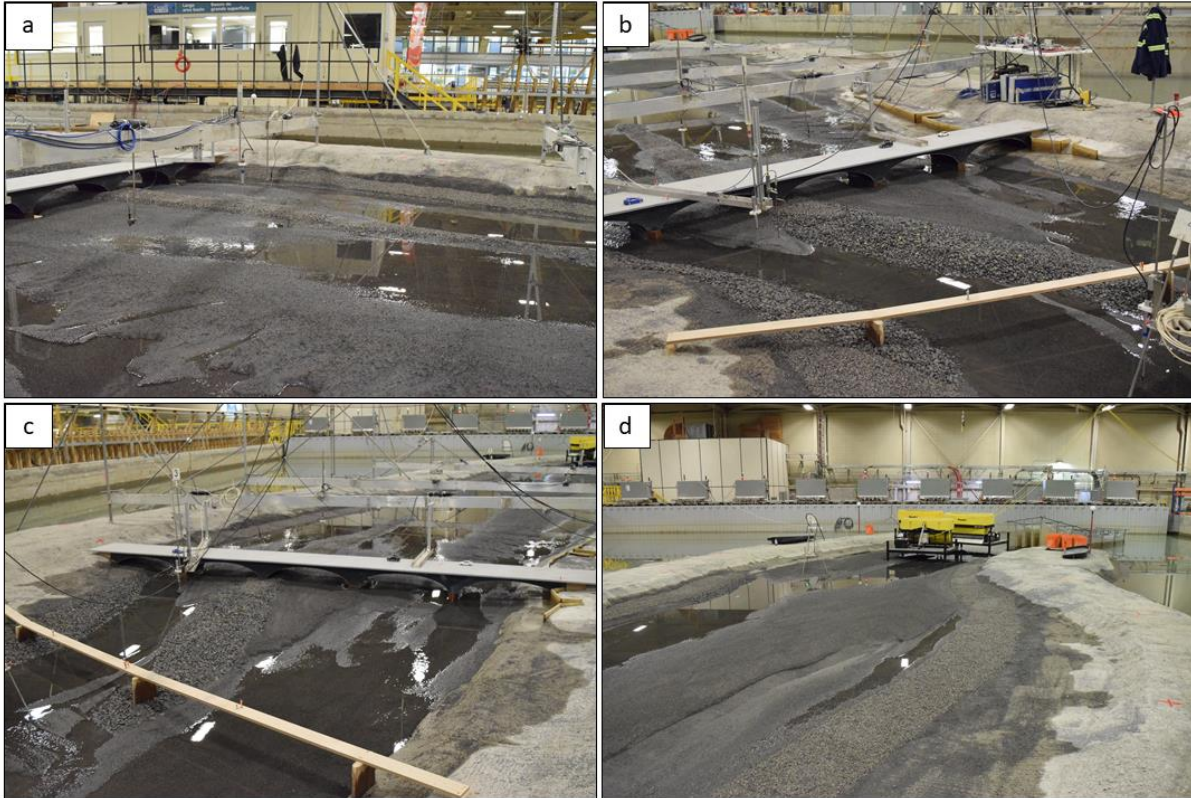
Figure 65. Photos of the model after TSA\_850; a) standing at Poppy Plaza, looking across the channel and downstream, b) standing near the south side of the downstream boundary, looking upstream, c) standing near the north abutment of the LTR bridge, looking upstream, and d) standing at Poppy Plaza, looking upstream.

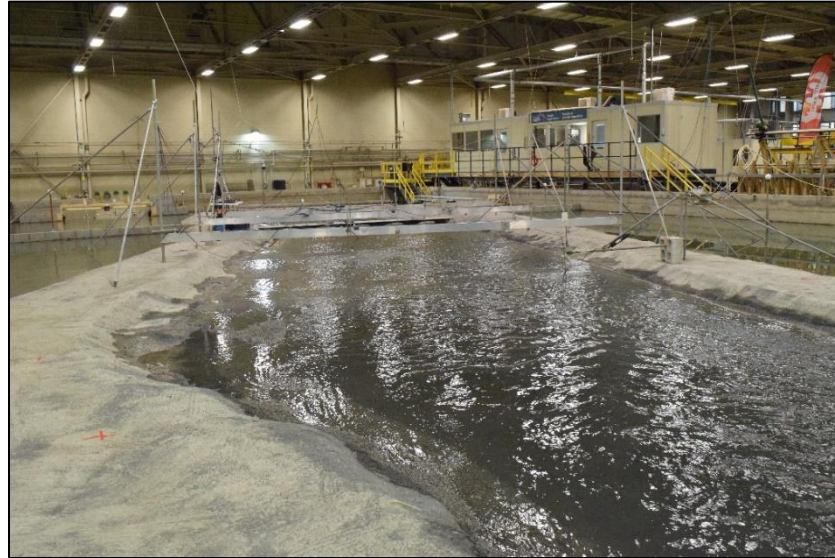
Figure 68. Photo of the model during TSA\_1400.

Similar to TSA\_850, localized net deposition was observed in the habitat channel and the habitat channel crossover, and localized net erosion was observed along the north bank of the habitat channel. The patterns of erosion and deposition observed along the south embankment, and north and south of the main bar, were generally similar to the patterns observed in TSA\_850. Compared to the initial bathymetry, net erosion was observed along the south embankment upstream of the main bar (zones 2 and 4), and net deposition was observed north and south of the main bar upstream of Louise Bridge (zones 5 and 6). Localized erosion was observed immediately downstream of the armoured nose of the main bar, resulting in a failure of the bar in this location (Figure 69a). Visual observations suggested that this failure was initiated by the turbulence observed in TSA\_850 (Figure 64) and exacerbated by the larger flow of TSA\_1400. Localized erosion was also observed where the main bar intersects Louise Bridge, which coincides with a bridge pier. The scour adjacent to the landing appeared to be larger than that observed in TSA\_850. Figure 68 shows a photo of the model during TSA\_1400 and Figure 69 shows select photos of the model after TSA\_1400.

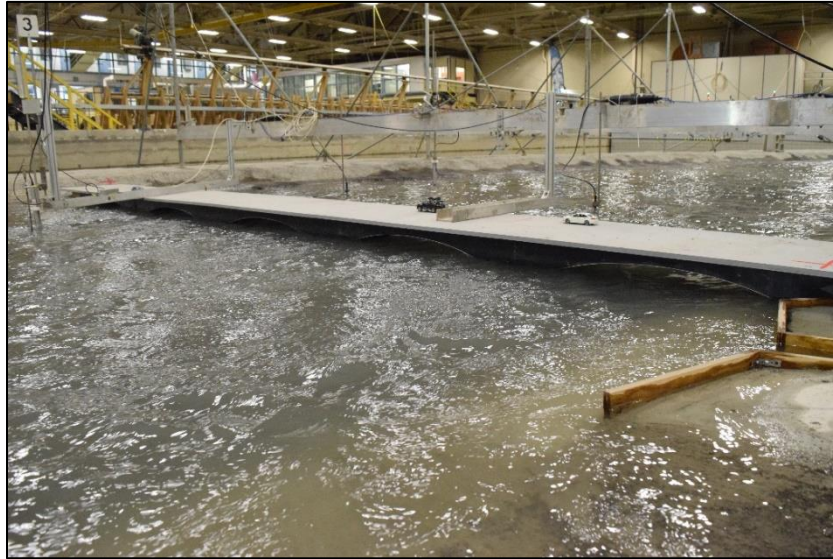
Figure 72. Photo of the model during TSA\_2100.

The patterns of erosion and deposition observed in TSA\_2100 were generally similar to those observed in TSA\_1400. Localized net deposition was observed in the habitat channel and the habitat channel crossover, and localized erosion was observed along the north edge of the habitat channel. Erosion along the south embankment appeared to be more localized to the embankment nose and the areas immediately adjacent to the embankment nose compared to the previous TSA tests. The crest of the embankment nose

was eroded resulting in failure of the feature. Unlike TSA\_850 and TSA\_1400, net deposition was observed at the mid-section of the south embankment (zone 4). Similar to the previous TSA tests, net deposition was observed in the areas north and south of the main bar, upstream of Louise Bridge (zones 5 and 6). Localized erosion immediately downstream of the main bar nose was greater than that observed in the previous TSA test, exacerbating the failure of the bar in this location. Localized erosion in the vicinity of bridge piers, and adjacent to the landing was greater than that observed in TSA\_850 and TSA\_1400. Figure 72 shows a photo of the model during TSA\_2100 and Figure 73 shows select photos of the model after TSA\_2100.

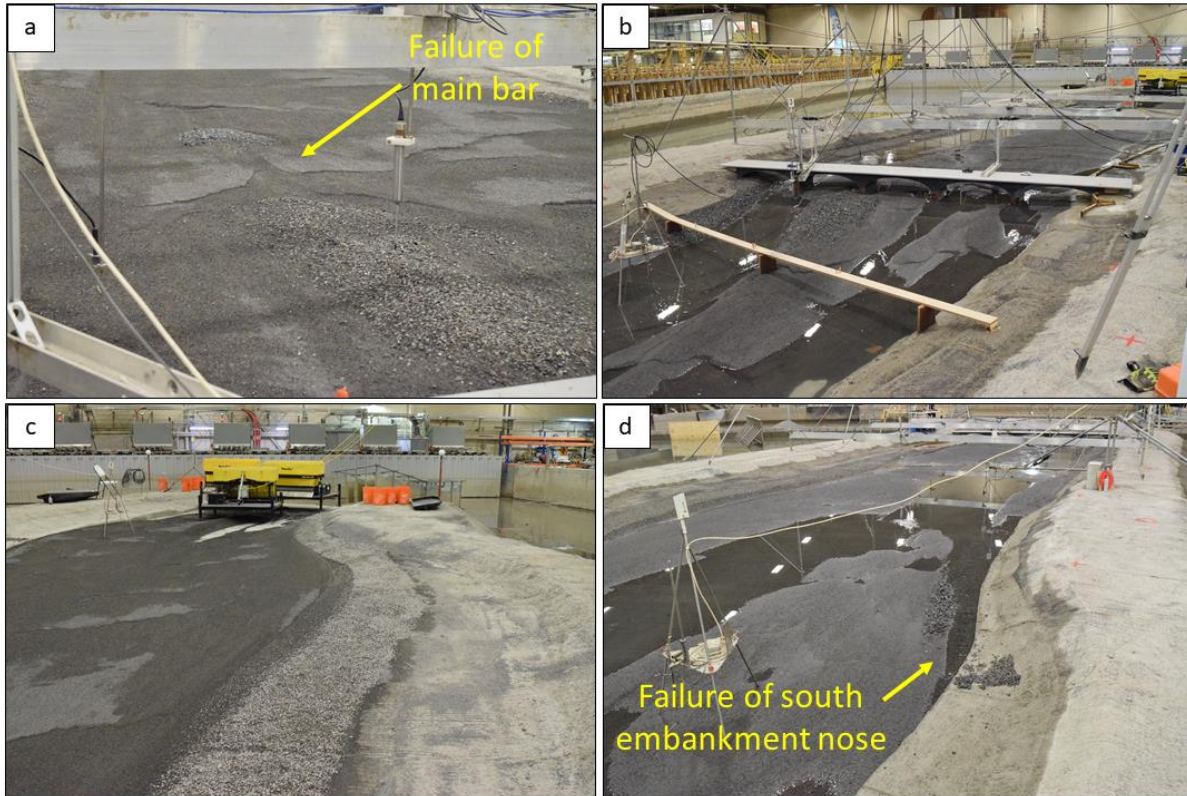
Figure 73. Photos of the model after TSA\_2100; a) standing on Louise Bridge, looking upstream at the main bar, b) standing at the north side of the downstream boundary, looking upstream, c) standing at Poppy Plaza, looking upstream, d) standing near the south side of the upstream boundary, looking downstream.

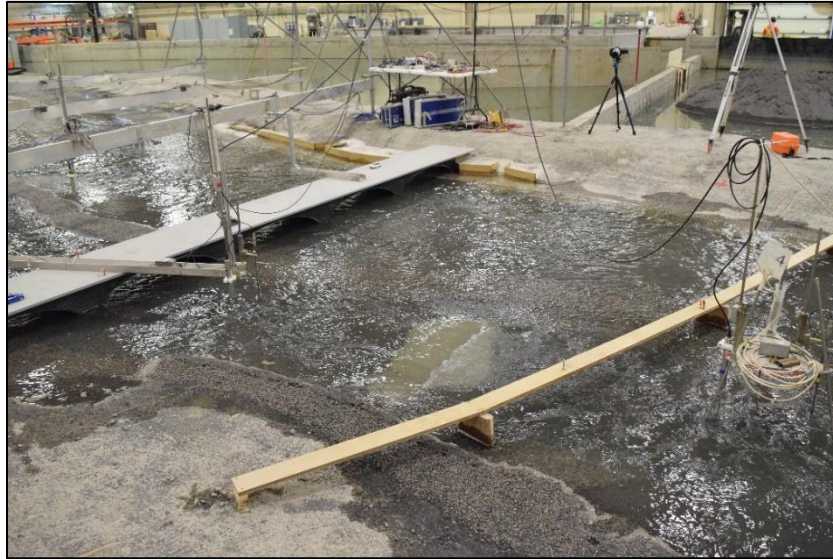
Figure 81. Photo of the model during TSB\_850.

The scan data indicated localized sediment deposition in the habitat channel. Localized erosion of the south embankment was observed, immediately downstream of the armoured embankment nose; repelling groyne #1 is situated at the downstream end of the armoured embankment nose. Localized deposition was observed at the tip of repelling groyne #2. However, the thin layer of river sediment that initially covered the crests of the repelling groynes (repelling groynes #1, #2, and #3) was eroded during TSB\_850, particularly

where no additional protection was provided by the bioengineering stone. Net erosion was observed on the north and south side of the channel leading up to the main bar (zone 3 and 4). Except for some localized erosion immediately downstream of the main bar nose, deposition was generally observed along the north edge of the main bar. Net deposition was observed in the upstream portion of the recreation channel (zone 6), although some localized erosion was observed along the south edge of the main bar. Localized erosion was observed underneath Louise Bridge, immediately adjacent to the landing. Figure 81 shows a photo of the model during TSB\_850 and Figure 82 shows select photos of the model after TSB\_850.

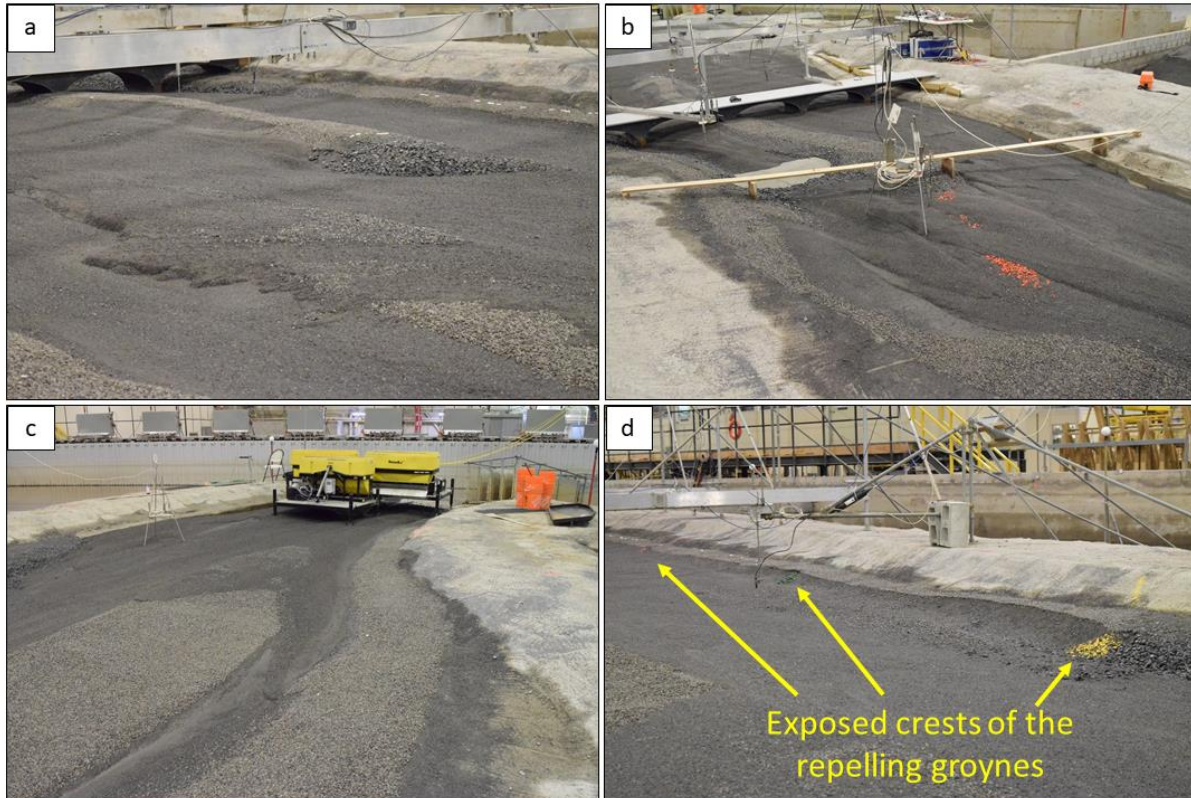
Figure 82. Photos of the model after TSB\_850; a) standing at Poppy Plaza, looking across the channel and downstream at the main bar, b) standing at the south side of the downstream boundary, looking upstream, c) standing at Poppy Plaza, looking upstream, d) standing at the north side of the upstream boundary, looking at the south embankment.

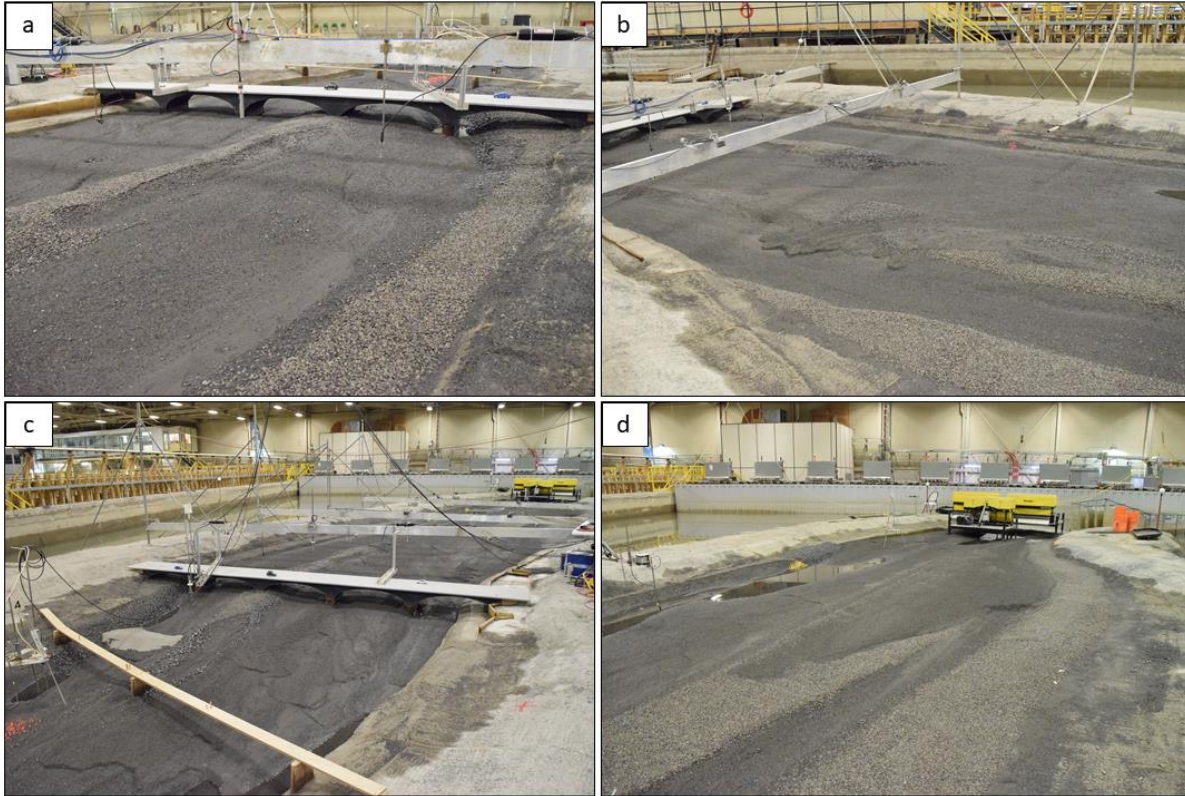
Figure 86. Photos of the model after TSB\_1400; a) standing at the south embankment, looking downstream, b) standing at Poppy Plaza, looking across the channel and downstream at the main bar, c) standing near the north abutment of the LRT bridge, looking upstream, and d) standing at Poppy Plaza, looking upstream.

The general patterns of erosion and deposition observed in TSB\_1400 were generally similar to the patterns observed in TSB\_850. Additional deposition was observed in the habitat channel. Additional erosion was observed downstream of the south embankment nose and in the vicinity of repelling groyne #2. Similar to TSB\_850, localized erosion was observed on the north edge of the main bar, immediately downstream of the main bar nose. The upstream portion of the recreation channel, leading up to Louise Bridge, continued to be an area of net deposition (zone 6). However, similar to TSB\_850, net erosion was observed along the south edge of the main bar. Localized erosion was observed at the crest of the main bar between Louise Bridge and the LRT bridge. Figure 85 shows a photo of the model during TSB\_1400 and Figure 86 shows select photos of the model after TSB\_1400.

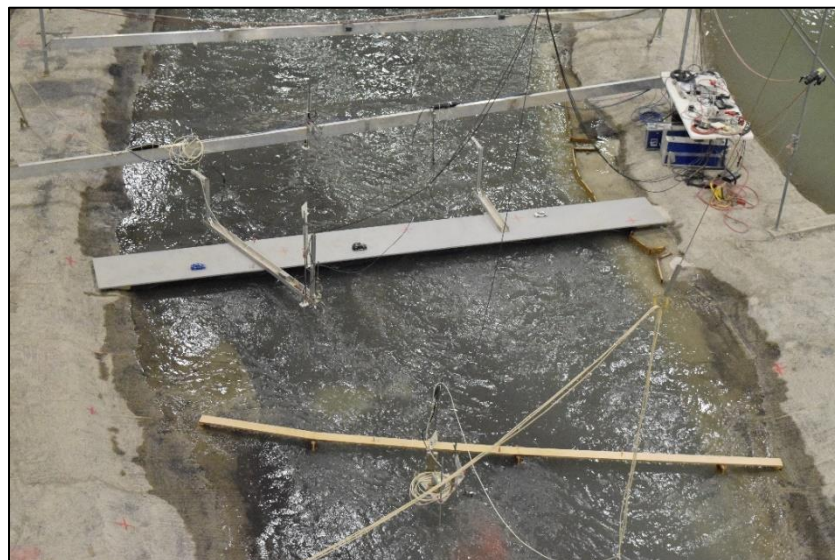
Figure 89. Photo of the model during TSB\_2100.

Similar to the previous TSB tests, sediment deposition was observed in the habitat channel, erosion was observed along the south embankment, and net deposition was observed in the recreation channel upstream of Louise Bridge (zone 6). Localized erosion was observed immediately upstream of the armoured nose of the south embankment. A section of the main bar upstream of Louise Bridge failed during the 100-year flow, leading to localized erosion in the vicinity of the failure. Similar to TSB\_1400 localized, net erosion was observed at the crest of the main bar between Louise Bridge and the LRT bridge. Deposition was observed in the recreation channel downstream of Louise Bridge, both upstream and downstream of the concrete hump (zone 8). Erosion was observed on the crest of the landing resulting in a failure of the feature. Figure 89 shows a photo of the model during TSB\_2100 and Figure 90 shows select photos of the model after TSB\_2100.

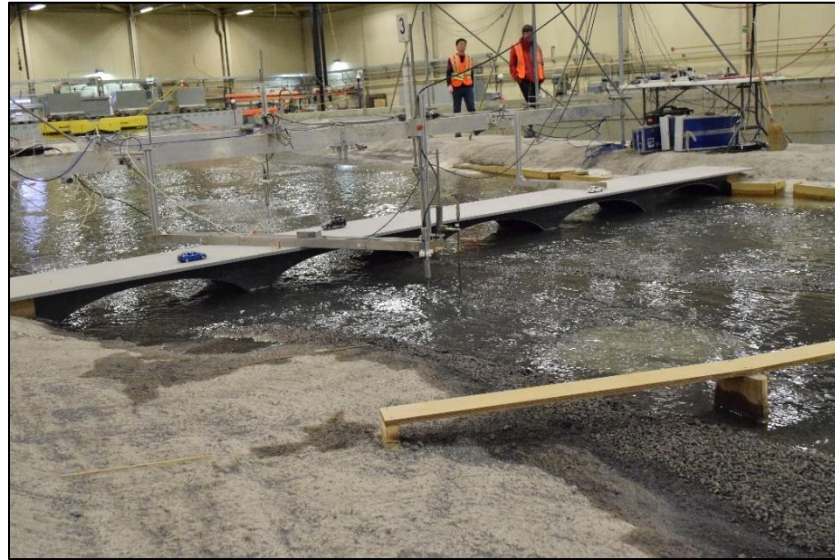
Figure 98. Photo of the model during TSC\_850.

The scan data indicated some localized sediment deposition in the habitat channel, although the deposition was not as extensive as the deposition observed for the 10-year flow tests for TSA (TSA\_850) and TSB (TSB\_850). Erosion was observed along the south embankment upstream of the main bar (zones 2 and 4) and deposition was observed north and south of the main bar upstream of Louise Bridge (zones 5 and 6). Deposition was also observed north of the main bar underneath, and immediately downstream of, Louise

Bridge. Deposition was generally observed along the south edge of the main bar downstream of Louise Bridge. Localized erosion was observed adjacent to the landing. Figure 98 shows a photo of the model during TSC\_850 and Figure 99 shows select photos of the model after TSC\_850.

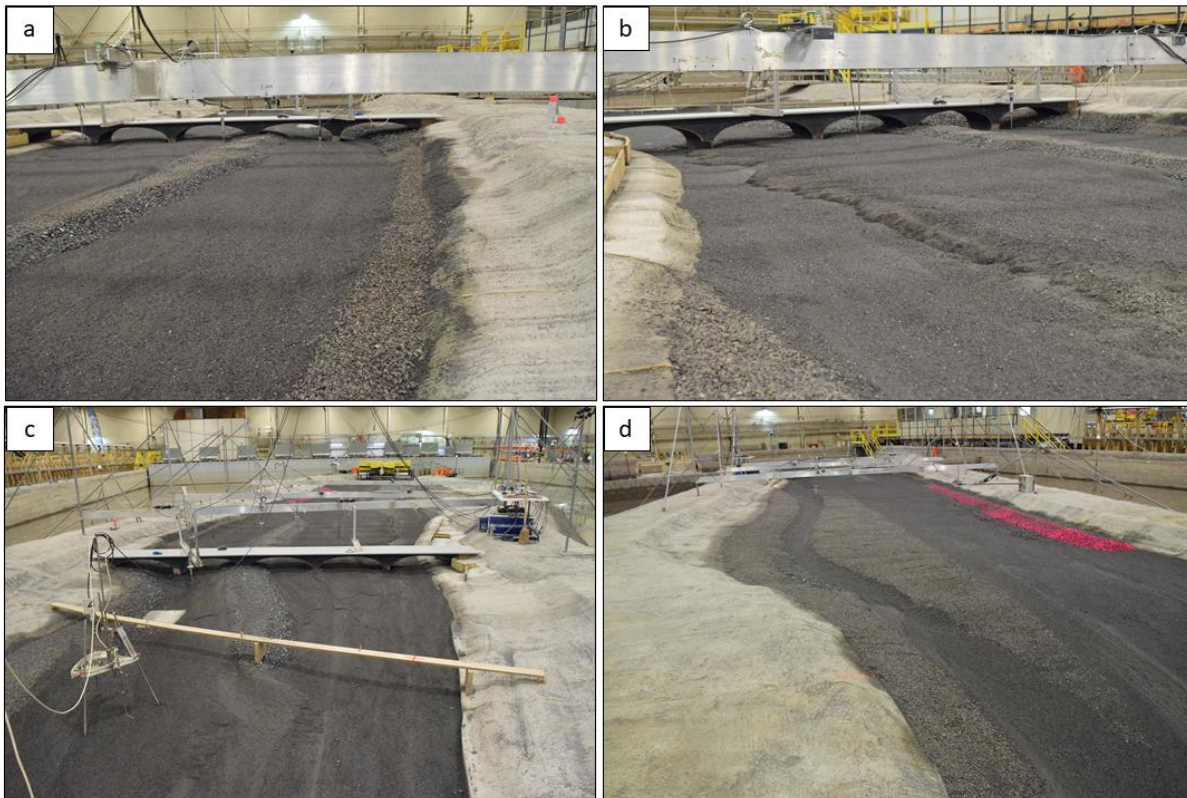
Figure 99. Photos of the model after TSC\_850; a) standing at the south embankment, looking downstream, b) standing at Poppy Plaza, looking downstream, c) standing at the downstream boundary, looking upstream, and d) standing at the north side of the upstream boundary, looking downstream.

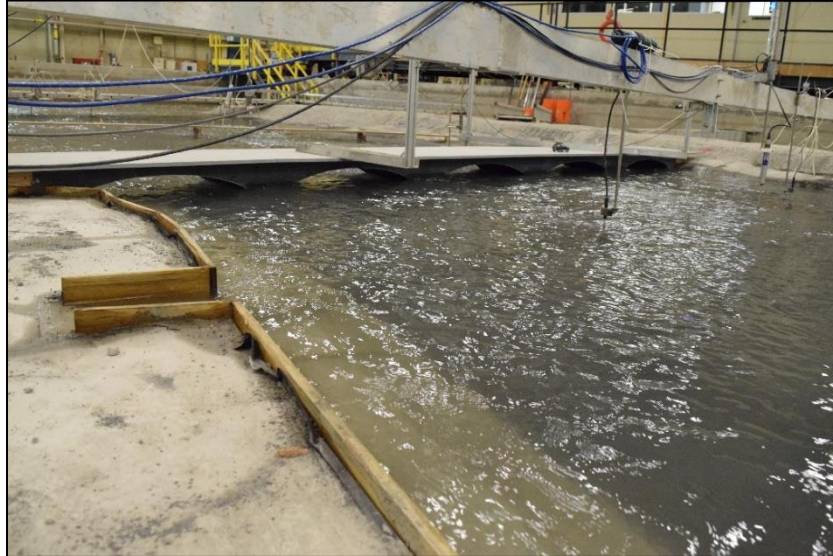
Figure 102. Photo of the model during TSC\_1400.

Similar to TSC\_850, localized net deposition was observed in the upstream portion of the habitat channel and net erosion was generally observed along the edge of the south embankment. Localized net erosion was observed immediately adjacent to the nose of the south embankment. However, localized deposition was observed northward and upstream of the nose of the south embankment adjacent to the localized erosion. Similar to TSC\_850, net deposition was observed north and south of the main bar, upstream of Louise Bridge (zones 5 and 6). Except for localized pier scour, net deposition was generally observed north

of the main bar underneath, and immediately downstream of, Louise Bridge. Deposition was generally observed along the south edge of the main bar underneath of Louise Bridge. Localized erosion was observed adjacent to the landing. Figure 102 shows a photo of the model during TSC\_1400 and Figure 103 shows select photos of the model after TSC\_1400.

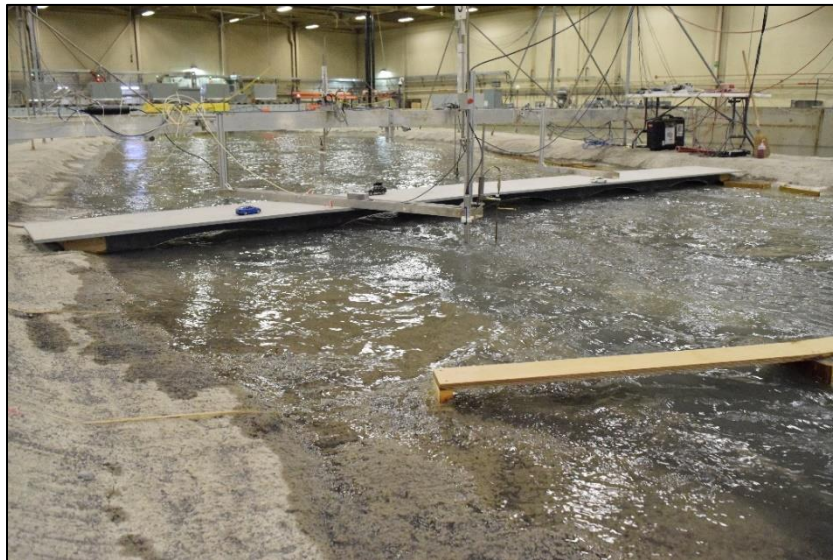
Figure 106. Photo of the model during TSC\_2100.

Similar to the previous TSC tests, localized net deposition was observed in the upstream portion of the habitat channel. Some localized deposition was also observed in the downstream portion of the habitat channel. Net erosion was observed along the south embankment and upstream of the embankment nose. Net deposition was observed north and south of the main bar, upstream of Louise Bridge (zones 5 and 6). Except for localized pier scour, net deposition was generally observed north of the main bar underneath, and immediately downstream of, Louise Bridge. Net deposition was generally observed along the south edge of the main bar. A large portion of the landing was eroded, including erosion of the crest, resulting in a failure of the feature. Figure 106 shows a photo of the model during TSC\_2100 and Figure 107 shows select photos of the model after TSC\_2100.
