## **Physical Model Study of Gravel Bar Realignment Designs for the Bow River near Louise Bridge**

Report No.: NRC-OCRE-2024-TR-018

Prepared for: The City of Calgary

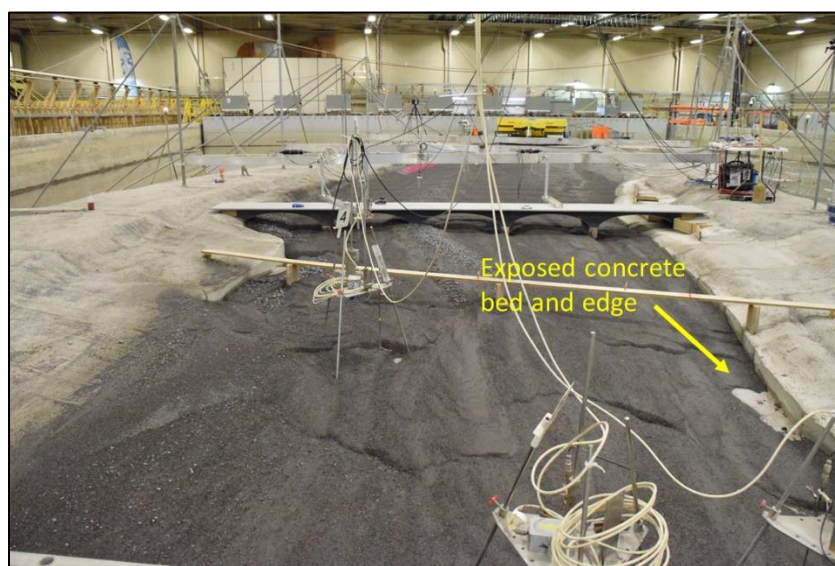
Figure 111. Example of scour exposing the concrete bed and the edge of the concrete bed.

As described in Section 3.3, the mobile bed included all spaces within the study area where geomorphic change during large flood events could reasonably be expected (taking into account existing armouring) as well as locations where topographic modifications were expected in accordance with the conceptual bar realignment designs. The elevation of the concrete bed underlying the mobile bed (and, therefore, the thickness of the mobile bed) was selected such that the maximum scour depths anticipated from numerical modelling by Yu et al. (2022) could be fully accommodated by the mobile bed, without scour down to the

concrete. However, during the test program, some portions of the concrete bed (and the edges of the concrete bed) became exposed owing to localized scour. This was particularly evident along the northern portion of the mobile bed, near the downstream boundary, where lateral and downward erosion was limited by the concrete (see Figure 111, for example, which shows the resulting bathymetry after TSC\_2100 near the downstream boundary). However, in reality, lateral erosion at this location of the study site is also limited by the presence of armour stone. It is challenging to comment on the realism of model results where downward scour exposing the non-erodible concrete floor was observed. As described in Section 3.4.3, available borehole data suggest that there is a non-erodible clay layer underlying the alluvial channel sediment at the study site. However, the continuity and elevation of the clay layer outside of discrete borehole locations is not well understood. The non-erodible concrete floor of the model was not designed to represent the clay layer. However, it is reasonable to assume there is a vertical limit to downward scour at the study site owing to the presence of the clay layer.
