December 14, 2023

**Subject: Bow River 10<sup>th</sup> St Gravel Bar Project: Tree Survey Summary**

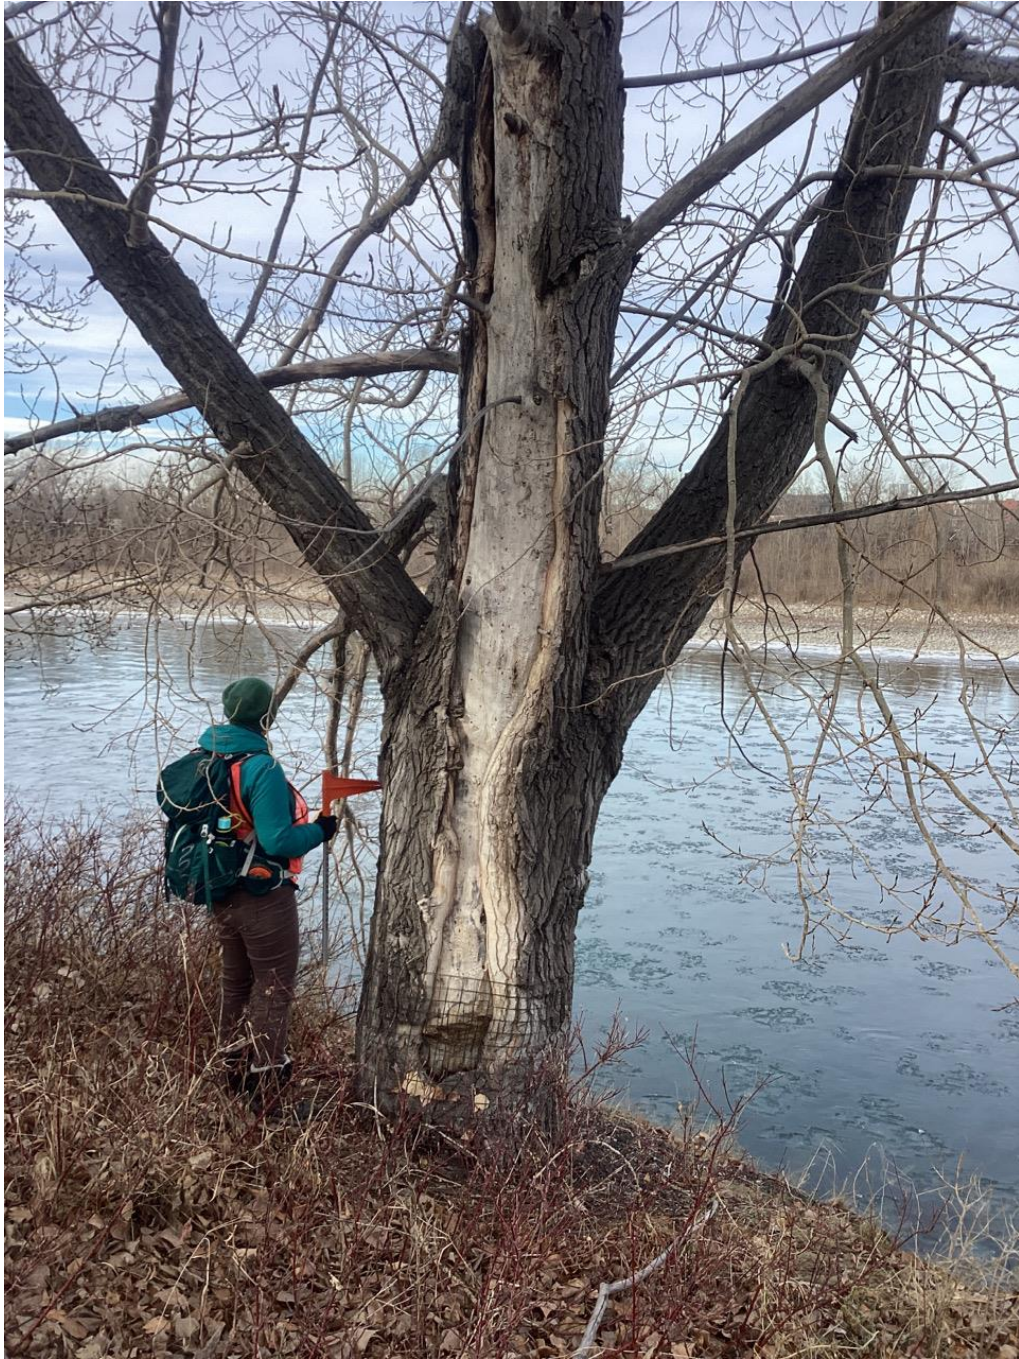
Large Balsam poplar, main stem dead.

Not all trees were in good health; there was a great deal of beaver damage causing abnormal growth patterns, such as forking near the base of the stem or off shoots from remaining stumps. Some trees appeared to have grown horizontally for a time before upwards, possibly a result of flowing water impacting growth at a young age. There were several trees leaning heavily or growing horizontally out of the riverbank. Damage or abnormal growth form was documented with photographs where possible, but a full condition assessment was not part of the scope of this survey.

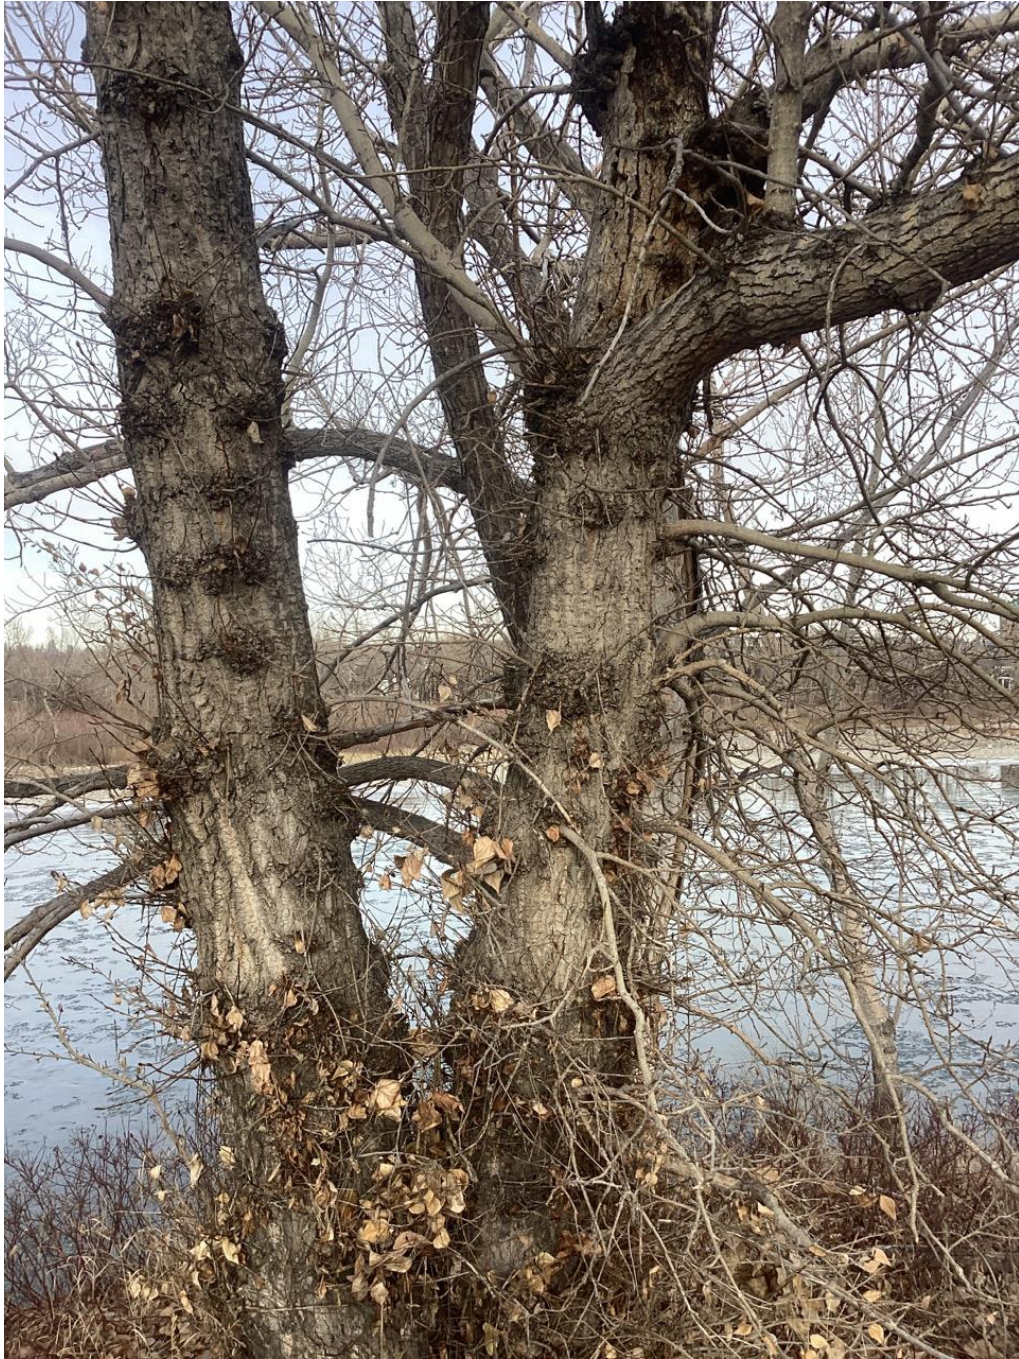
Large Balsam poplar, main stem split at base.

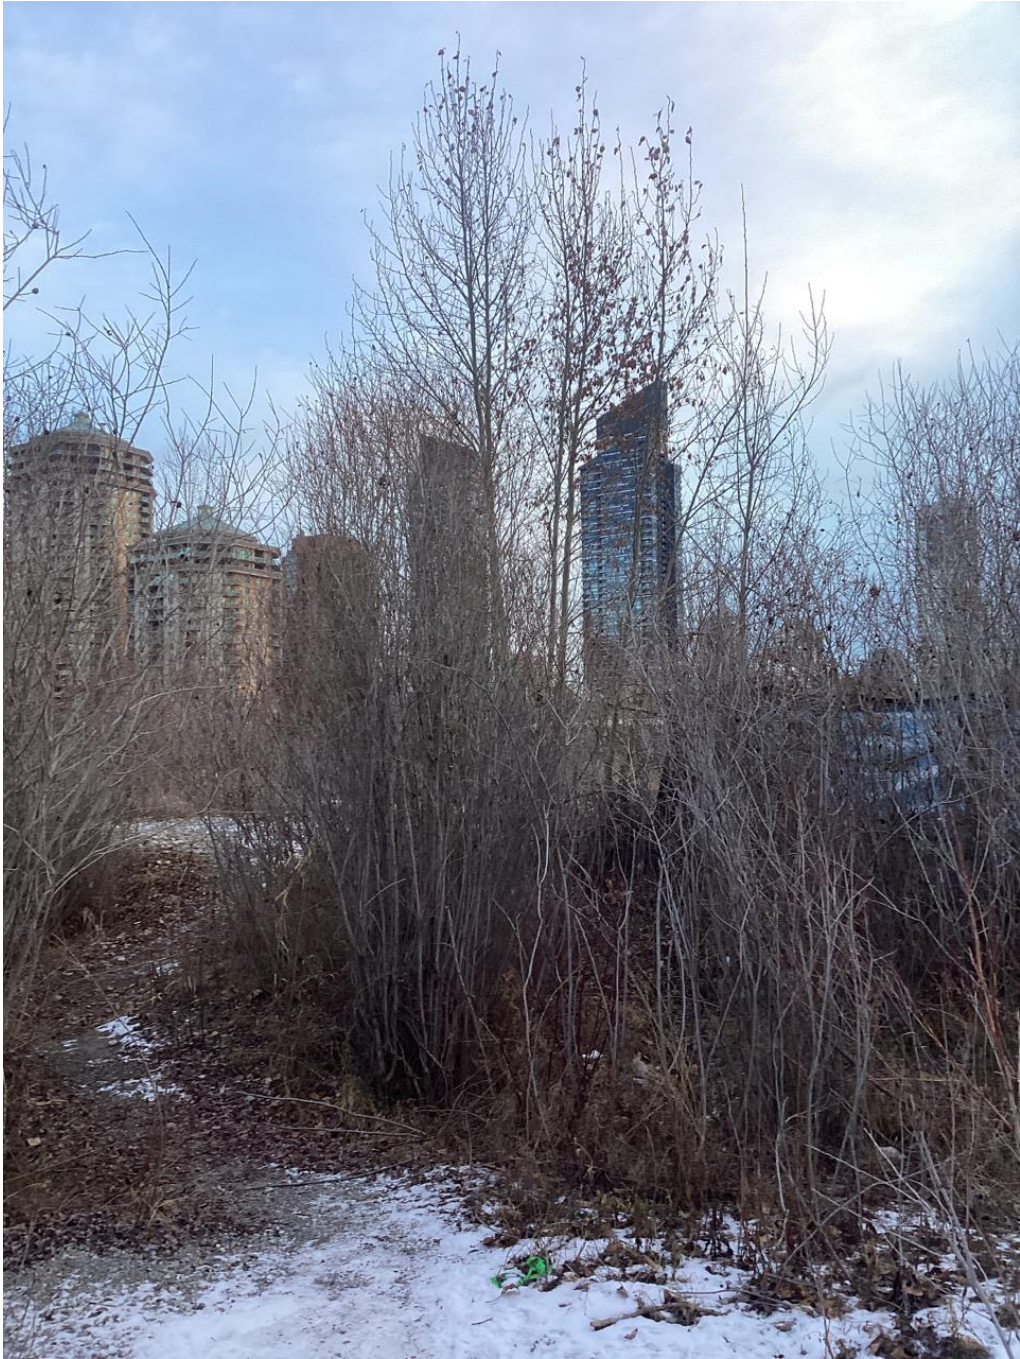
Cluster of Balsam poplars near an encampment.

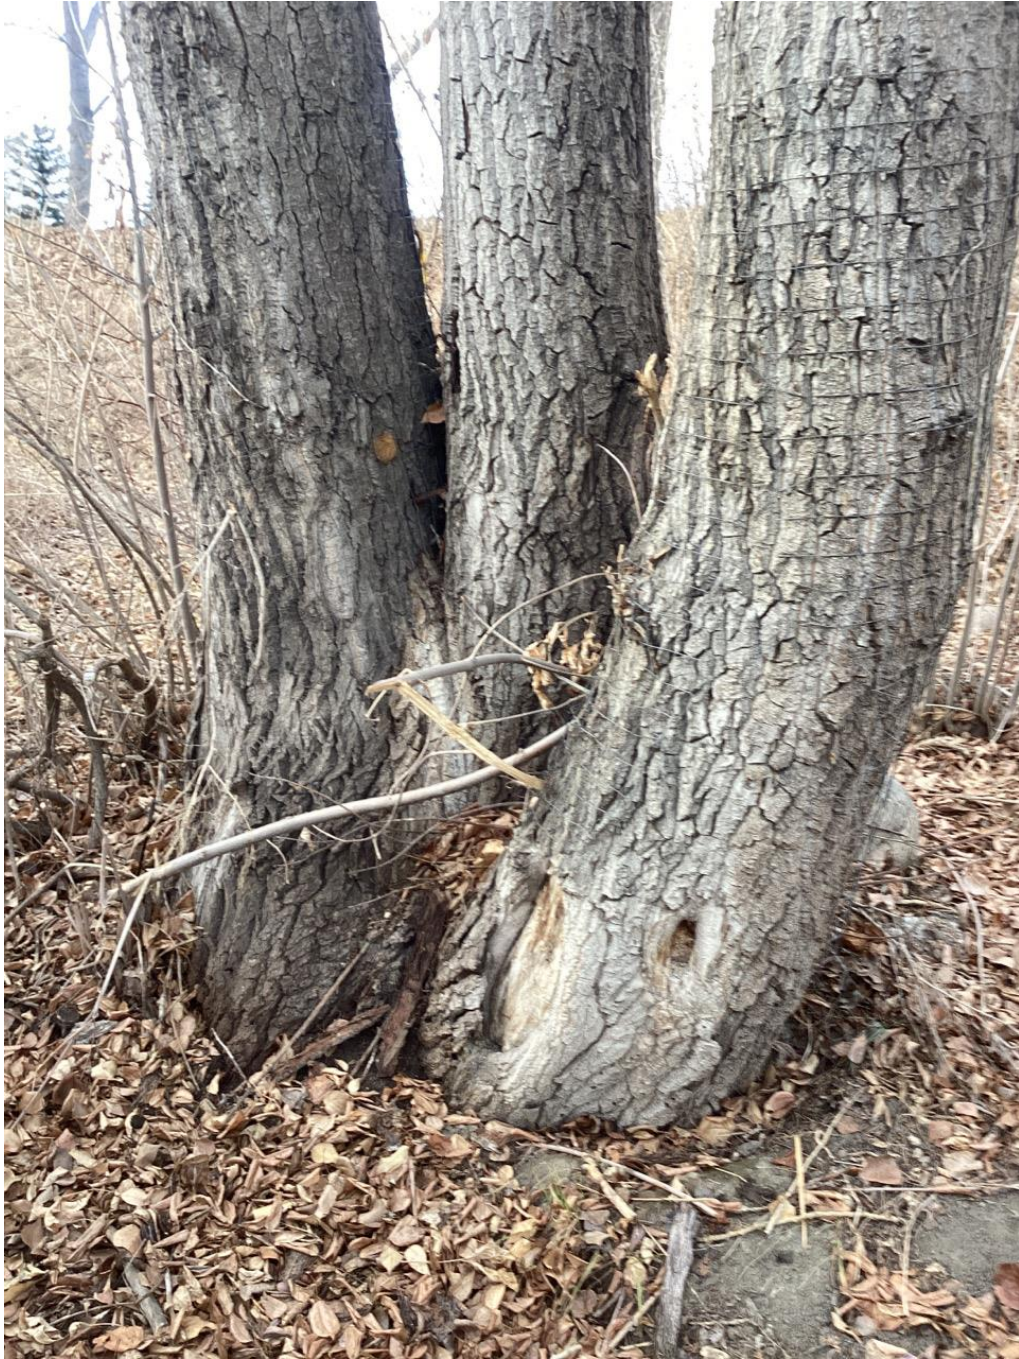
Large Balsam poplar, main stem split into three – possibly multiple trees but recorded as a single tree.

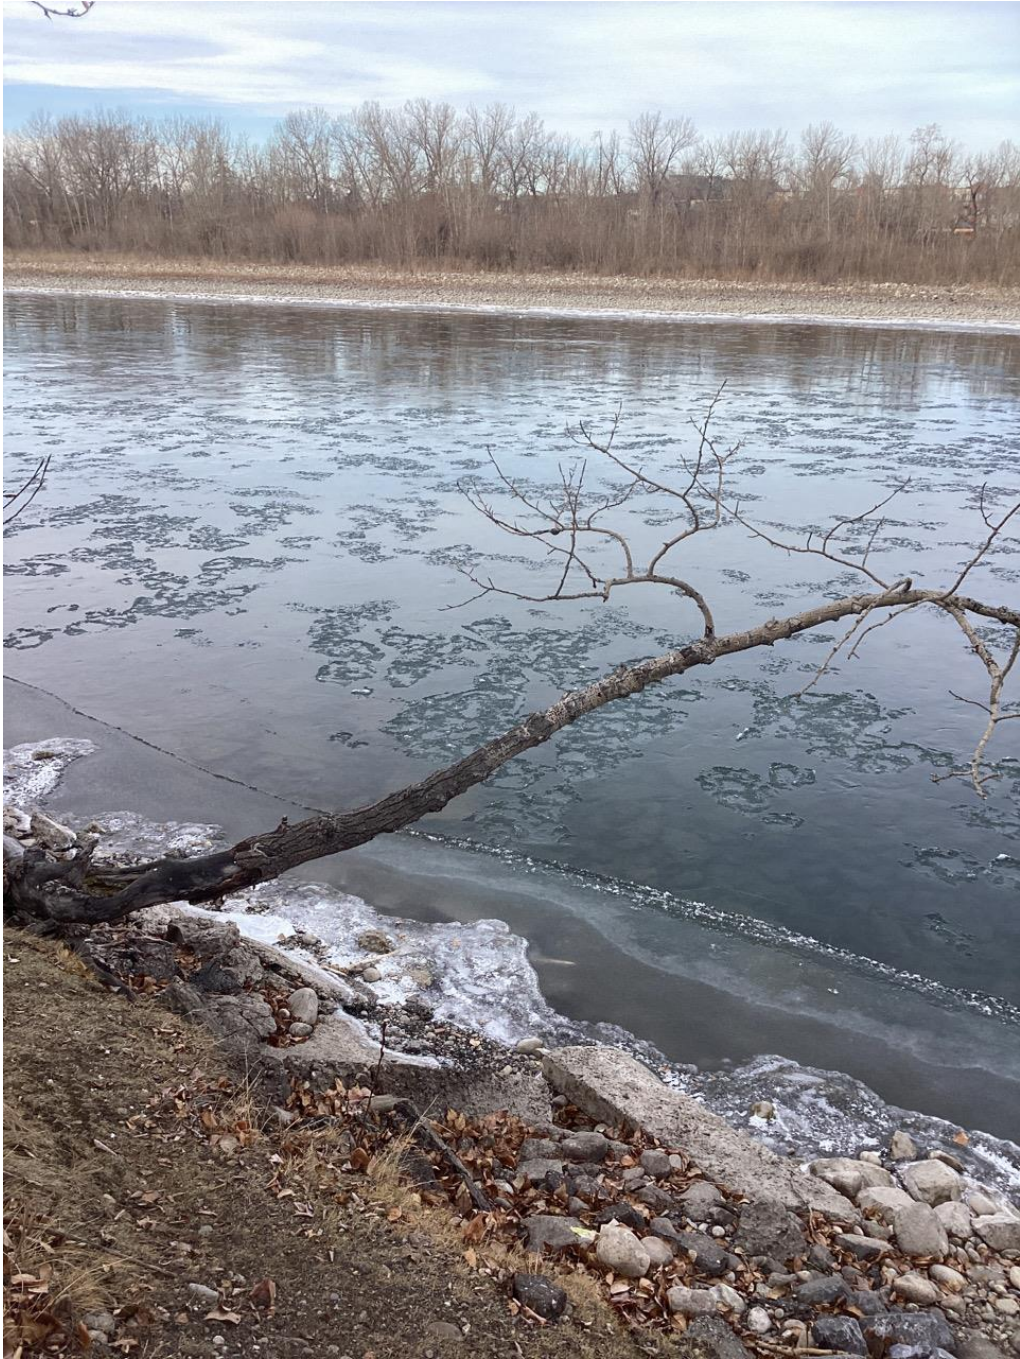
Balsam poplar growing horizontally out of riverbank.

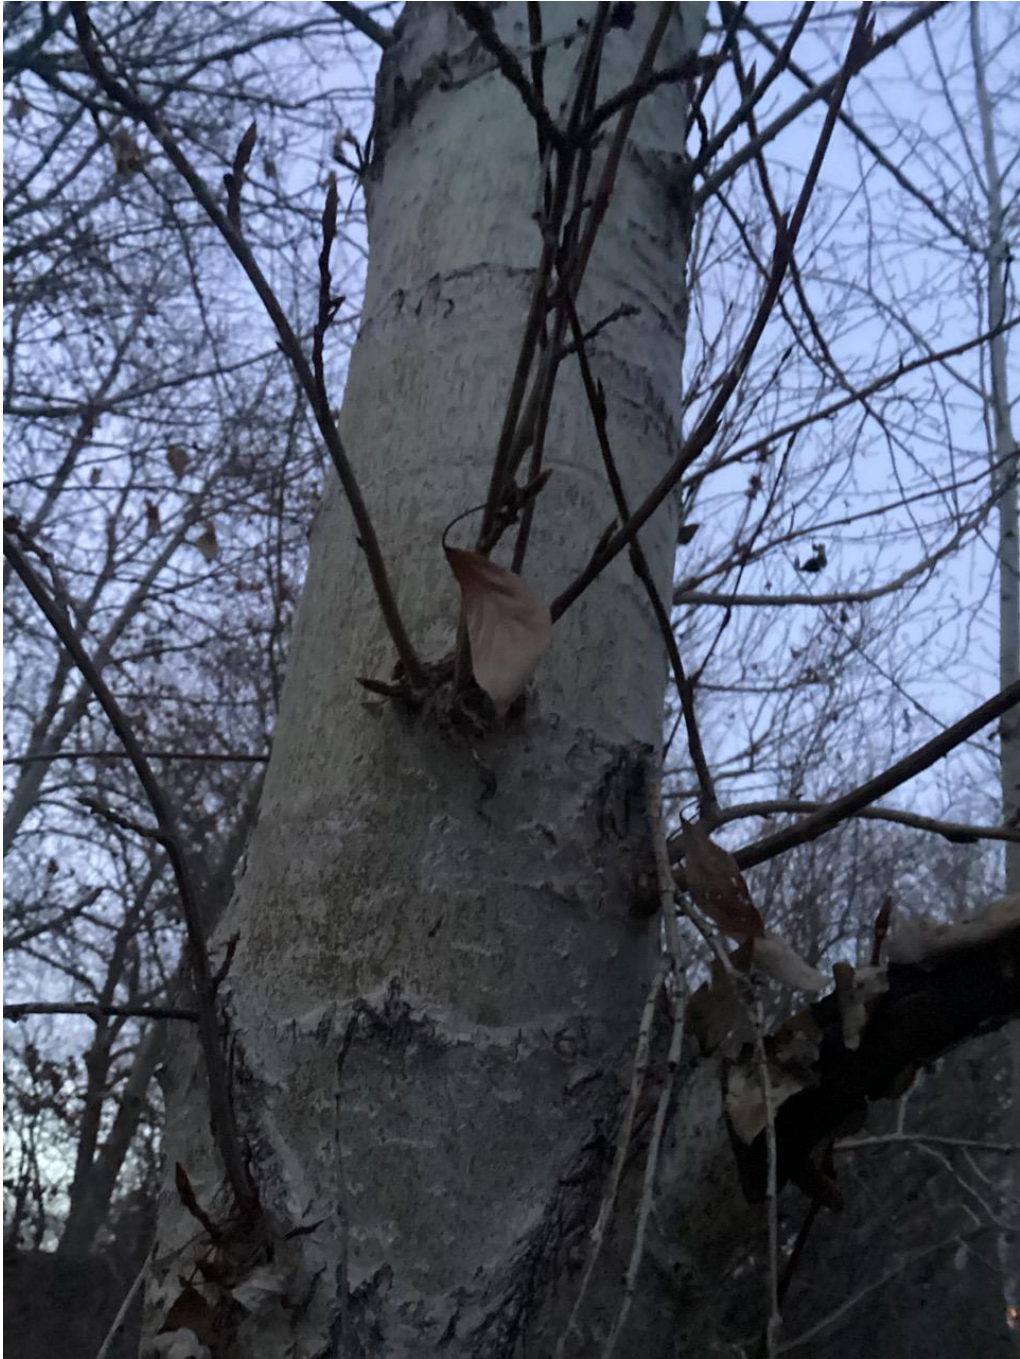
Possible Narrow-leaved Cottonwood, confirmation needed.

A total of 188 trees were recorded across the surveyed area (Table 1). Eight different tree species were observed, with one unknown species. Seven trees, noted as uncertain or unknown, require confirmation in the spring and summer when leaves return, as leaves are one of the most distinguishing features. Confirmation is required for two possible Balsam poplars, one Manitoba maple, two unknown poplars, and two unknown species (Figure 1). Balsam poplar (*Populus balsamifera*) was by far the most commonly recorded species at nearly 85% of surveyed trees. All trees with a DBH greater than 50cm were Balsam poplar.
