# S<sub>2</sub>

## HFH1-NWT Arts & Culture Campus

**MASTER PLAN REPORT**  
25 OCT, 2022

**PREPARED FOR**  
THE CITY OF CALGARY

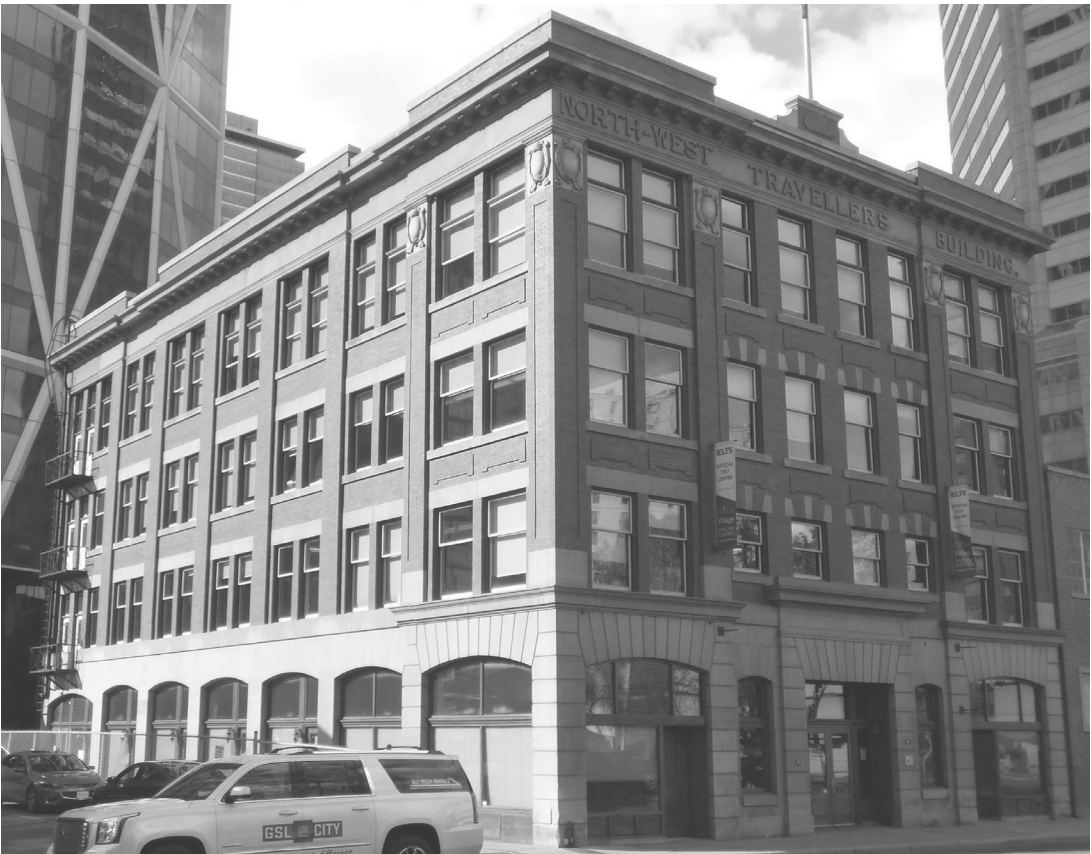
North-West Travellers Building

- Any new construction or new building elements should not interfere with the overall appearance of the building from the front.
- As with all contemporary architecture, the design must respect and be quiet to allow for the heritage buildings to be character-defining to the site.
- There should be no new structure or construction that would significantly impact the heritage character and something that could not be removed or dismantled without impacting the original structure and building elements.
- Character defining heritage elements within the building like ceilings, window cornices and sills, elevator to be conserved and maintained.
- Accessibility to be checked throughout the building.

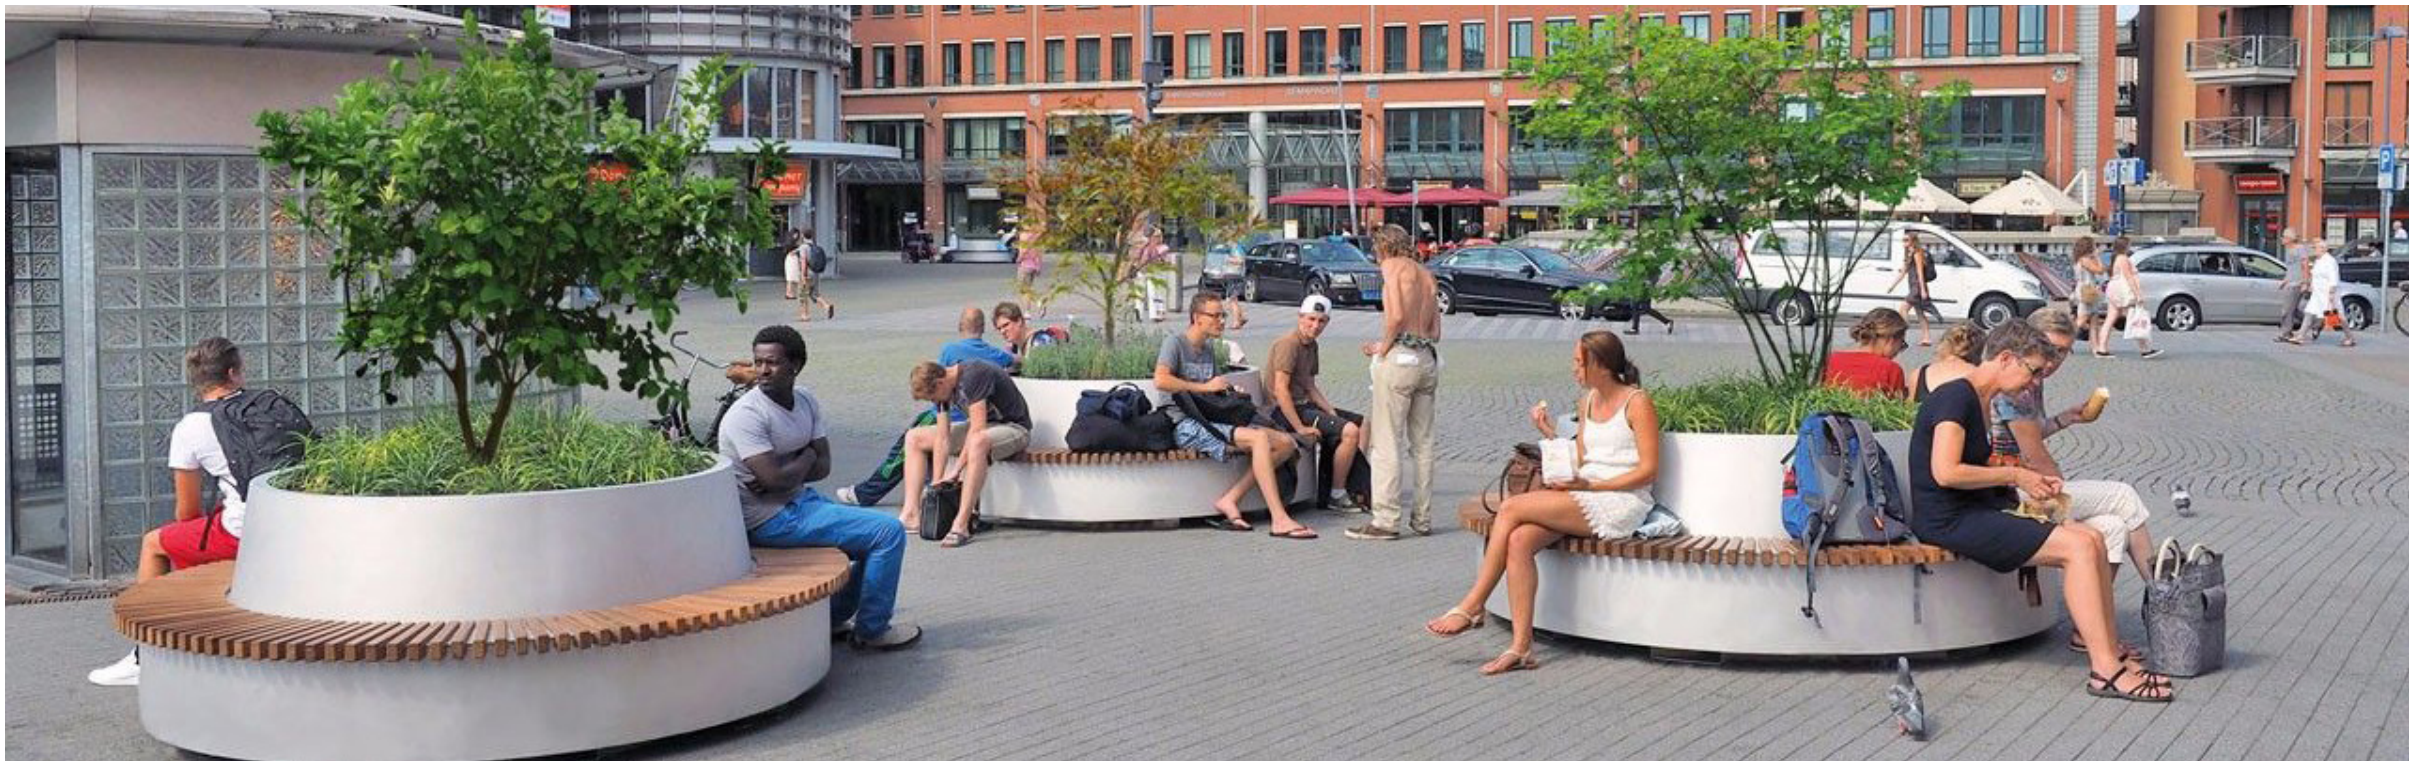
- 1 Seating Planters
- 2 Pop Up Furnishings
- 3 Community Signage

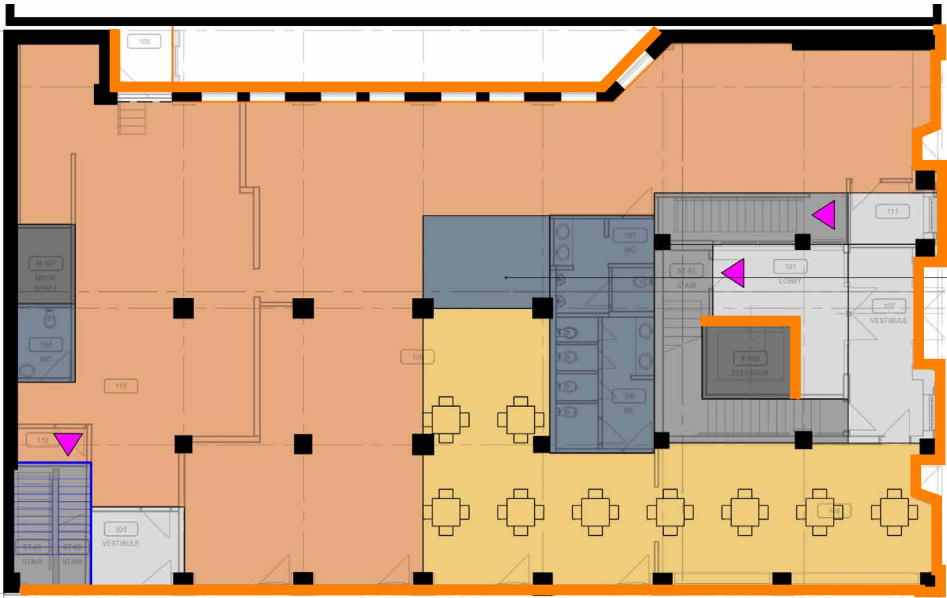
#### Scenario 1- Retail + Cafe

Additional washrooms may be needed

- Approx total Rentable Area:**  
435 m2 / 4582 ft2
- Approx Usable Area:**  
Coffee Shop = 93 m2 / 1001 ft2  
Retail = 257 m2 / 2766 ft2
- Occupancy Classification:**  
Group A, Division 2
- Occupancy Load assumed to support:**  
Retail: 70 people  
Coffee Shop: approx 36-40 people
- Existing Acoustic Separation:**  
Acoustic ceiling in the washrooms
- Existing Fire Separation:**  
Sprinklered throughout

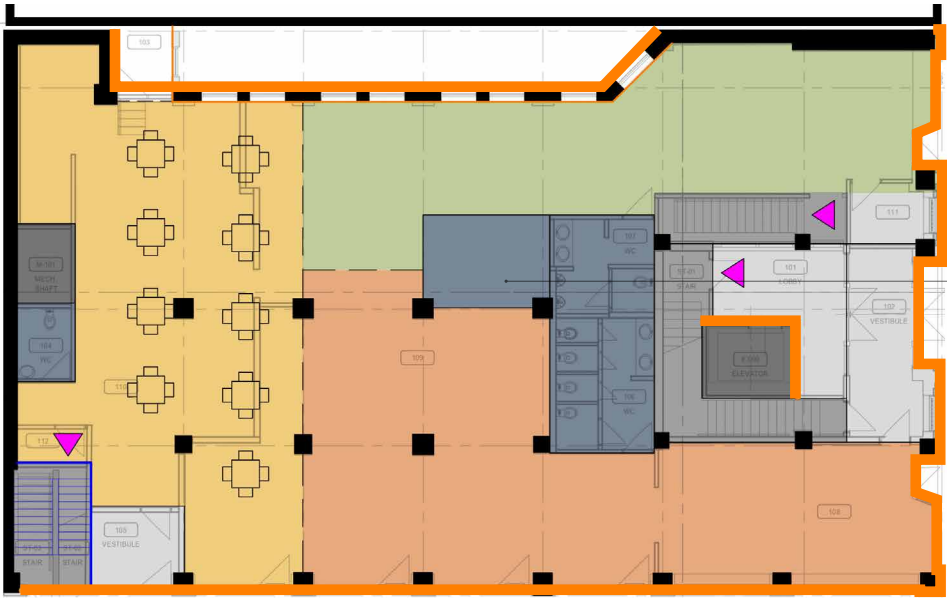
#### Scenario 2- Retail + Cafe + Gallery

Additional washrooms may be needed

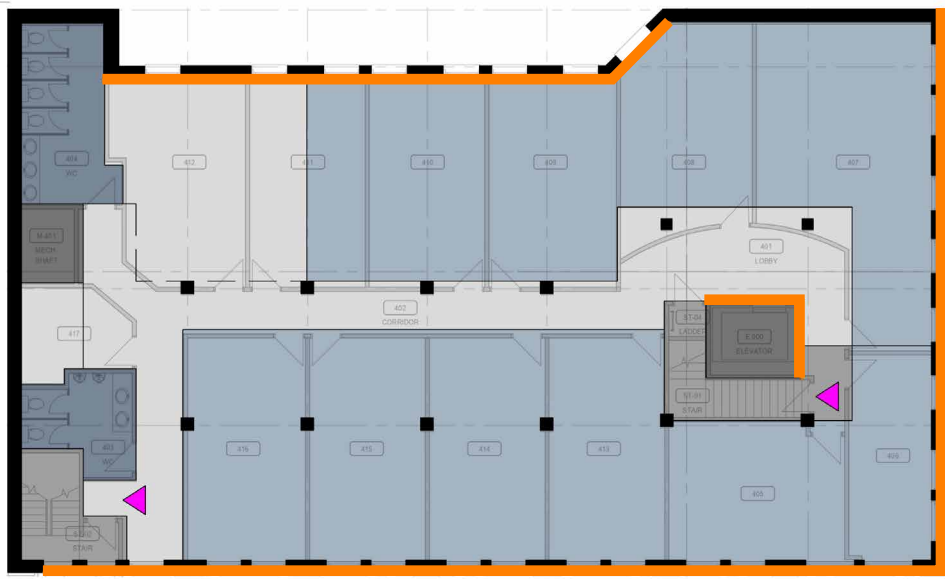
#### Scenario 2- Arts Hub + Co-Op Offices

- Approx total Rentable Area:**  
455 m<sup>2</sup> / 4897 ft<sup>2</sup>
- Approx Usable Area:**  
Co-Op Offices = 168 m<sup>2</sup> / 1808 ft<sup>2</sup>  
Arts Hub Office = 139 m<sup>2</sup> / 1496 ft<sup>2</sup>
- Occupancy Classification:**  
Group D
- Occupancy Load assumed to support:**  
30-35 People
- Existing Acoustic Separation:**  
Acoustic ceiling in the washrooms
- Existing Fire Separation:**  
Sprinklered throughout

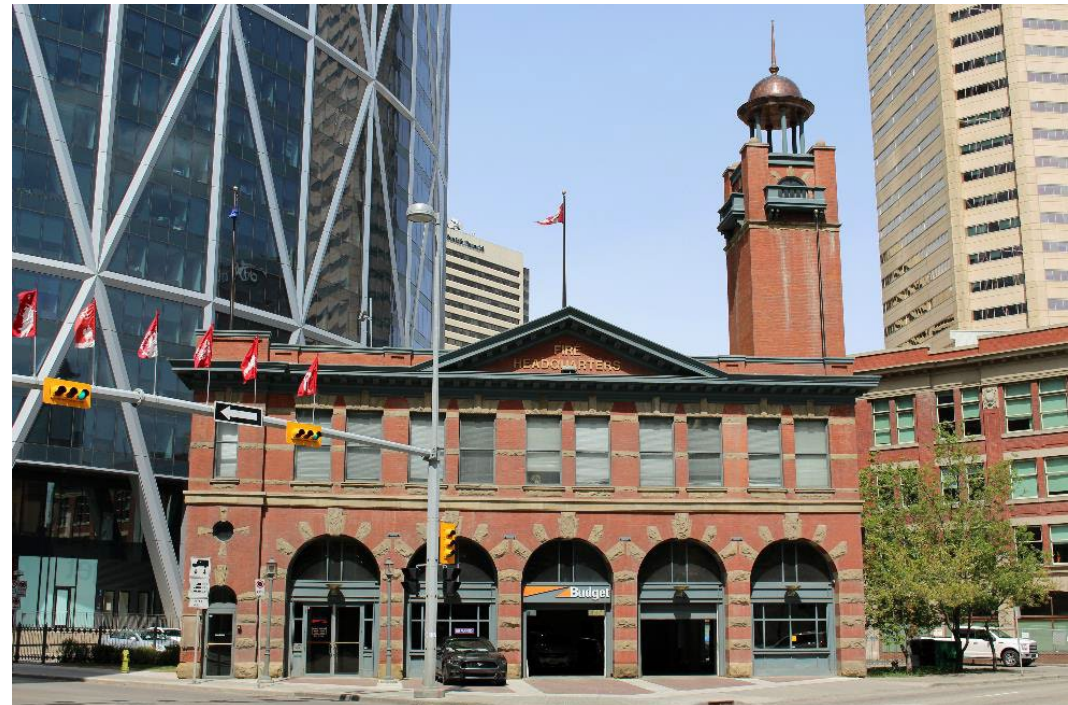
# HISTORIC FIRE HALL #1

Calgary Fire Hall No. 1 is a two-storey, concrete and masonry building amidst high-rise office buildings in downtown Calgary. The front facade, with its five bay doors and pedimented metal cornice, is diagonally oriented toward the corner.

<b>Brick Cracking at Bay Doors</b>			
AA11.3	<p>The large 3.0m wide bay doors into room 105 are showing through brick cracking all the way through the wall suggesting a failure of the block bearing under the concrete lintel beams. There are signs of repair to this condition in the past, but the repair is suffering the same failure as the original brick. The cracking through the bearing is such that full re-build of the wall is necessary. A new longer header over the door would avoid the problem developing again. If the lintel is to remain as a historic element an alternate bearing solution may be available at each end of the lintels. Not included in the life cycle costing.</p>	1 sum	78,750.00	78,750
	<b>Door Opening in NW Exterior Wall</b>			
AA11.4	<p>Man door with very shallow lintel located below windows. Header does not appear to be in distress however it is a critical element which does not appear adequate. Some brick deterioration around door frame.</p> <p>Leave the door framing as is and locally repair/repoint the masonry wall. OR, Infill door.</p>	1 sum	5,250.00	5,250

Quantity	Unit Rate (\$)	Total (\$)
A1 Fire Hall #1				
A11 Heritage				
	<b>Stepped Cracks at Arches</b>			
AA11.5	Stepped cracks in brick mortar associated with dropped keystones: far right arch on main elevation, arch on west elevation. Rake out joints with missing mortar to sound surface and repoint using matching color consistency, texture and inclusions. Mortar to be non-hydraulic as per original mortar.	2 no.	31,500.00	63,000
	<b>NE bay doors into back of building.</b>			
AA11.6	Load bearing brick walls each side of wo large bay doors. Door header is concrete lintel. Through cracking exists in multi-wythe clay brick walls below concrete lintel beam bearing points.	1 sum	21,000.00	21,000
	Local repairs required. Bearing length of original concrete header may not be adequate with second level addition. New lintel with increased bearing on repaired brick wall below may be necessary.			
	<b>Hose Tower Walls</b>

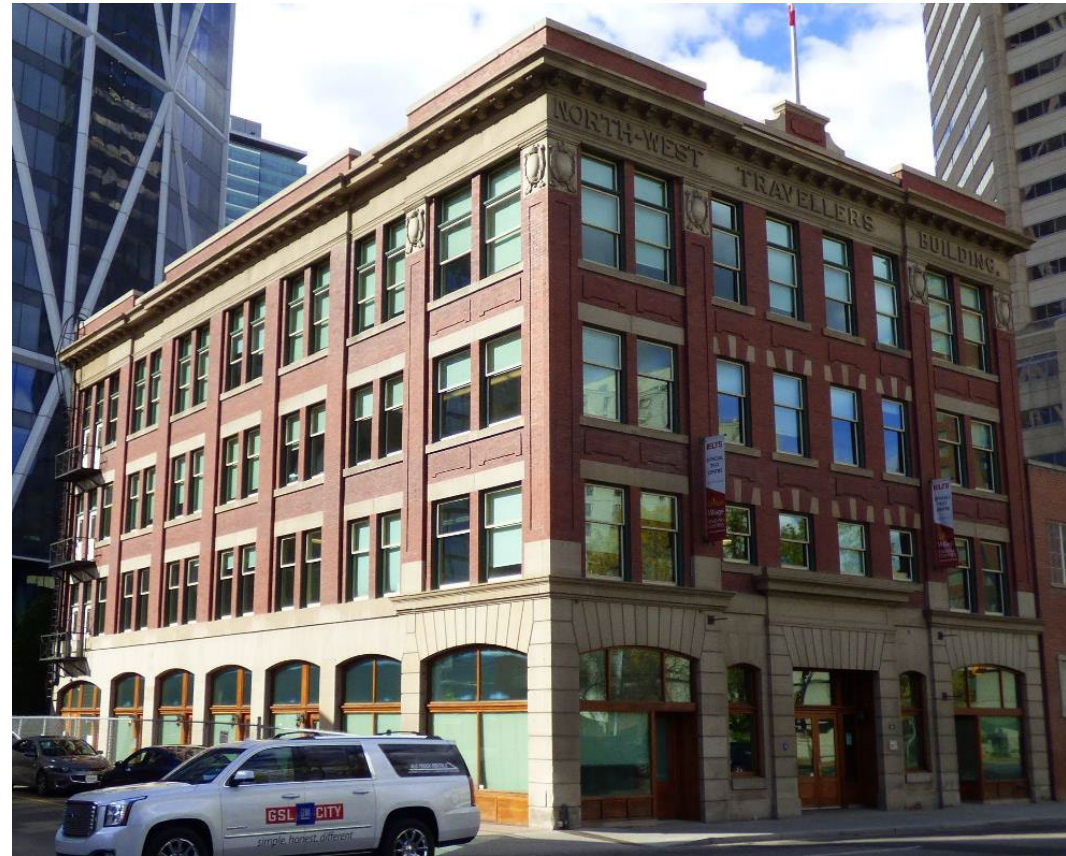
# NORTH-WEST TRAVELLERS BUILDING

The North-West Travellers Building is a four-storey red brick building in the Edwardian Classical Style, from the pre-World War One period, located on one city block at First Street and Fifth Avenue SW in downtown Calgary.
