REPORT

2025 Year-End

SE Calgary Odour Monitoring System

COC002-REP-2026001-R0

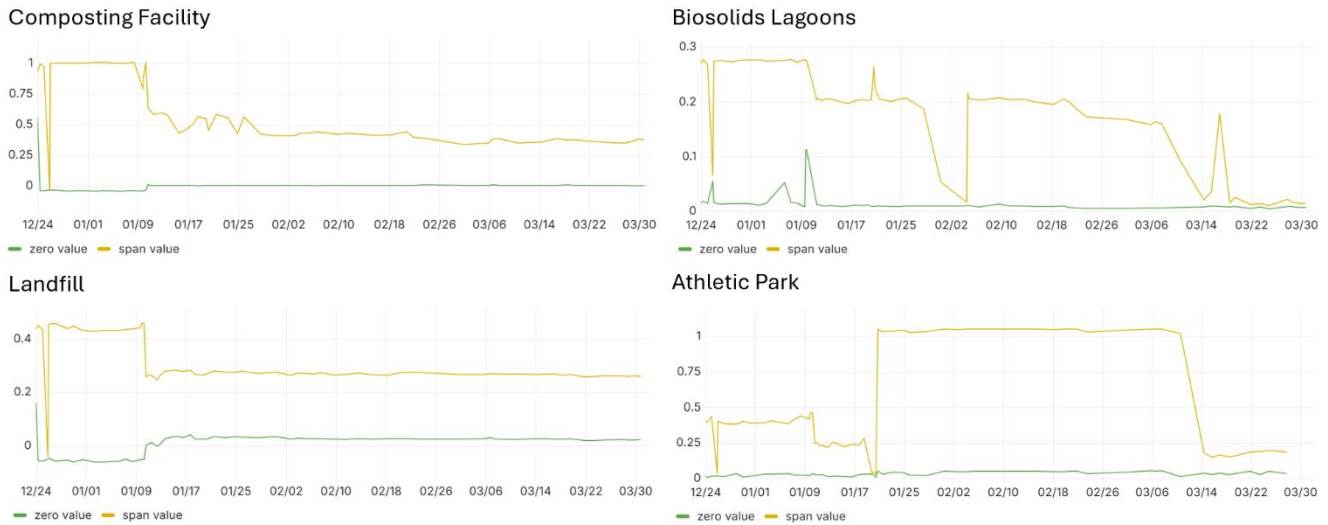
Calibrations performed for each H₂S instrument from January 1 to March 31, 2025, are shown in Figure 2 and show the voltage output. At the end of March, the output for all H₂S instruments was changed from an analog signal to a digital output to reduce signal interference. Calibrations performed from April 1 to December 31, 2025, are shown in Figure 3 and show concentration in ppb as the output.

Figure 2. Maximum and Minimum Voltage Values Recorded During Calibration of Each H₂S Sensor from January 1 to March 31, 2025

Overall, the H₂S instruments demonstrated adequate responsiveness during calibration. Calibrations that did not produce an expected response were typically associated with system issues such as pump failure, high humidity events, or calibration gas cylinder issues.

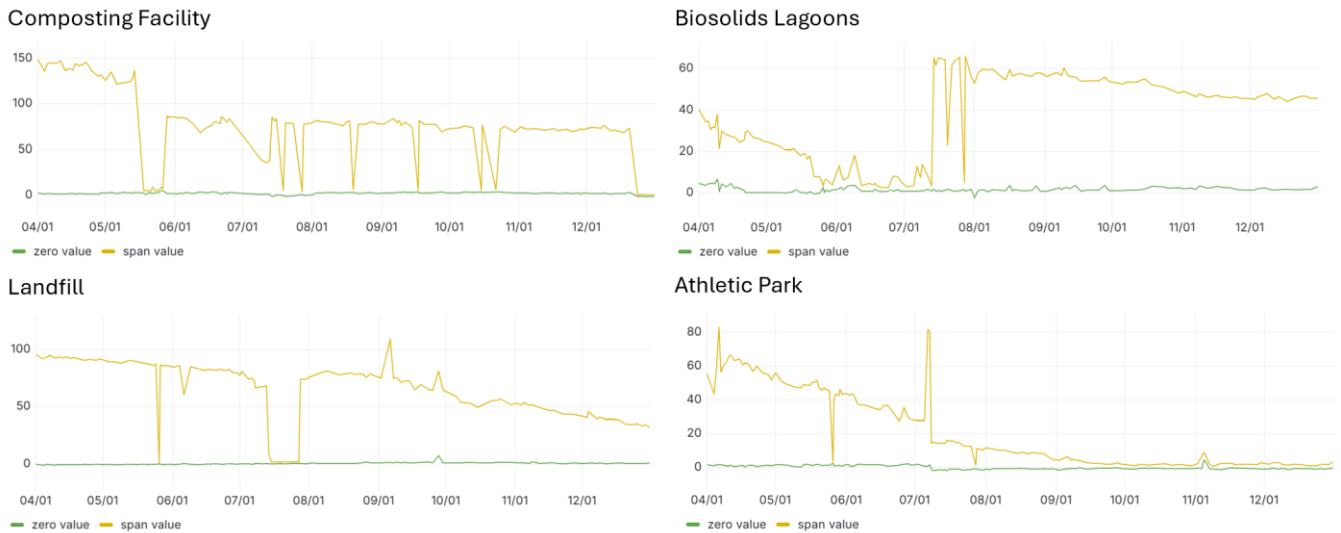
Figure 3. Maximum and Minimum Concentration Values (ppb) Recorded During Calibration of Each H₂S Sensor from April 1 to December 31, 2025

Decreasing span values recorded for the H₂S instruments at the Landfill and Athletic Park as the year progressed were attributed to an unexpected decrease in H₂S concentration within the calibration gas cylinder. This was confirmed through independent measurements taken in the field. The anomaly was first observed at the Lagoons sub-array in June. Although calibration data collected over this period was excluded from the data processing, it confirms that air samples were consistently delivered to the instrument through the valve manifold system. The gas cylinder supplier was consulted to investigate the issue; however, no conclusive cause has been determined.

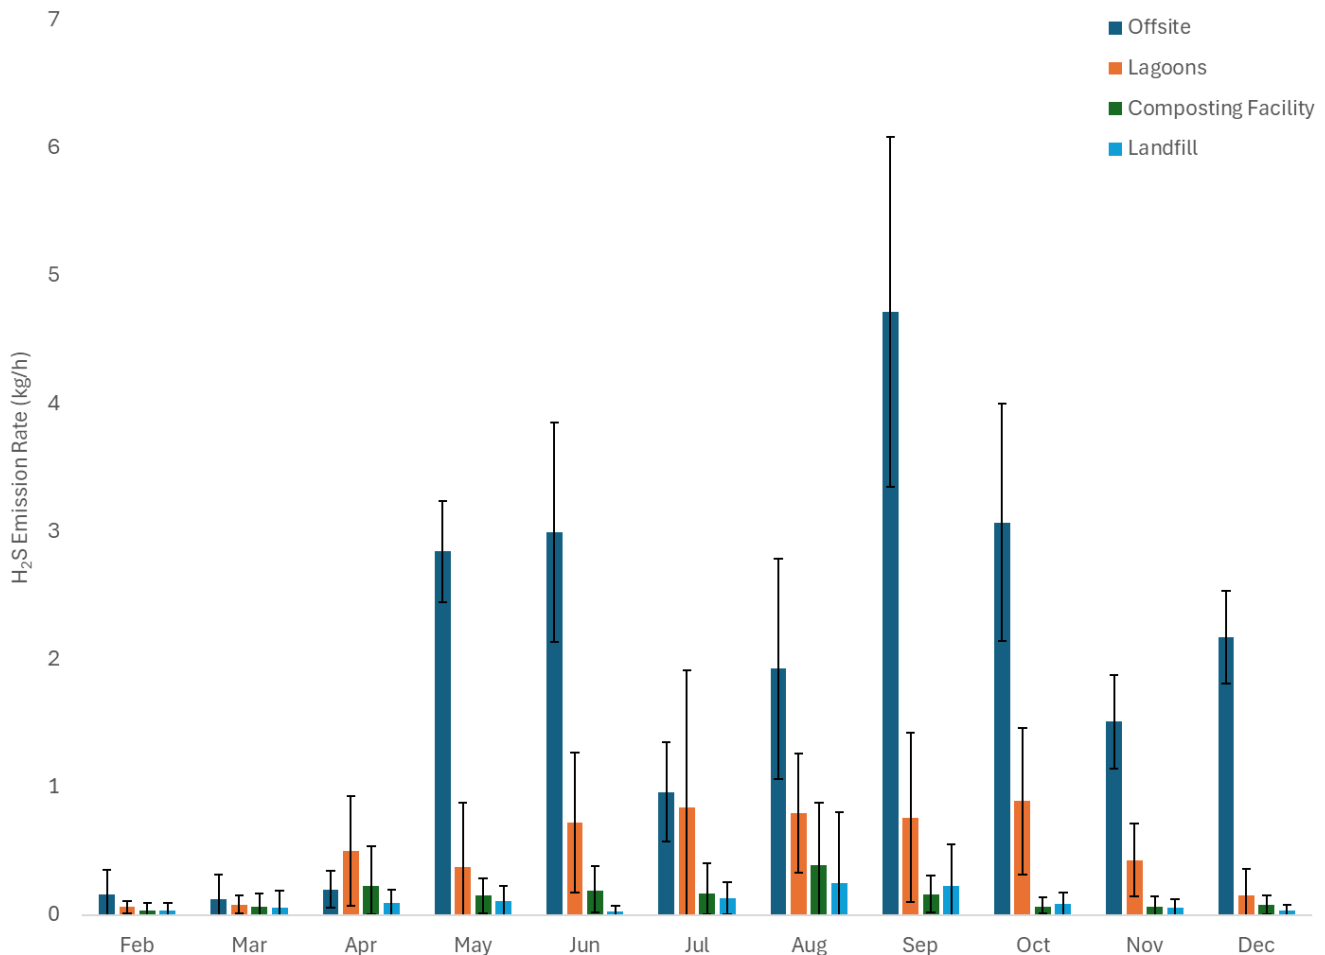
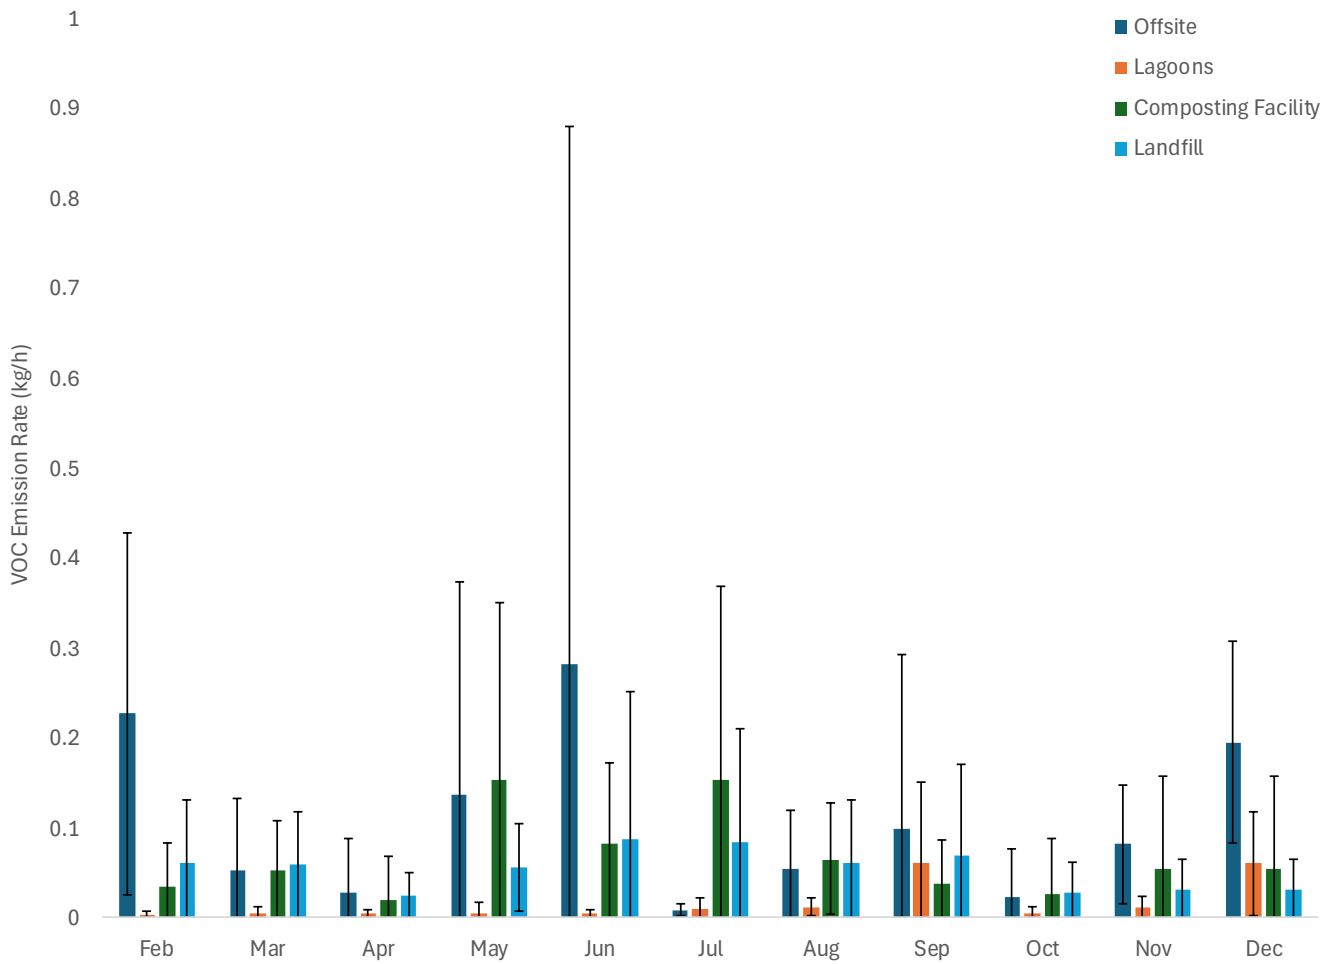
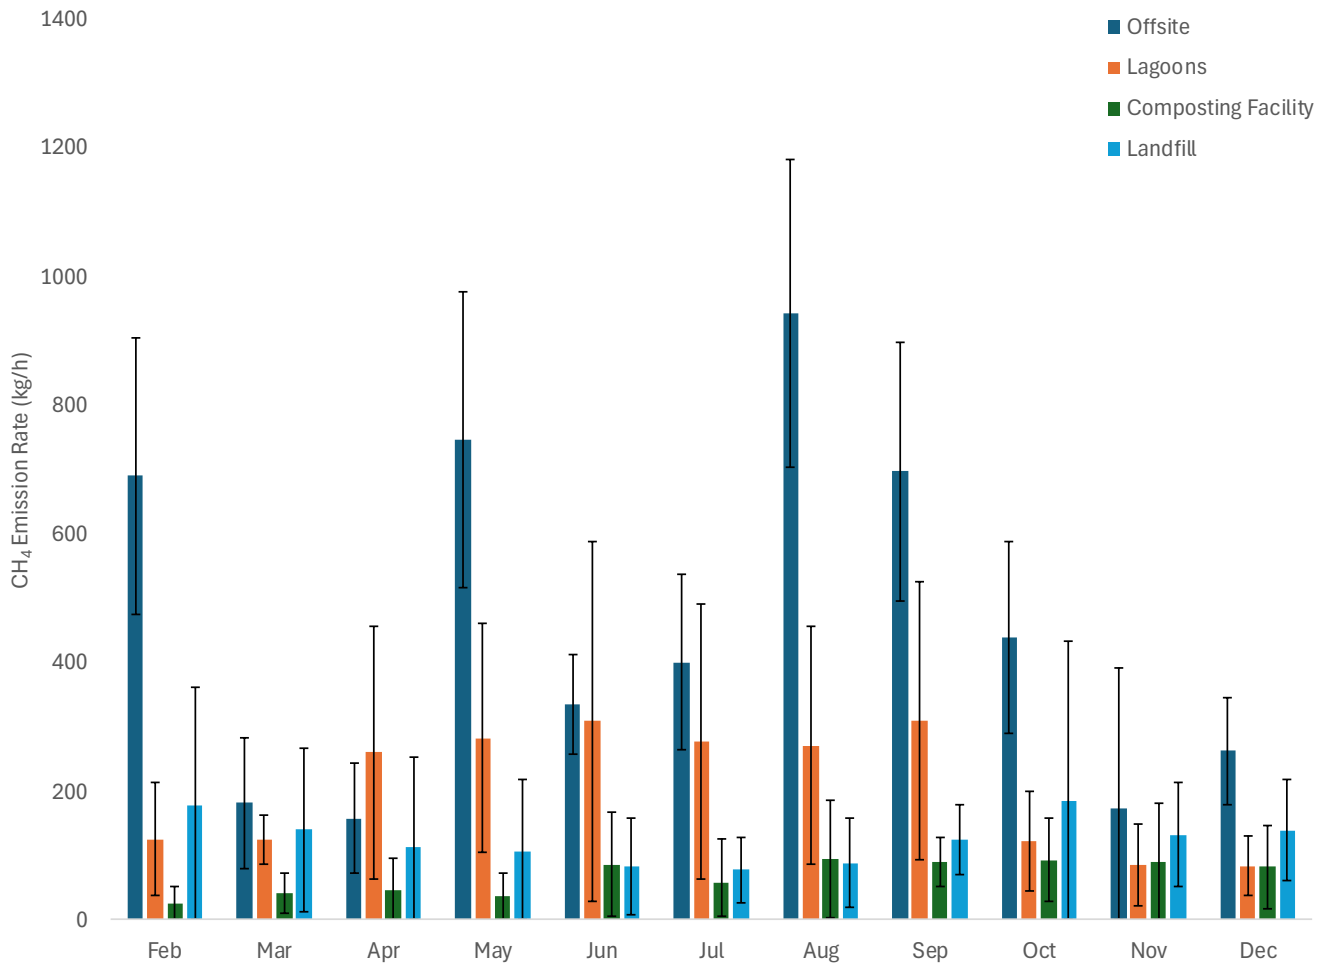
Figures 6 to 8 present boxplots of H₂S, VOC, and CH₄ emission rates showing the average value with whiskers representing the 10th and 90th percentile values for each area from February to December 2025. These plots provide a visual comparison of monthly changes in emission rates. The 10th and 90th percentiles illustrate the typical range of emission rates for each month and source.

Figure 6. Boxplot of Monthly Area H₂S Emission Rates with the Average (Mean), 10th and 90th Percentiles

Figure 7. Boxplot of Monthly Area VOC Emission Rates with the Average (Mean), 10th and 90th Percentiles

Figure 8. Boxplot of Monthly Area CH₄ Emission Rates with the Average (Mean), 10th and 90th Percentiles

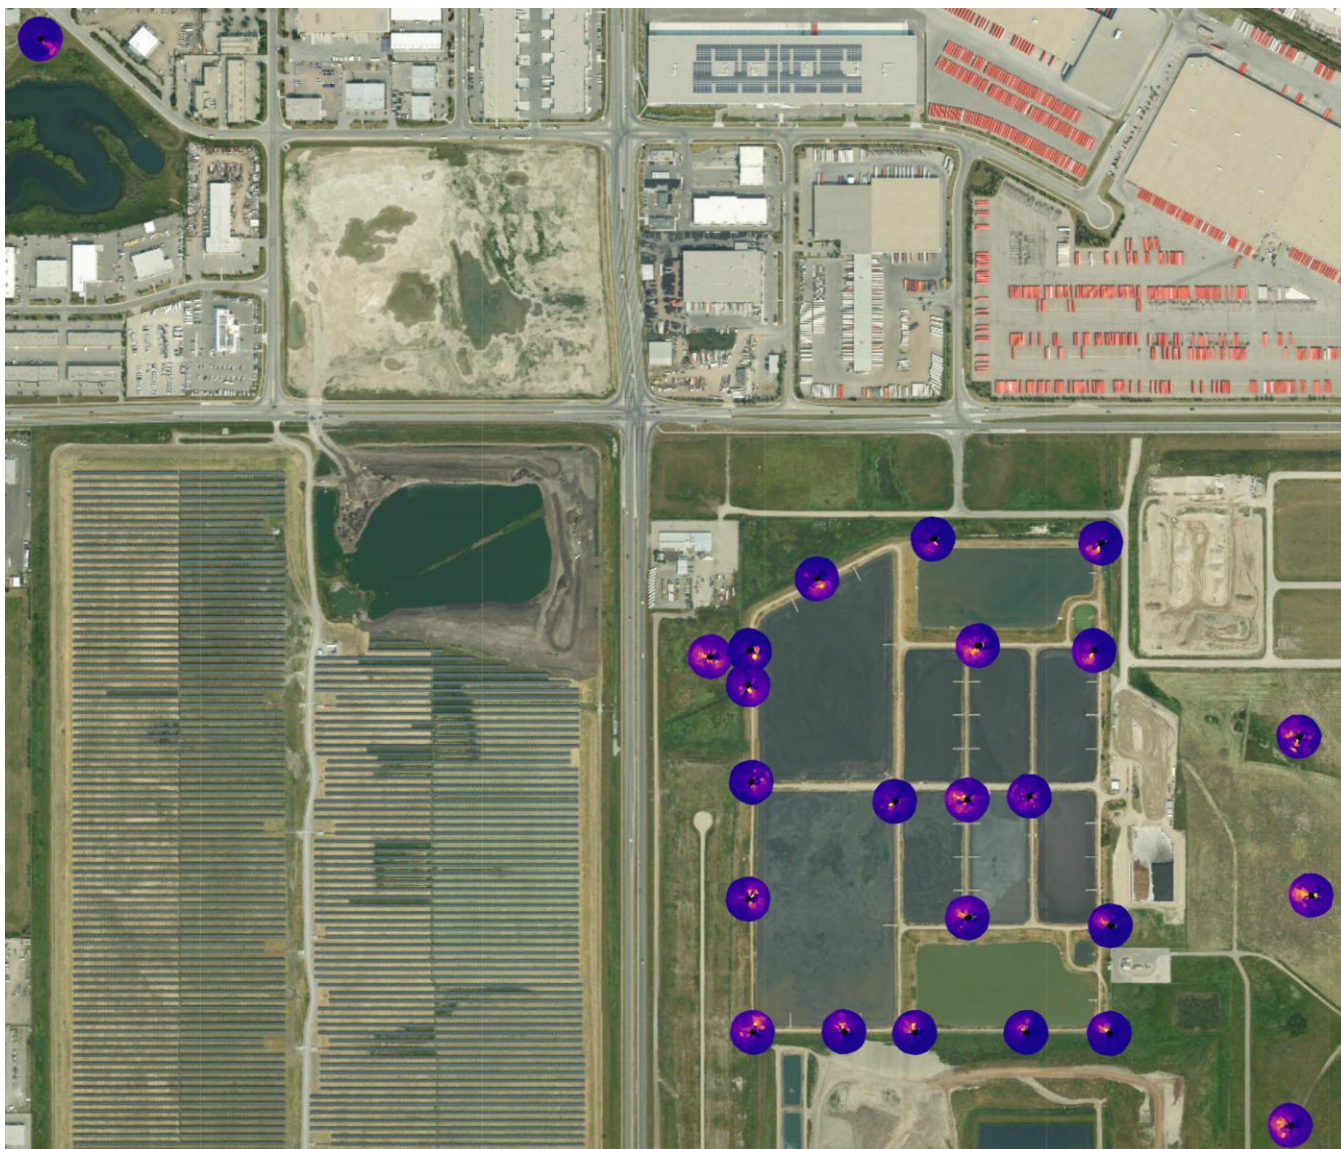
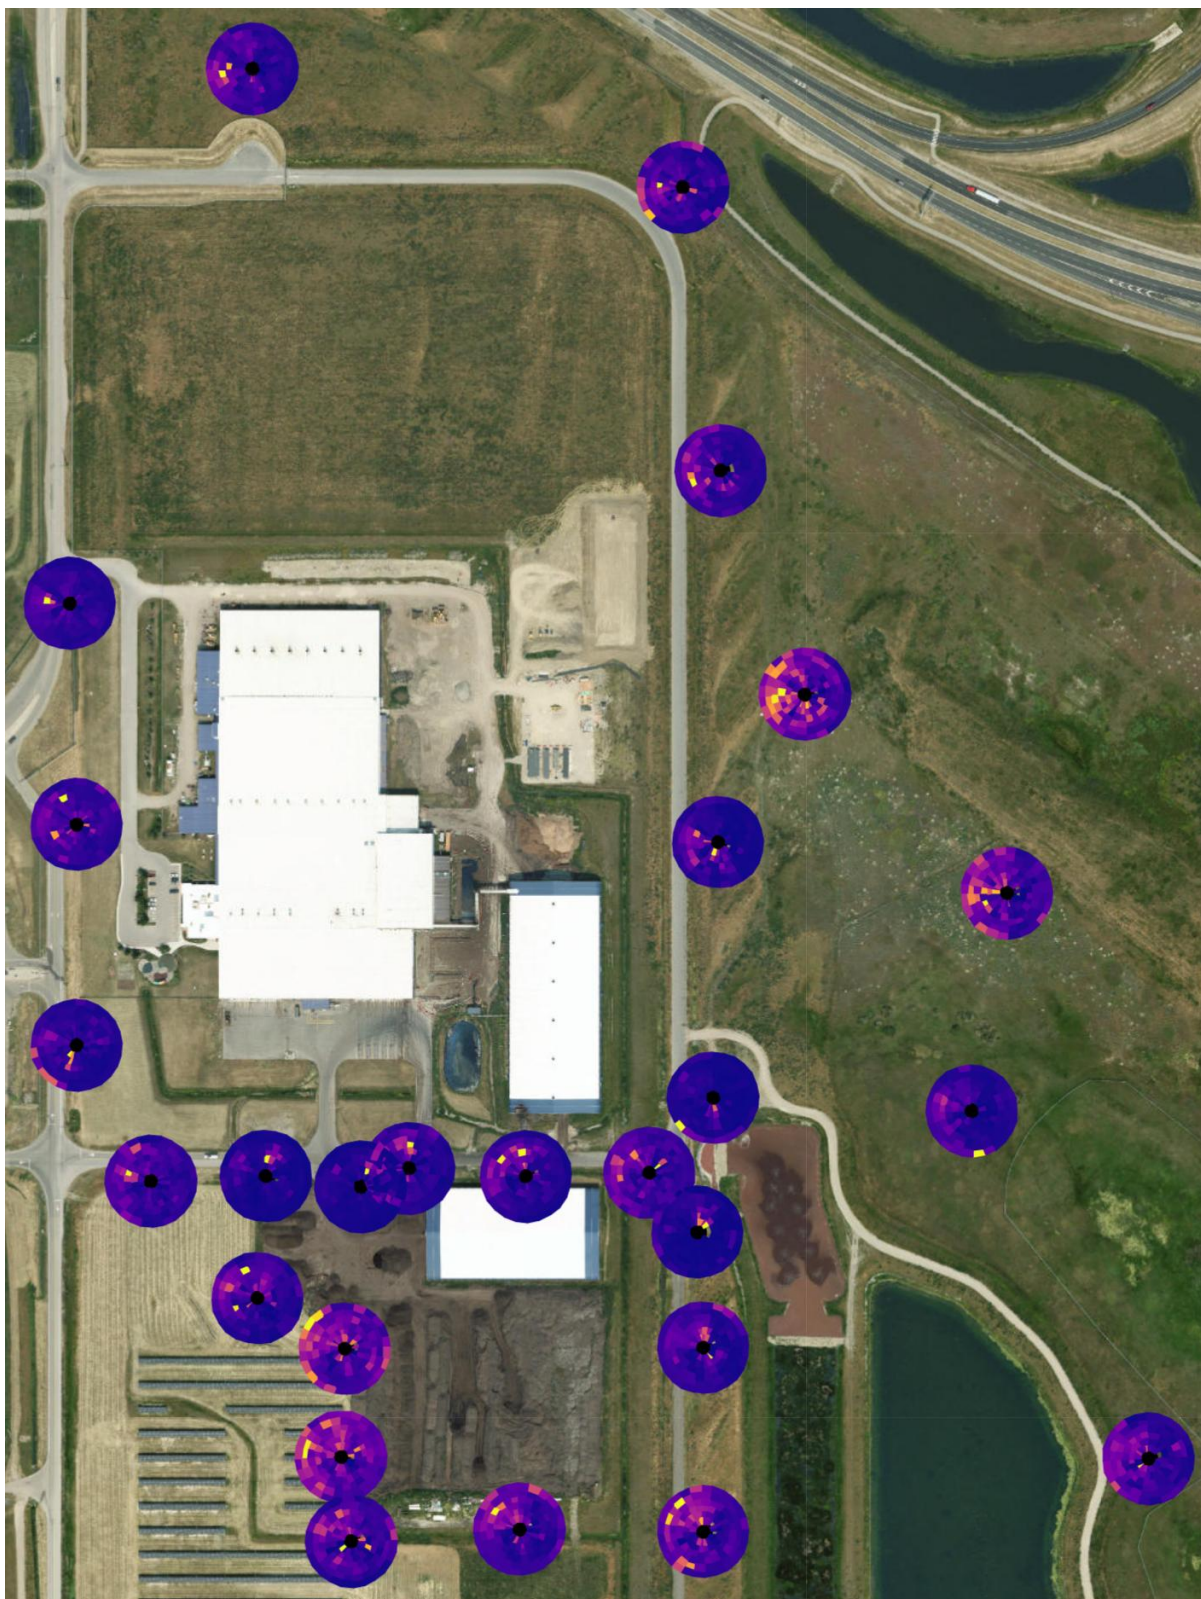
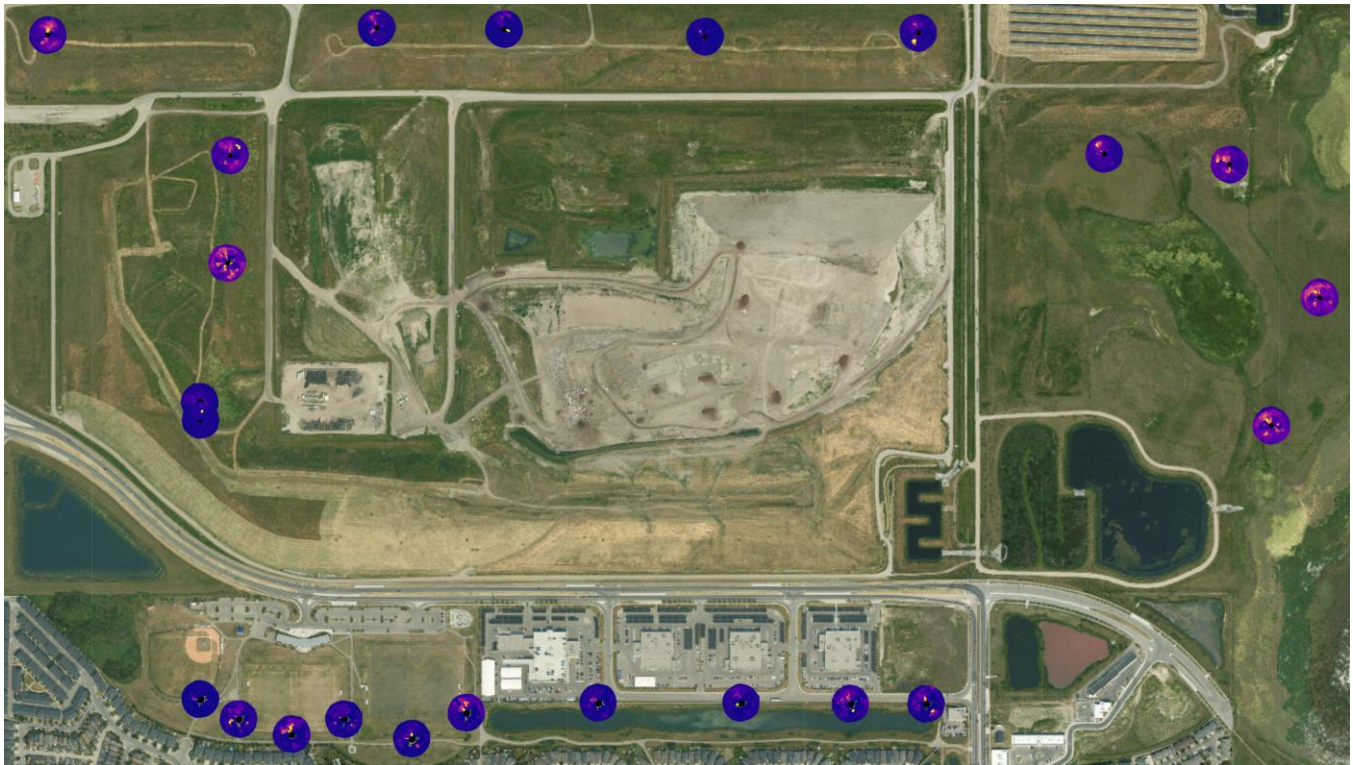
Figures 9 to 11 present H₂S radial surfaces at each inlet location and at the CRAZ monitoring station. These radial surfaces show inlets that detected plumes from one or more H₂S emission sources. Additional guidance on interpreting radial surfaces can be found in Appendix B: Radial Surfaces.

Figure 9. Aerial View of the Biosolids Lagoons and CRAZ Monitoring Station (Top Left Corner) with H₂S Radial Surfaces at each Inlet Location

Figure 10. Aerial View of the Composting Facility with H₂S Radial Surfaces at Each Inlet Location

Figure 11. Aerial View of the Landfill and Athletic Park with H₂S Radial Surfaces at Each Inlet Location

Several defined plumes were observed at multiple inlet locations. Agreement in plume trajectories among these locations, along with consistency in calculated emission rates provides increased confidence in identifying potential emission sources. Continued monitoring over time, including plume detections from multiple directions, helps further refine the location of these sources.

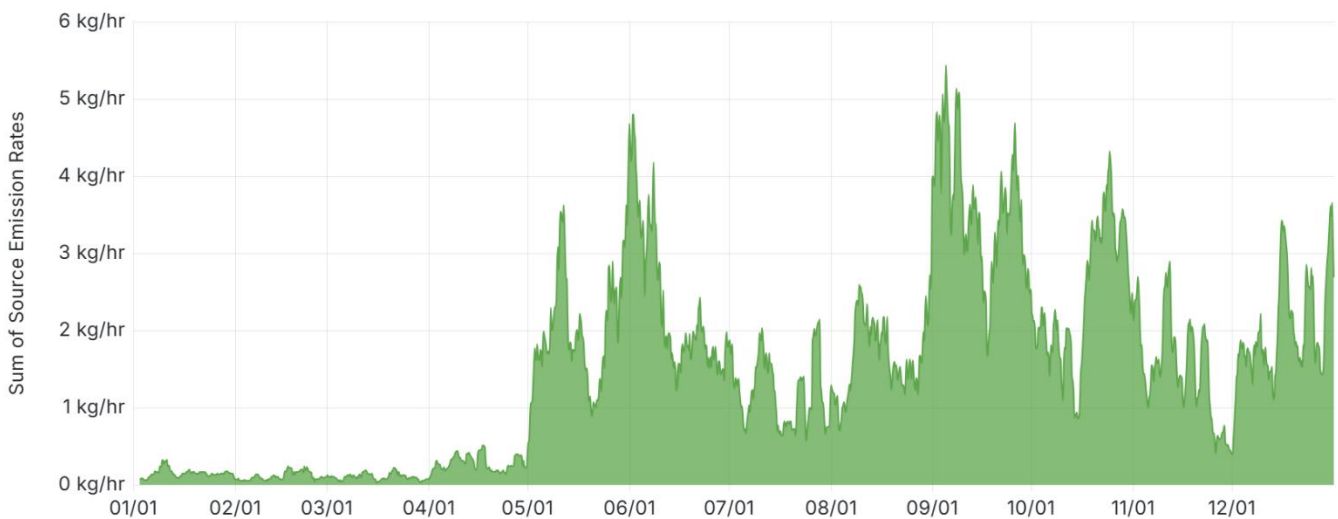
Figure 16. Emission Rate Over Time for Offsite H₂S Emission Source

Emissions from the offsite source were lower until May, increasing afterward with the highest rates observed in June and again from September to October. The offsite source is less well characterized, as plumes from this

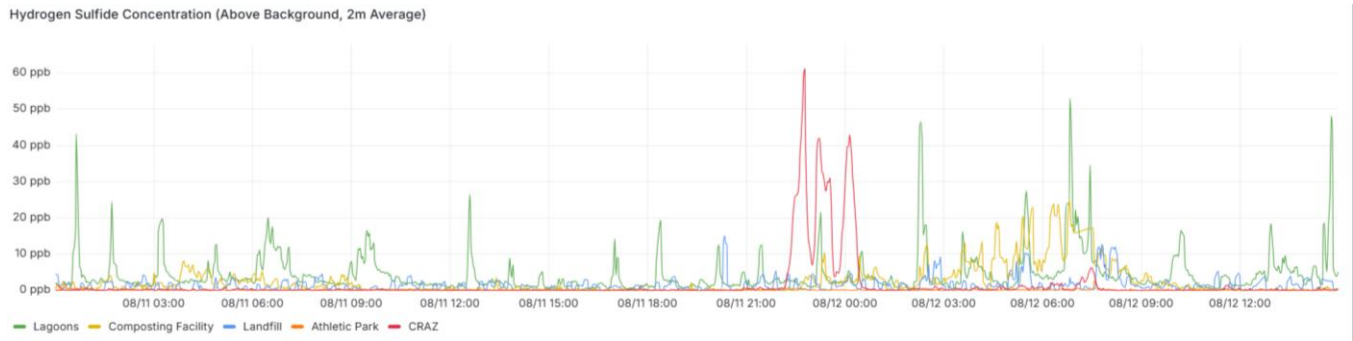
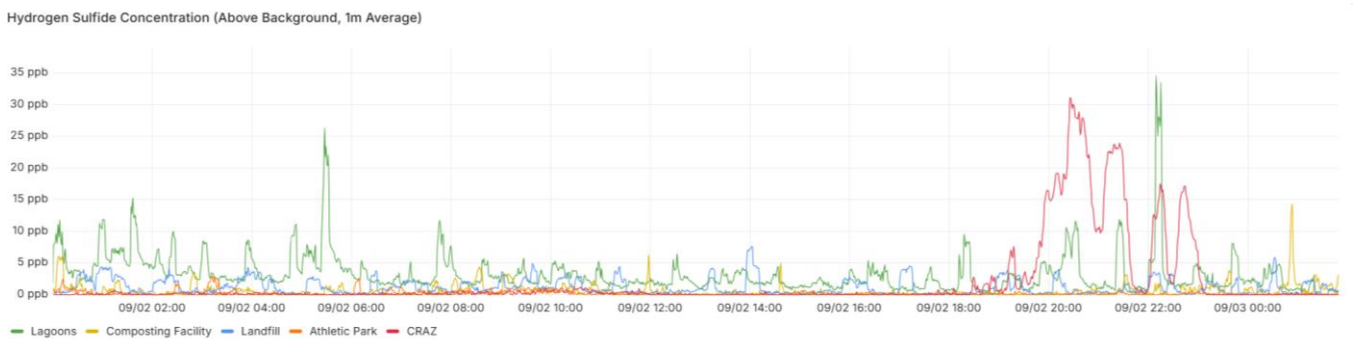
There is evidence of a potential offsite H₂S source located between the CRAZ monitoring station and the Shepard Complex. On the late evening of August 11 – 12 and on September 2, elevated H₂S concentrations were observed at the CRAZ station while winds were blowing from the site. However, during this same time, onsite H₂S concentration measurements were low, indicating that the high readings at the CRAZ station could not have originated from the site. These concentration patterns are shown in Figures 17 and 18.

Figure 17. H₂S Concentrations Measured at the CRAZ Monitoring Station from August 11 – 12

Figure 18. H₂S Concentrations Measured at the CRAZ Monitoring Station on September 2 – 3

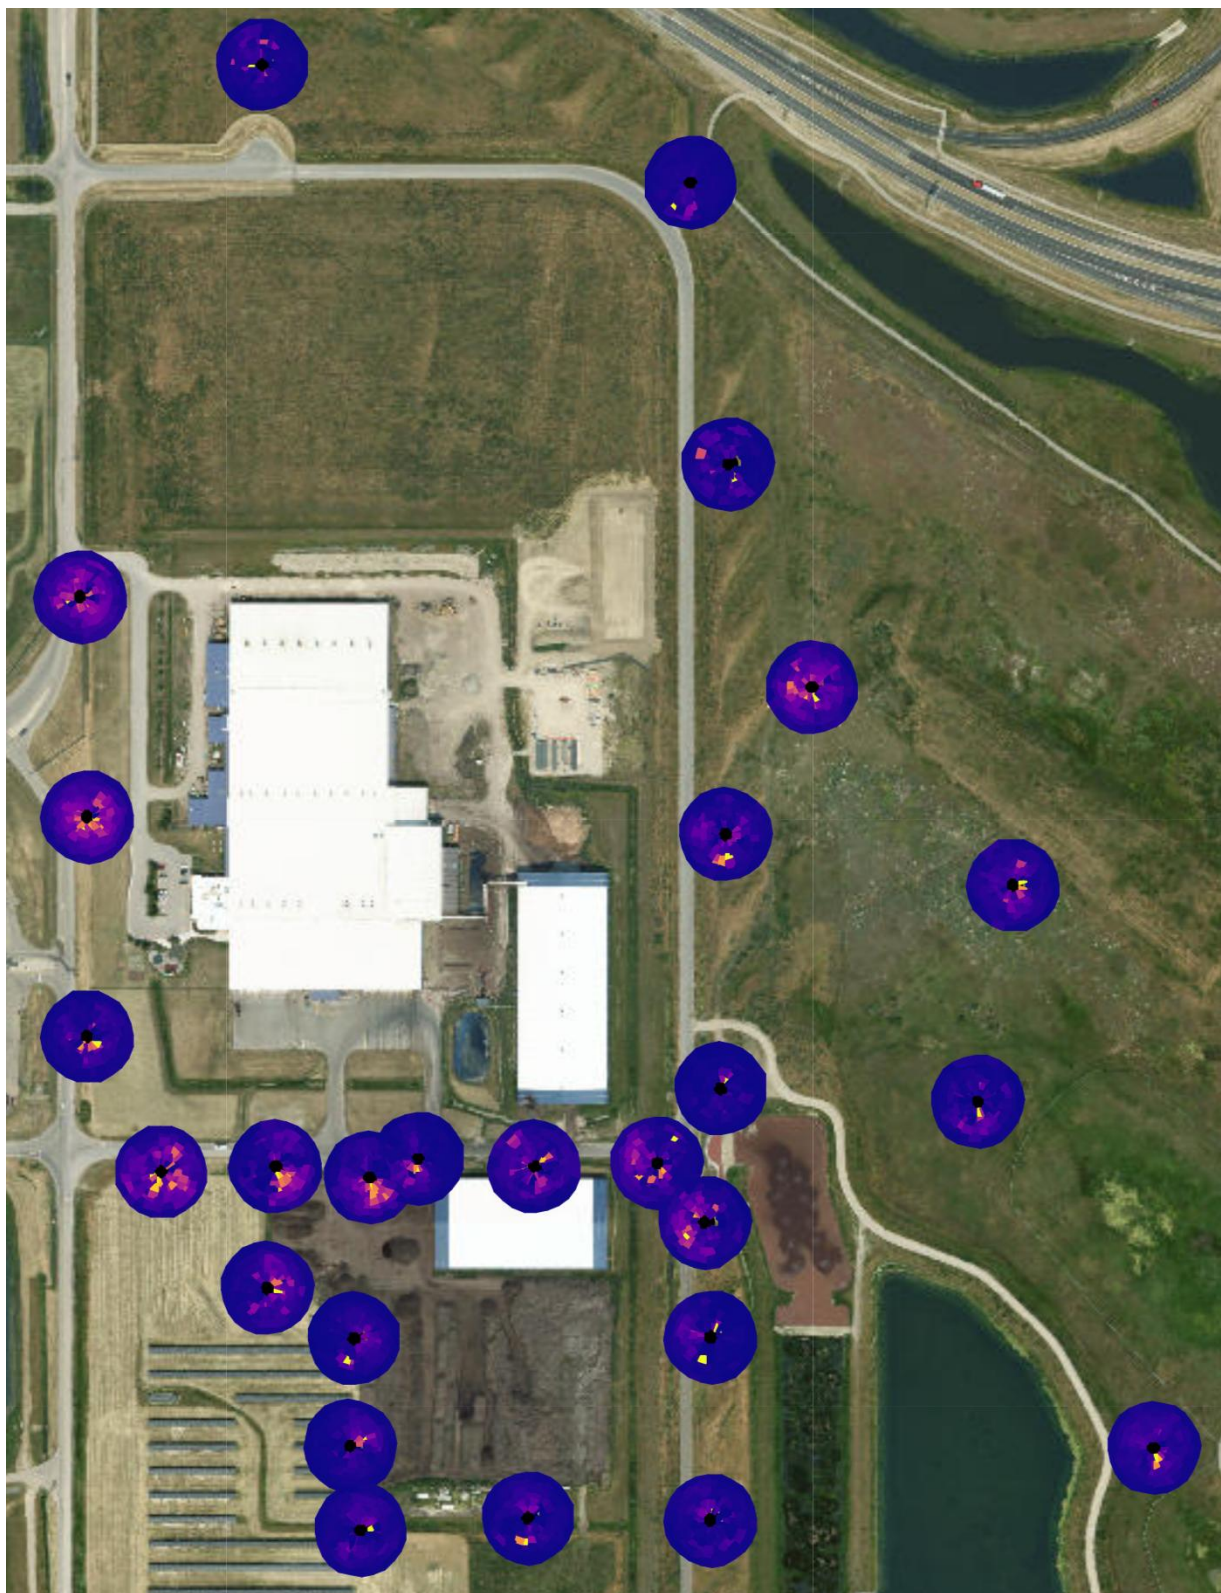
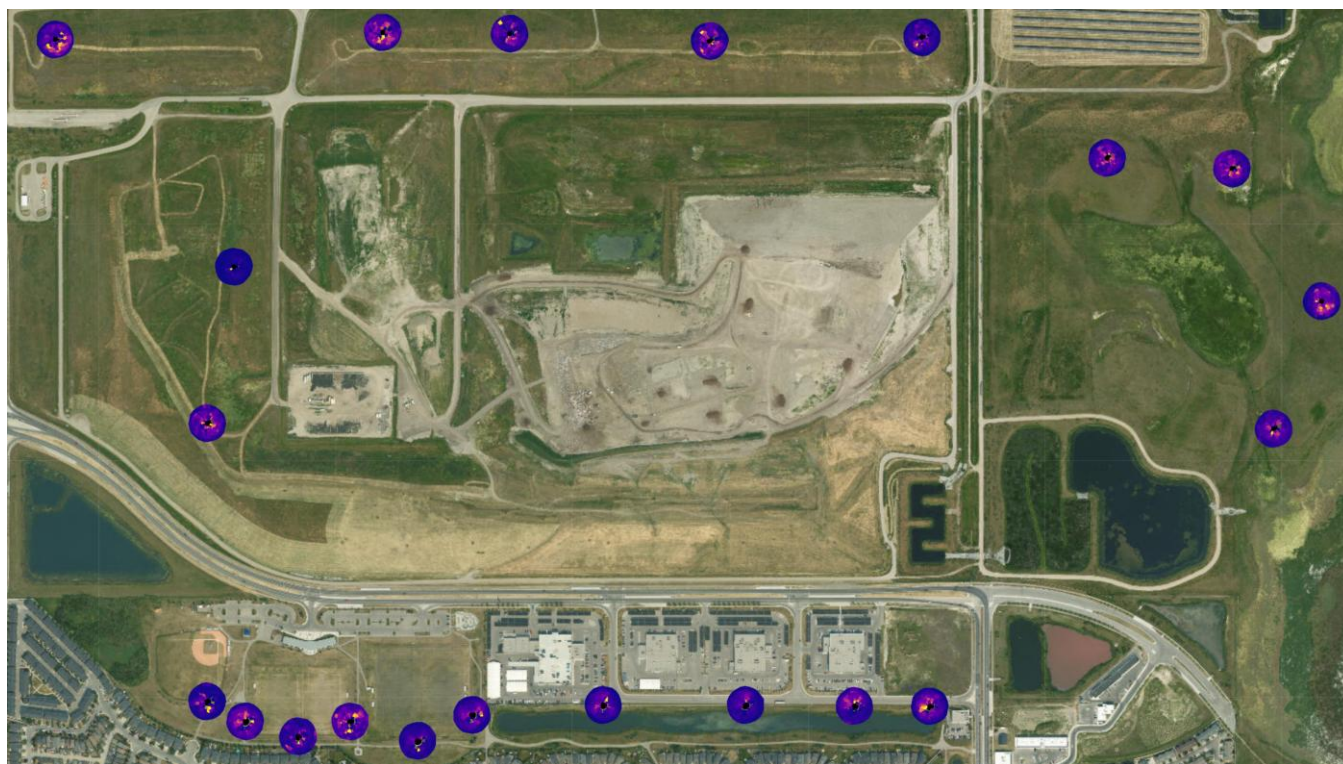
Figures 19 to 21 show radial surface plots of VOC data collected in 2025 for each inlet location at the Shepard Complex. VOC plume signatures are visible in these radial surfaces and show that inlets at all monitoring sub-arrays detected one or more VOC emission sources.

Figure 19. Aerial View of the Biosolids Lagoons with VOC Radial Surfaces at Each Inlet Location

Figure 20. Aerial View of the Composting Facility with VOC Radial Surfaces at Each Inlet Location

Figure 21. Aerial View of the Shepard Landfill and New Brighton Athletic Park with VOC Radial Surfaces at Each Inlet Location

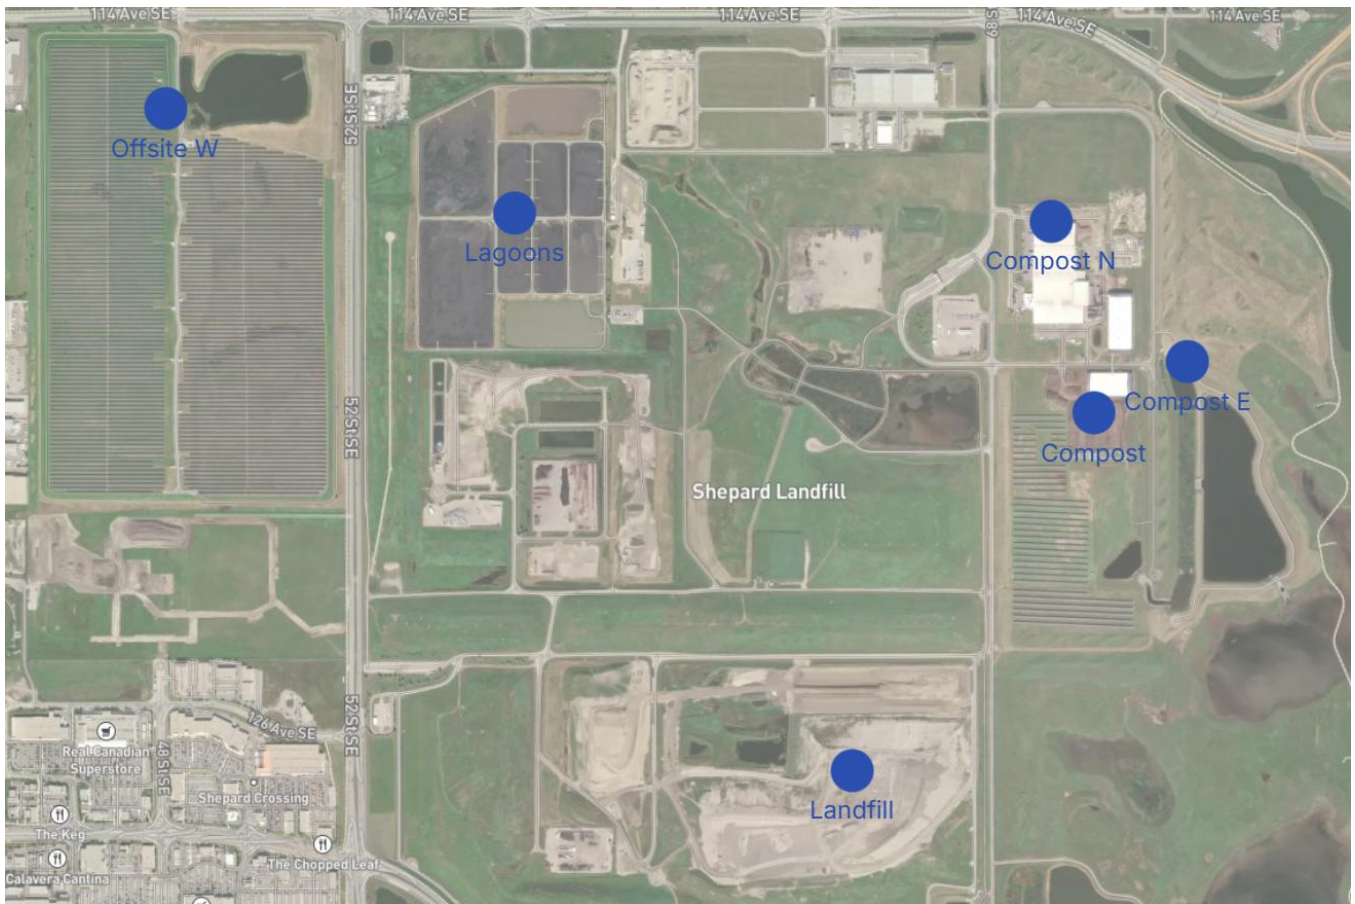
Figure 22 shows the locations of focal points for onsite VOC sources at the Lagoons, Landfill, and Composting Facility as well as a potential offsite source west of the site identified through the Airdar analysis.

Figure 22. Location of Onsite VOC Sources

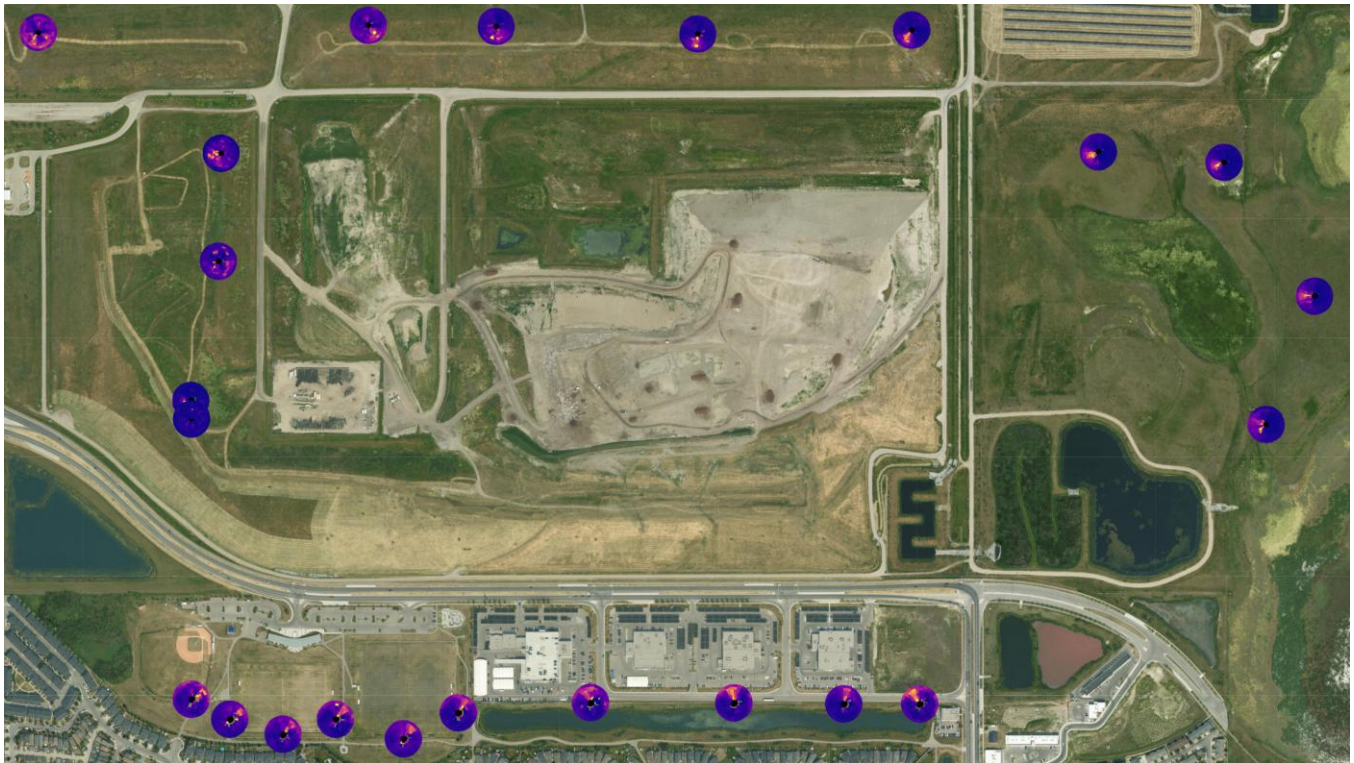
Figures 27 to 29 show radial surface plots of CH₄ data collected in 2025 at each inlet location. Plume signatures are evident in these radial surfaces, indicating that CH₄ emission sources were detected by inlets across all four monitoring arrays.

Figure 27. Aerial View of the Biosolids Lagoons with CH₄ Radial Surfaces at Each Inlet Location

Figure 28. Aerial View of the Composting Facility with CH₄ Radial Surfaces at Each Inlet Location

Figure 29. Aerial View of the Shepard Landfill and New Brighton Athletic Park with CH₄ Radial Surfaces at Each Inlet Location

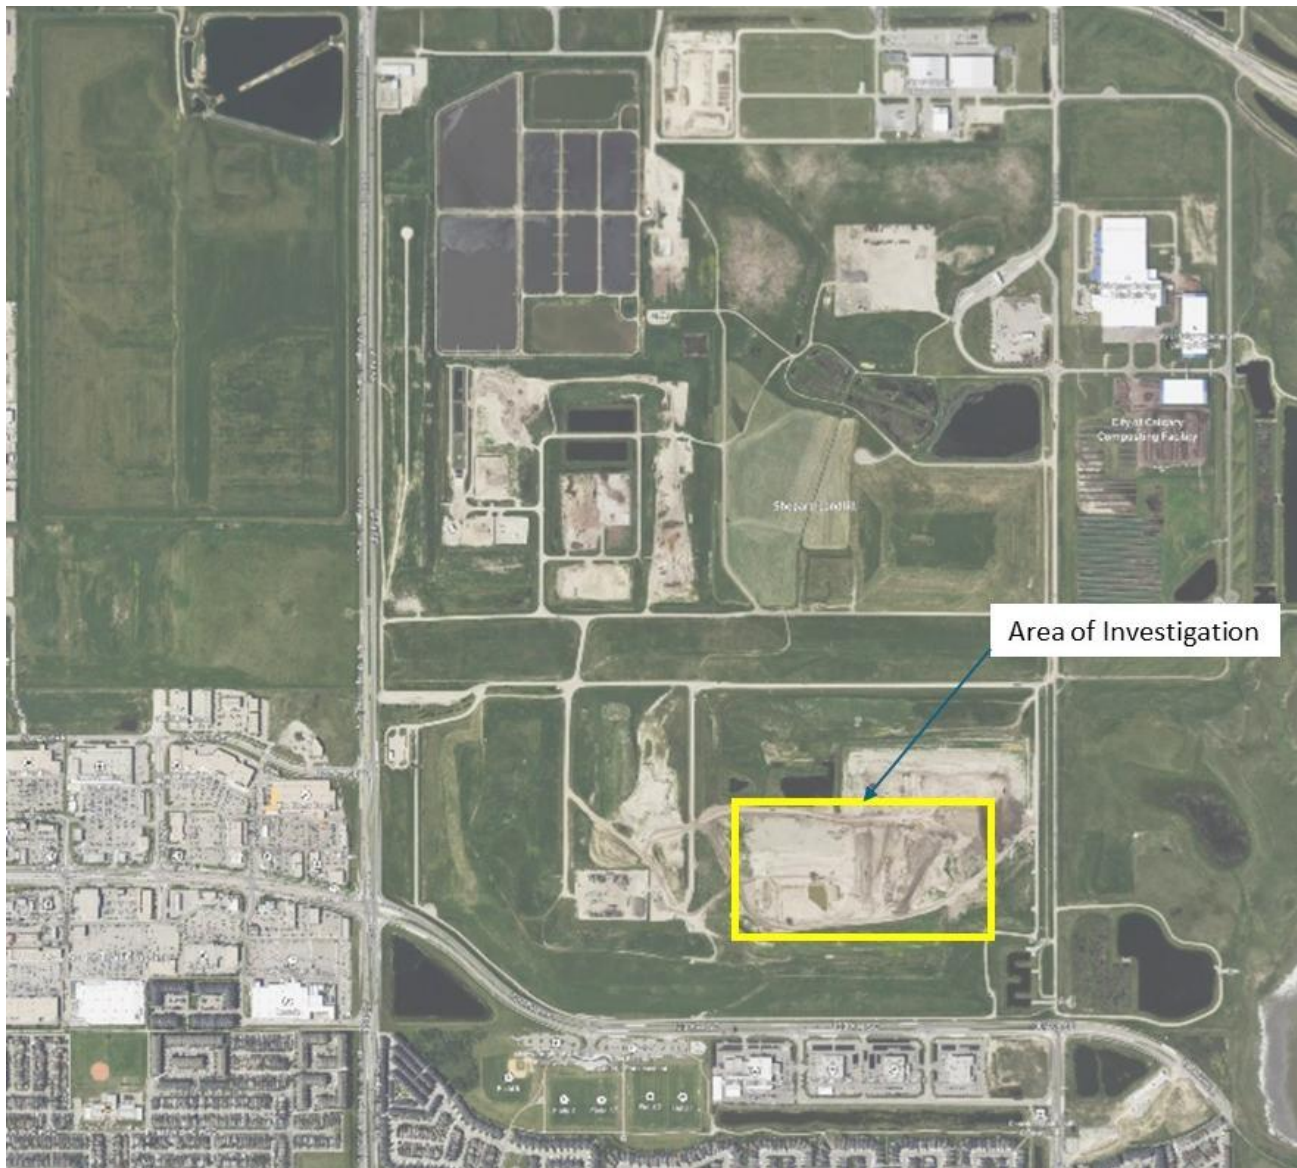
The first field investigation was conducted from August 12 – 14 to confirm the locations of the identified sources. Three mobile CH₄ sensing units equipped with Axetris CH₄ sensors and GPS capabilities were used by field technicians to conduct surveys around the Landfill, both on foot and by vehicle. These sensing units were also used to obtain near-source measurements at the predicted source locations. During these investigations, field technicians documented odours observed during their surveys, with particular attention to the “rotten grass” odour frequently described in the complaints. The investigation area covered at the Landfill using the mobile sensing units is shown in Figure 35.

Figure 35. Aerial View of the Shepard Complex Showing Area of Investigation on the Landfill Using Mobile Sensing Units from August 12 – 14

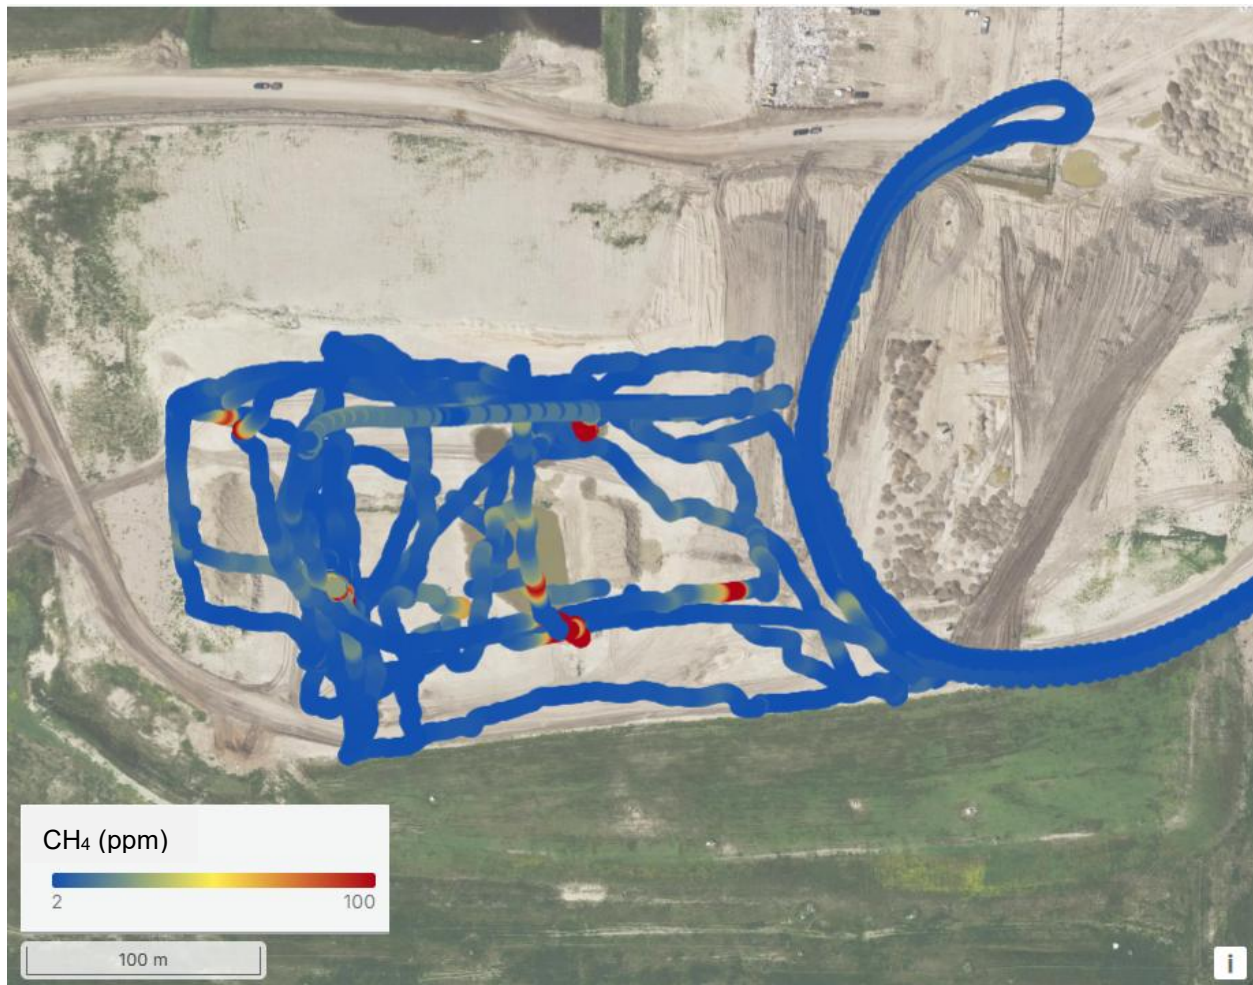
Figure 36 shows the spatial distribution of CH₄ concentrations (ppm) measured across the Landfill during the field investigation. Wind direction was primarily from the southeast during this time, coming from approximately 100 degrees. The colours represent the relative concentration level detected, allowing for visual comparison of CH₄ emission intensity across the Landfill. Localized areas of relatively higher concentrations are observed in this figure.

Figure 36. Spatial Results from Field Investigation Using Mobile CH₄ Sensing Units Showing Areas of Elevated Readings Downwind of Riser Vents (Wind Direction Approximately 100°)

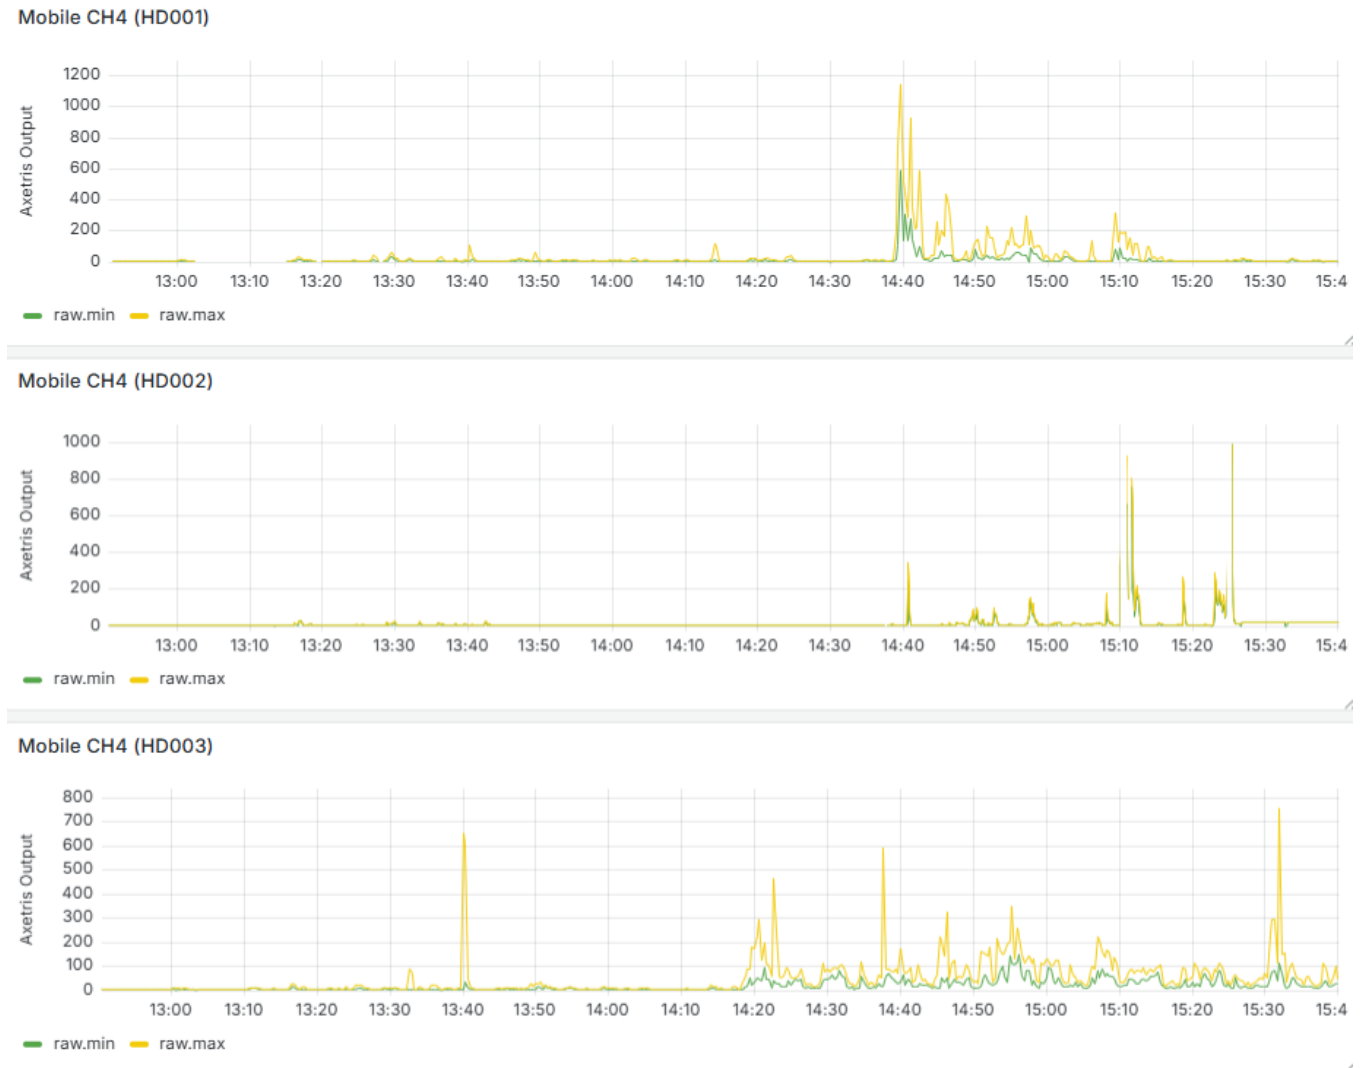
Figure 37 shows instrument readings in response to CH₄ concentrations measured during the field surveys by each deployed sensing unit (HD001, HD002, and HD003). Elevated readings above baseline levels were detected by the sensing units during this field investigation.

Figure 37. Methane Concentrations (ppm) Measured by the Axetris CH₄ Sensing Units During the August 12 Field Investigation
