REPORT

2025 Year-End

SE Calgary Odour Monitoring System

COC002-REP-2026001-R0

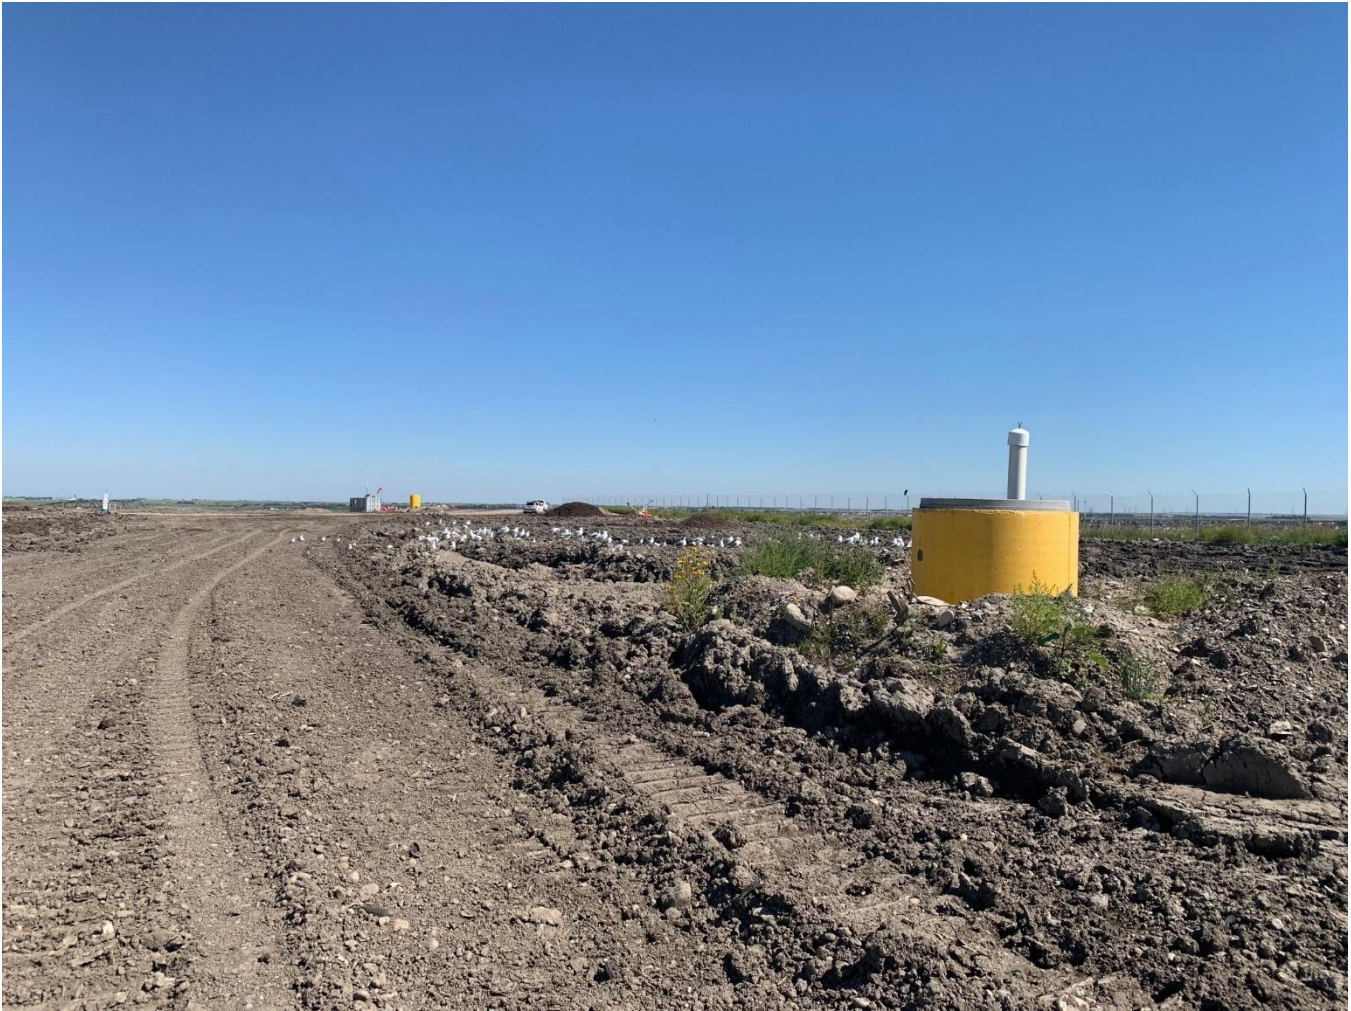
This field investigation revealed several areas of elevated CH₄ readings, including four to five distinct emission hotspots across the landfill cover. Elevated CH₄ readings (above background levels by a substantial margin) were consistently measured downwind of the Landfill leachate system access risers, with a characteristic “rotten grass” smell frequently described in odour complaints consistently detected near the risers. Figure 38 shows an example of a riser assessed during the field investigation.

Figure 38. Example of a Landfill Leachate System Access Riser Assessed During the Field Investigation

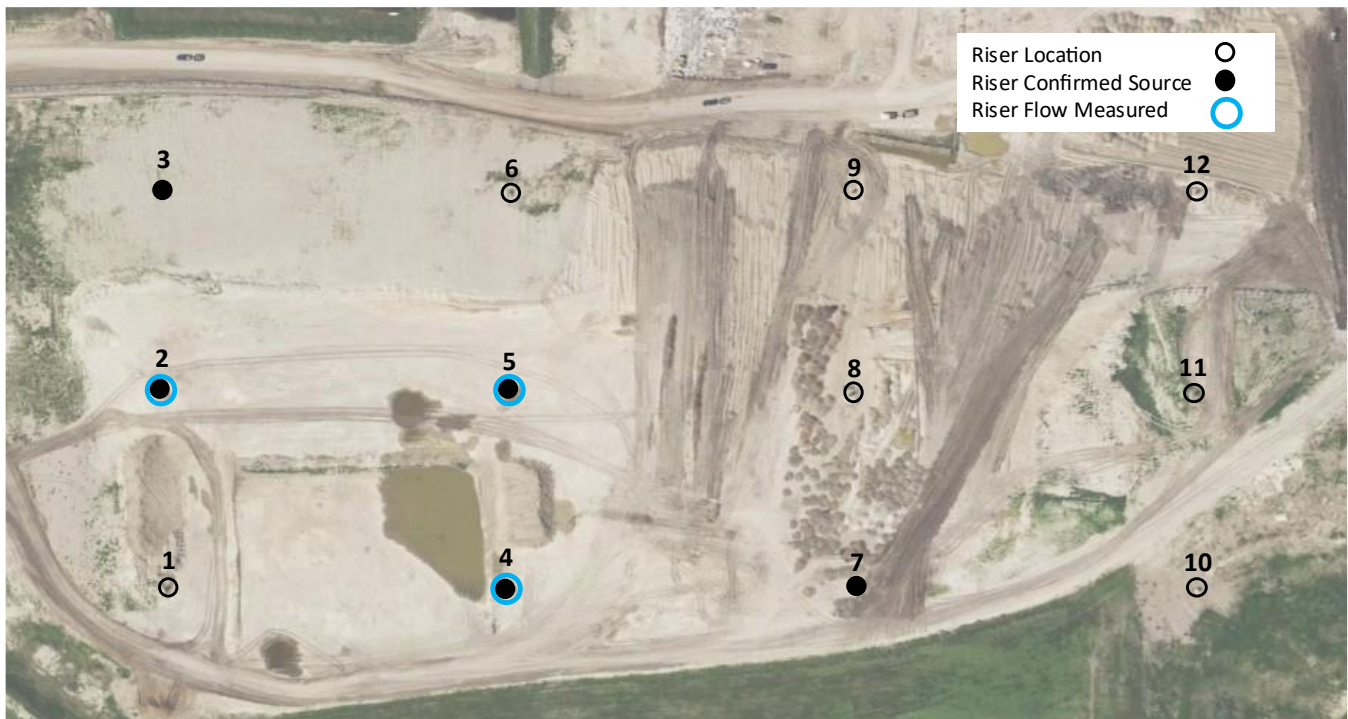
Figure 39 shows the locations of all visible risers across the active landfill. Risers identified as confirmed sources in this figure were investigated using a mobile CH₄ sensing unit where elevated CH₄ emissions were measured, and odours were confirmed. Risers indicated as unconfirmed sources were not examined up close using a mobile sensing unit. Figure 39 also identifies three specific risers where flow rates were measured. This was performed by covering the riser with plastic and directing the gas flow through a 100 mm conduit into a 74-liter plastic bag. The time required to fill the bag was recorded to estimate the flow rate. CH₄ concentration was measured at the conduit opening with a CH₄ sensing unit. Air sampled at these risers showed CH₄ concentrations ranging from 7% to 12%. The flow rates and concentrations of CH₄ measured from the three risers are shown in Table 7. These results suggest that the risers are important sources of CH₄ emissions. Additionally, other emission hotspots were detected on the landfill cover surface, though no significant odour was noted at these locations.

Figure 39. Aerial View of the Landfill Showing Riser Locations Investigated on August 12-14

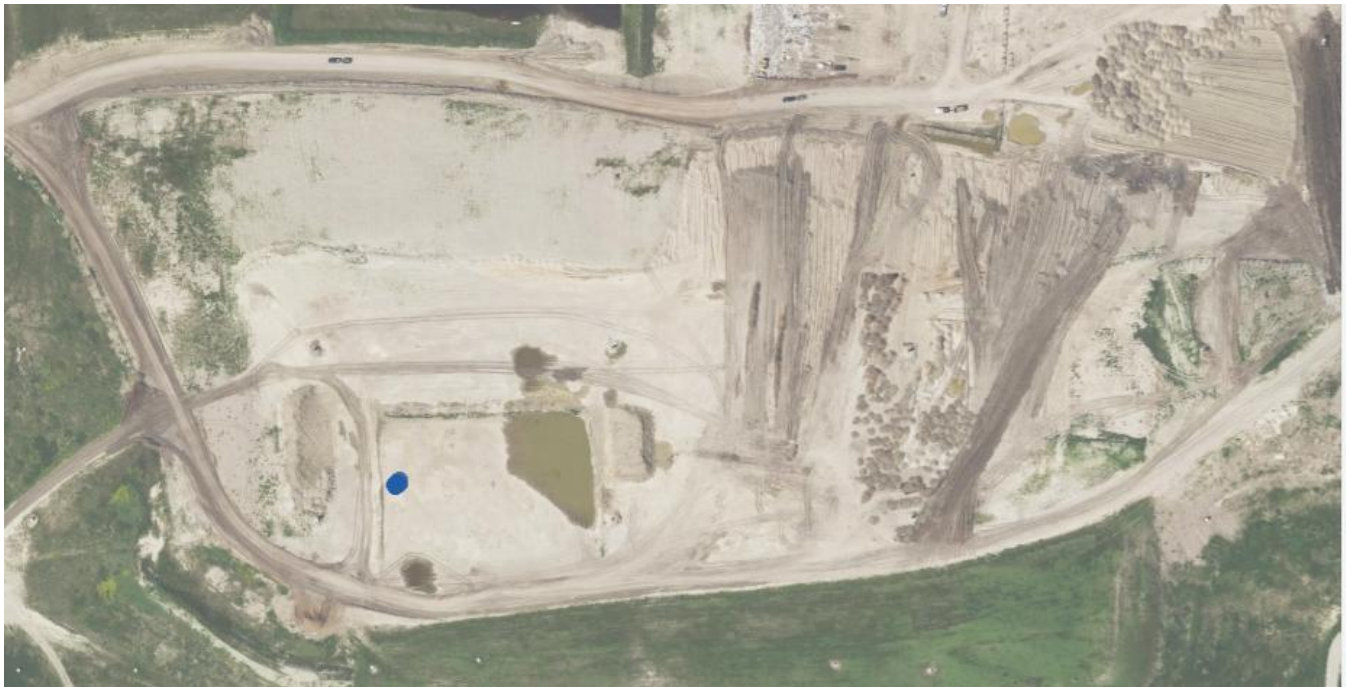
Elevated CH₄ levels were detected at the surface of the landfill, not associated with the risers. This is likely a result of CH₄ seeping through the landfill cover. A sensing unit was deployed at one of these locations for several days to monitor concentration patterns. The location of this hotspot is shown in Figure 40 and CH₄ concentrations measured at this location are shown in Figure 41.

Figure 40. Aerial View of the Landfill Showing the Location of an Identified Surface Hotspot on the Landfill Cover

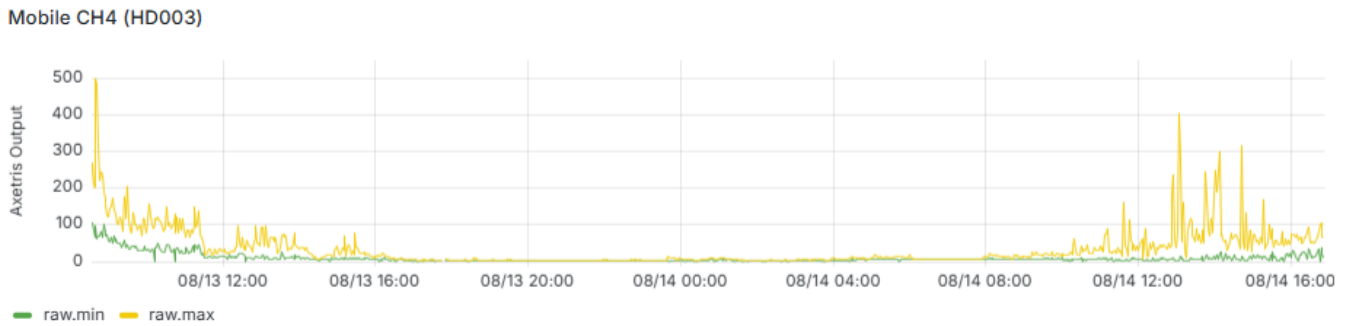
Figure 41. Methane Concentrations (ppm) Measured at a Surface Hotspot on the Landfill Cover Before and After a Rain Event on August 13

Rainfall during the monitoring period was observed to have a substantial influence on CH₄ emissions at the Landfill. During a rain event on August 13 beginning around 4:30 PM, a sharp decrease in CH₄ concentrations was observed at the surface hotspot, returning to background levels. This suggests that precipitation may temporarily suppress surface CH₄ emissions by increasing the moisture content of the landfill cover. When saturated, the permeability of the cover may become reduced, limiting the upward migration of gas through the cover material.

It is noted that these emissions were not accompanied by a rotten grass smell, suggesting that the chemistry or source of emissions in these spots may be different. It is possible that CH₄—when released directly through the cover instead of through a riser —does not co-emit the suite of compounds responsible for the reported odour.

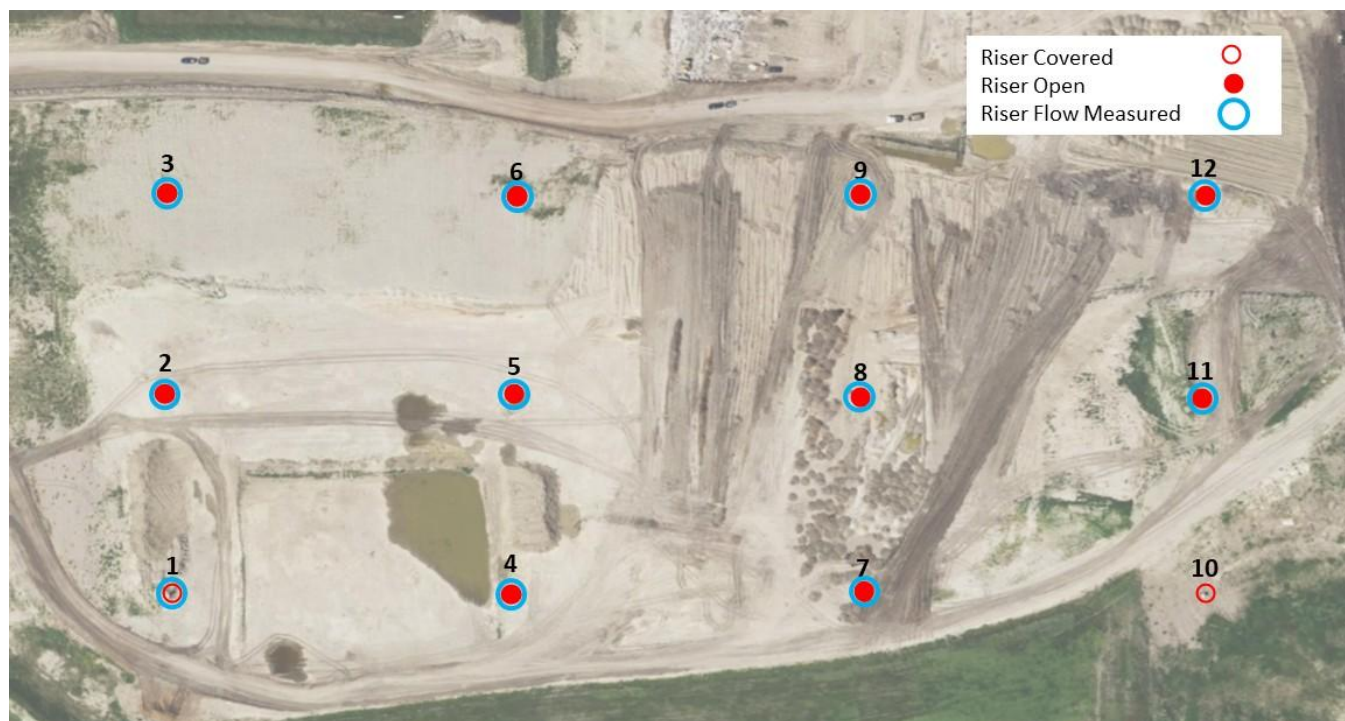
Figure 42. Aerial View of the Landfill Showing Riser Locations Confirmed as Important Sources of CH₄ and Odour

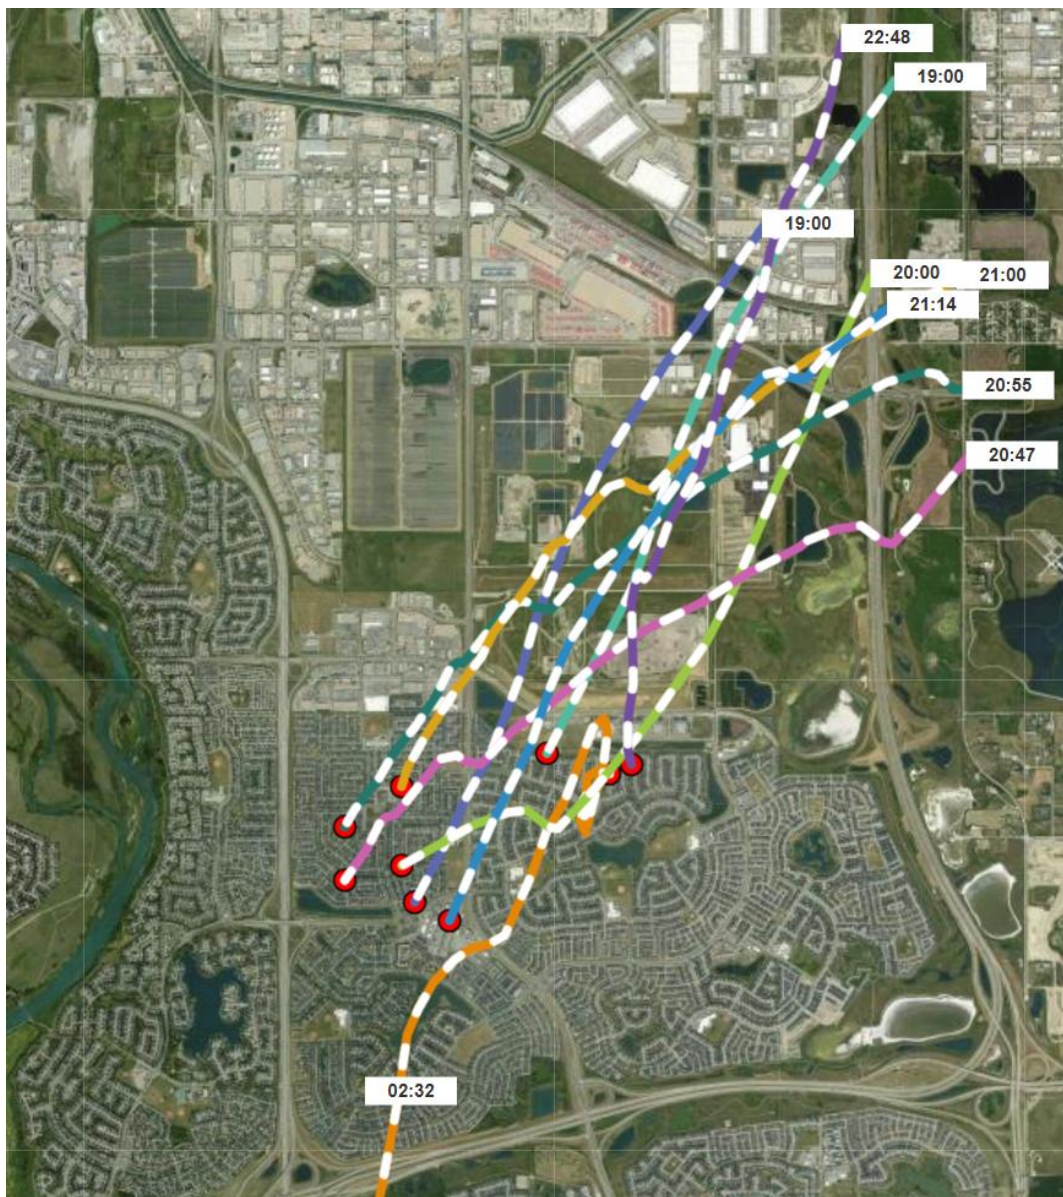
Figure 53. Estimated Path of the Air Traveling Before Each Complaint on October 8

Winds during the day were primarily from the north, shifting to the northeast (approximately 40°) in the evening, coinciding with the period when the majority of odour-related complaints were received. Figure 53 shows wind paths approximately two hours before each complaint and show trajectories passing over potential onsite sources at the Shepard Complex.

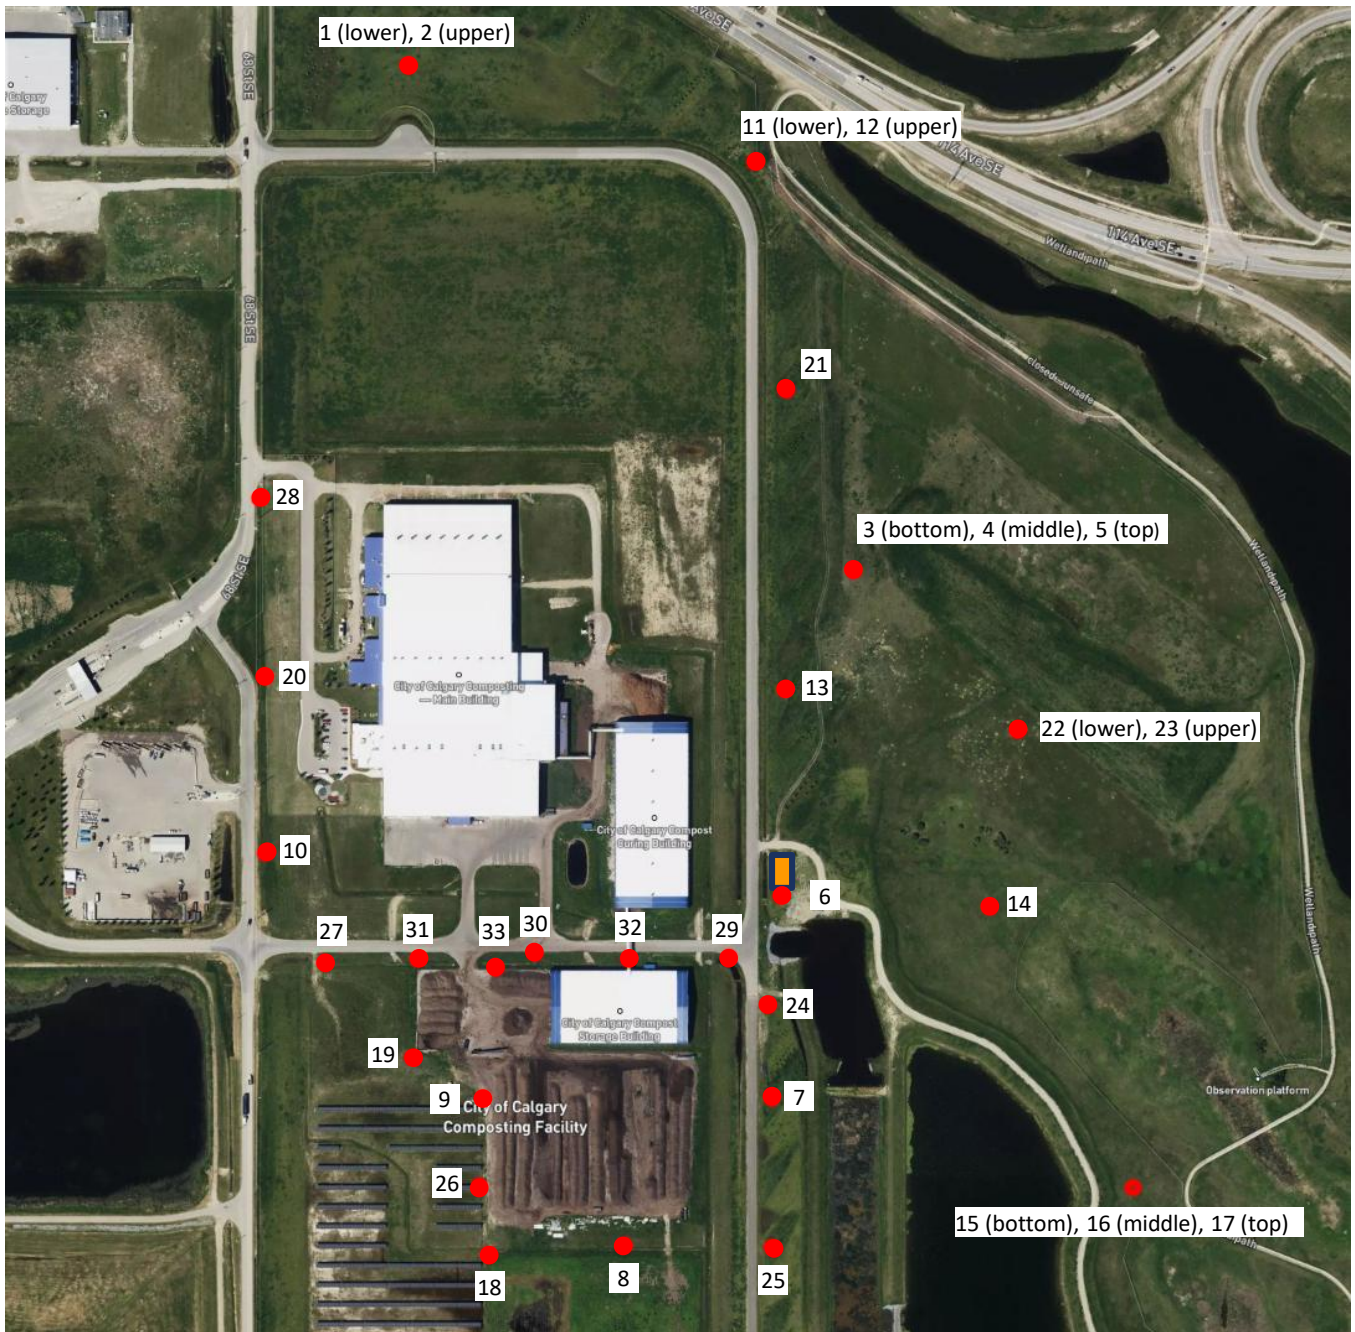
Figure 2. Layout of Sample Inlets at the Calgary Composting Facility

Most sample inlets are connected to one of the four monitoring arrays via small-diameter fluorinated ethylene-propylene (FEP) tubing. The distribution of sample inlets across each area of interest, along with their sampling heights above ground surface, are summarized in Table 1. The layout of sample line routes and sample inlet locations around the Shepard Complex is shown in Figures 1 to 4 of Appendix A: Supplementary Figures.

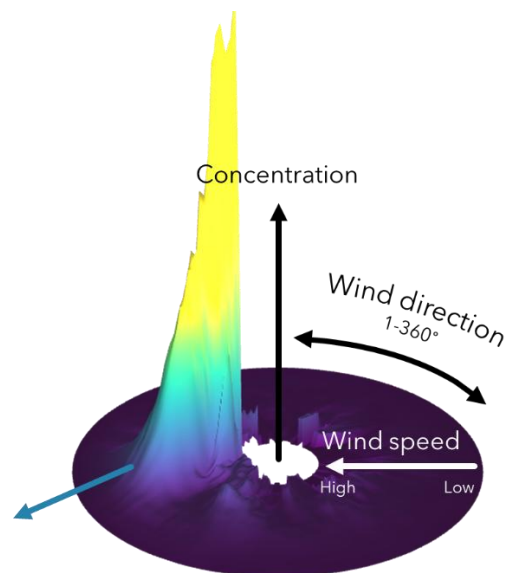
Figure 1. Example of a radial surface plot composed of concentration, wind direction, and wind speed, showing defined plume signatures.
