Bioengineering Demonstration and Education Project - 2019 Monitoring Report

The City of Calgary Riparian Monitoring Program

July 14, 2020

Final report prepared for:
The City of Calgary - Water Resources

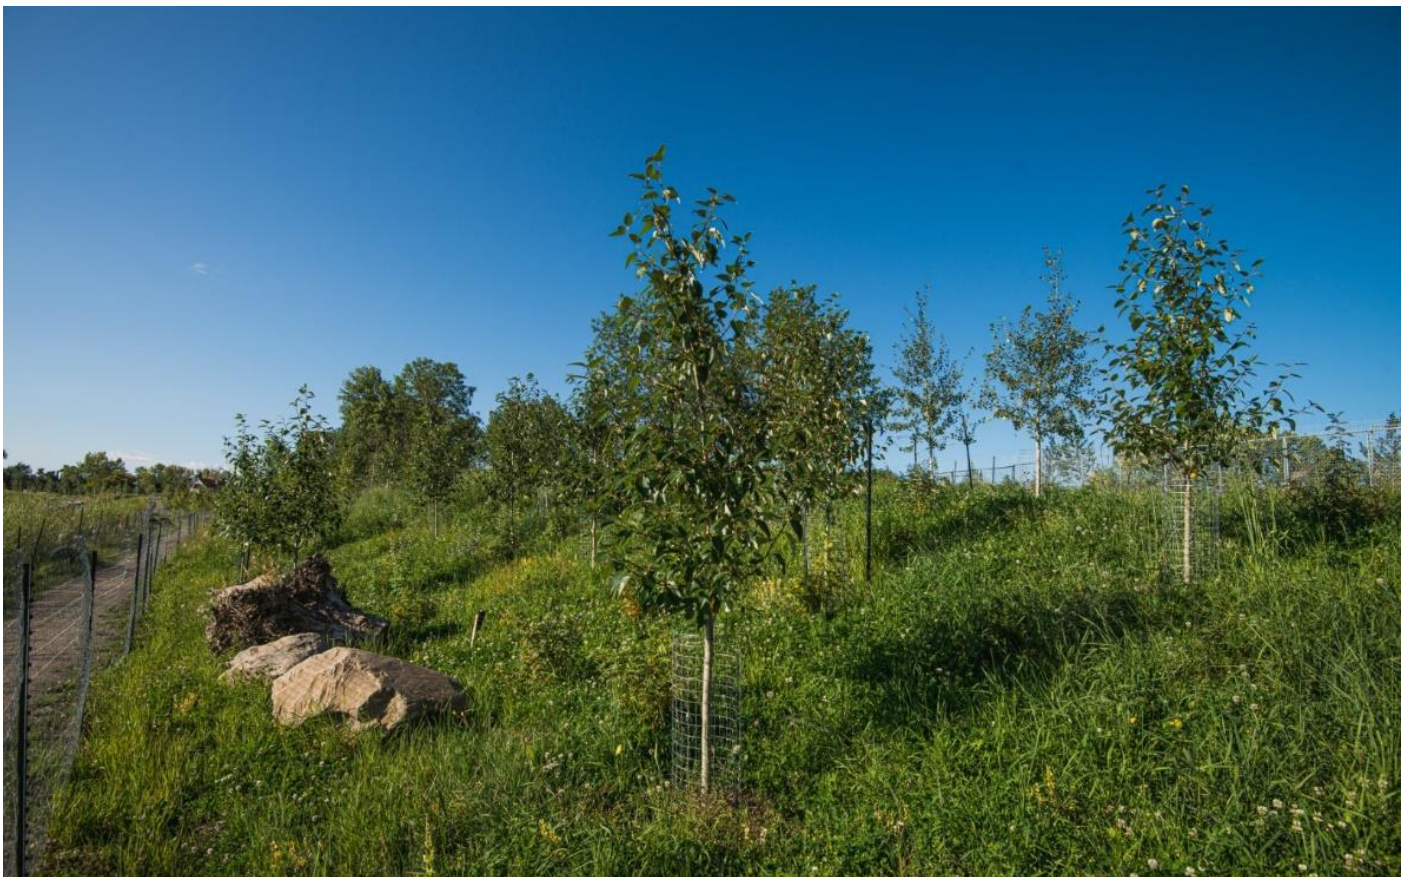
Photo 3-2: Trees Planted at Site 1

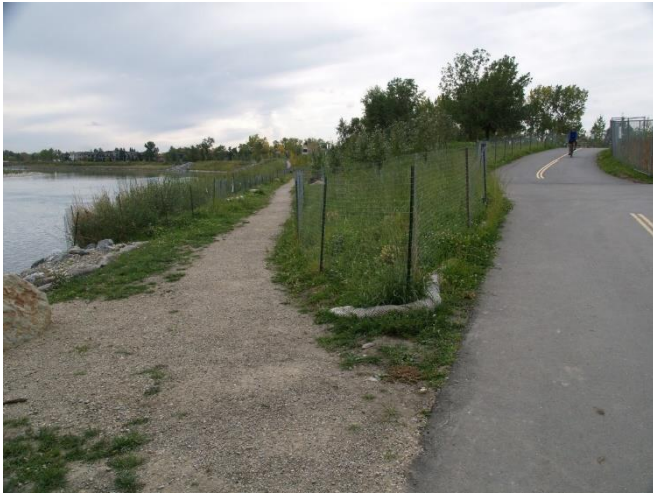
With respect to soil / hydrology parameters, Site 1 generally had good floodplain accessibility, low cover of human-caused bare soil, and low amounts of water withdrawals from the river system. The reach still has relatively low amounts of root mass protection from trees and shrubs, although this has improved with the BDEP planting work and it will continue to improve as the planted trees and shrubs mature. Human physical alteration has affected the entire bank and floodplain. Alterations include two bridges, the regional

Photo 4-1: View south of Site #1 from just south of Cushing Bridge (September 17, 2019) (E709336, N5658185)

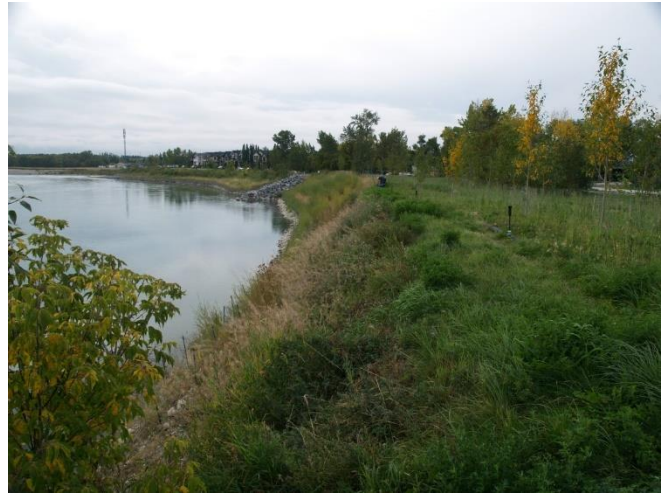
Photo 4-2: View south-southeast from the north end of Site #2 (September 17, 2019) (E709346, N5657964)

Site 2 is shown in Figure 1-1 and Photo 4-2. Site 2 received a riparian health score of 58% (Unhealthy) in 2019, which is an improvement on the score of 29% received in 2016, suggesting an upward trend in health rating. The bioengineering work completed for the BDEP project is directly responsible for the health improvements observed in Site 2.

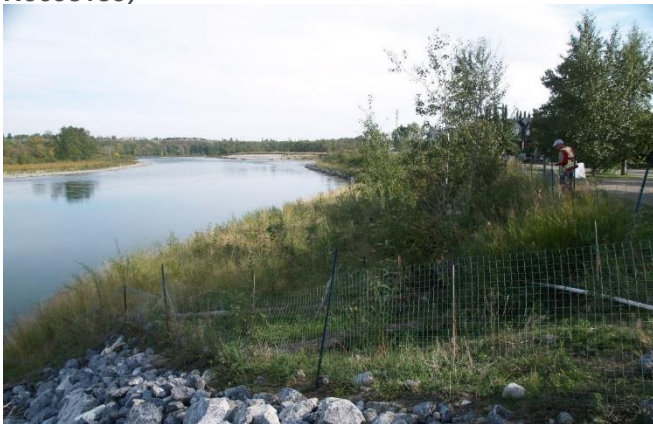
Photo 4-3: View southeast from the north end of Site #4 (September 16, 2019) (E709402, N5657842)

Site 4 is shown in Figure 1-1 and Photo 4-3. Site 4 received a riparian health score of 56% in 2019 (*Unhealthy*), which improves on the lower score in 2016 (i.e., 29%) that suggests an improving health trend for Site 4. This improvement is attributable to the successful BDEP bioengineering.

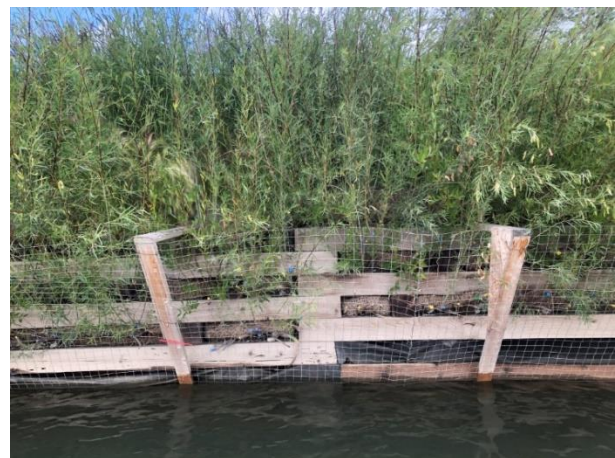
Photo 5-2: Typical vegetated timber crib wall section (shown with rodent fencing attached) (July 18, 2019)

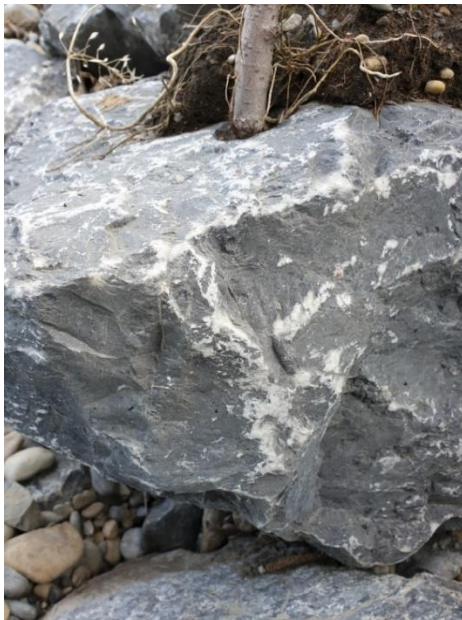
Photo 5-7: Installation of some of the live cuttings at Site 4-3
