# 2019 Annual Summary Report

## The City of Calgary Riparian Monitoring Program

July 14, 2020

Report prepared for:  
The City of Calgary - Water Resources

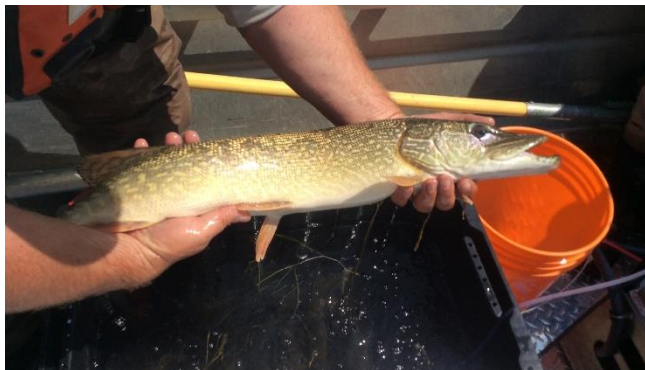
- Fish were observed using and were captured within the vicinity of the new habitat structures throughout the project area (Photo 6-1). Fish were observed in the fish shelters, boulder clusters, and surrounding habitats during winter, spring and summer assessments.

Photo 6-1: Northern pike captured during summer fish sampling

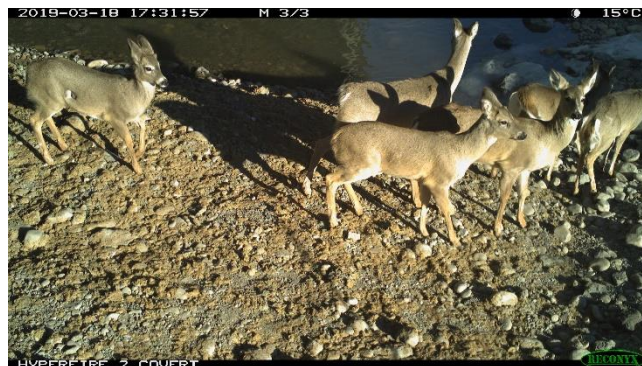
- A total of 212 wildlife species were identified during the wildlife camera analysis. The most abundant species observed was Canada goose (59%) followed by white-tailed jackrabbit (21%), white-tailed deer (8%) (Photo 6-2), and coyote (6%). Larger mammals such as deer species and coyotes appear to be using the BDEP wildlife corridor more than other smaller mammals.

Photo 6-2: White-tailed deer photographed on the BDEP wildlife passage corridor
