Bioengineering Demonstration and Education Project - 2021 Monitoring Report – Revision 1

The City of Calgary Riparian Monitoring Program

Report prepared for:
The City of Calgary - Water Resources
August 11, 2022

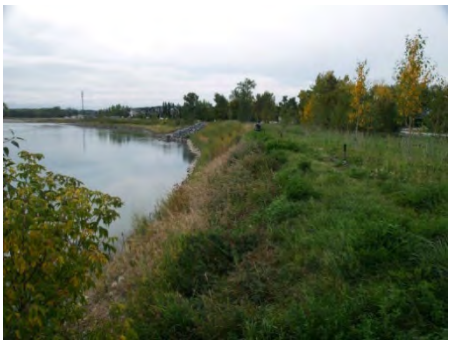
<p><i>Photo 4-7: View south-southeast from the north end of Site #2. Various bioengineering treatments were done at the base of the bank; however a naturally steep unvegetated cutbank with bank swallow nesting habitat was left unaltered. (September 17, 2019) (E709346, N5657964)</i></p>

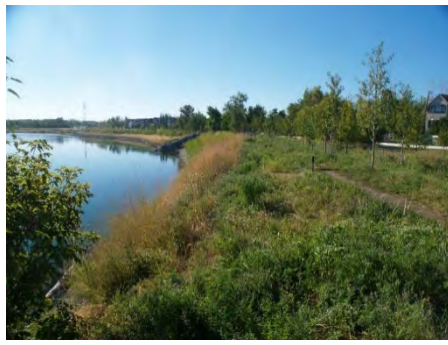
<p><i>Photo 4-8: Successful bioengineering plantings have improved tree/shrub health parameters, although disturbance-increaser and invasive species continue to be a management concern. (September 9, 2020) (E709346, N5657964)</i></p>
<p>2021</p>

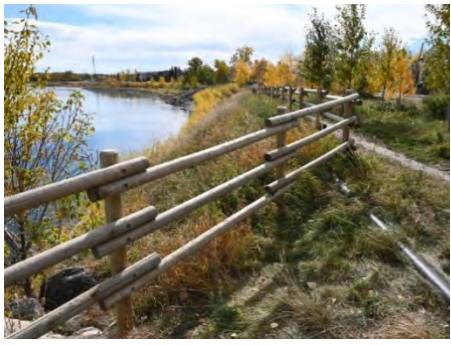
<p><i>Photo 4-9: Wood rail fencing has been installed since 2020 to curtail recreation access to sensitive swallow nest habitat and bioengineering plantings. Woody plants continue to show excellent vigour and new growth. (September 30, 2021) (E709346, N5657964)</i></p>

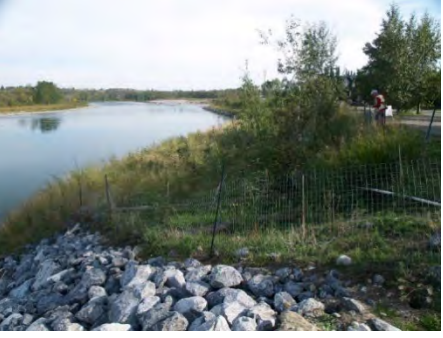
<p><i>Photo 4-11:: View southeast from the north end of Site #4. Tree and shrub plantings on the upper bank show successful establishment since 2015. (September 16, 2019) (E709402, N5657842)</i></p>

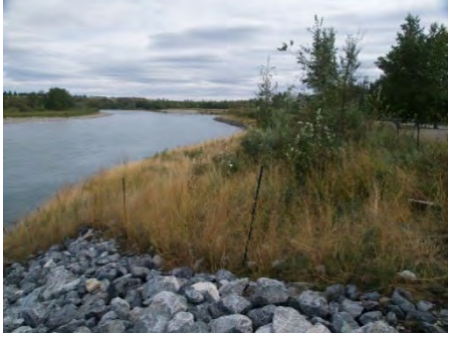
<p><i>Photo 4-12:: Successful vegetated riprap treatments have improved woody cover and tree regeneration scores as well as enhancing wildlife habitat. (September 8, 2020) (E709402, N5657842)</i></p>
2021

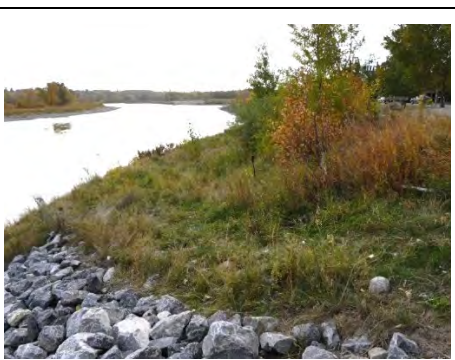
Although Site 1 and Site 2 have mostly shown consistent or sustained improvement since 2016, there has been a very slight riparian health decline since 2020 for Site 4. Some die-off of planted stakes and container plants is apparent in Site 4, likely in part due to drought conditions in Calgary in the summers of 2020-2021. This affected regeneration scores for both RHA and BRQI ratings for Site 4. Replacement plantings were installed in 2021 as a mitigation.

<p><i>Photo 4-13:: Some of the more recently installed cuttings and plantings have died off since 2019 along the mid portion of the bank. New compacted walking trails have also developed. (September 30, 2021) (E709402, N5657842)</i></p>

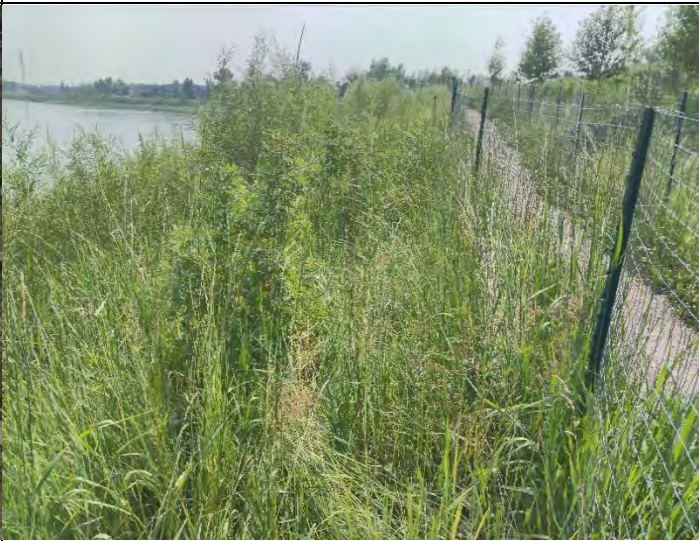
<p>Photo 4-16: Baseline (2016) conditions at BDEP Site 1-4, downstream from Cushing Bridge. This was previously a very steeply sloping portion of bank with concrete rubble and other debris. (July 22, 2016)</p>	<p>Photo 4-17: This portion of bank was pulled back (re-contoured) in 2018 to create a more gently sloping riverbank and riparian terrace that accommodates a new wildlife corridor. Pre-existing concrete rubble was removed in the process. Bioengineering techniques successfully applied here (BDEP, Site 1-4) included brush layers, brush mattresses and contour fascines. (July 15, 2021)</p>

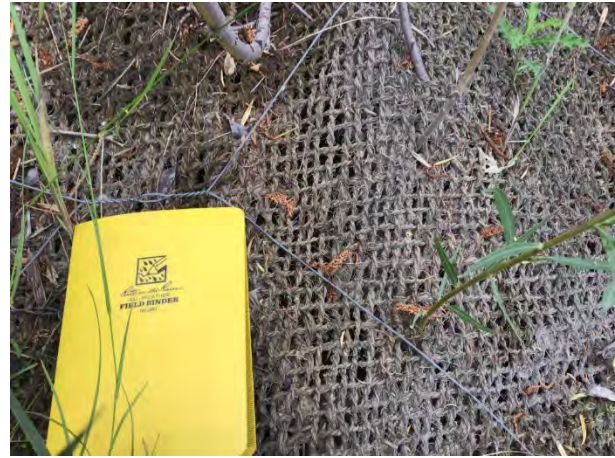
- The coir geogrid was used at Site 1 in the timber crib wall for material containment, and at Site 1 and Site 2 for erosion control until vegetation established. It was observed to be in good condition and there are no concerns with the coir geogrid continuing to provide erosion control as vegetation has fully established at those sites (Photo 5-3).

Photo 5-3: Coir matting at Site 2 (July 21, 2021)

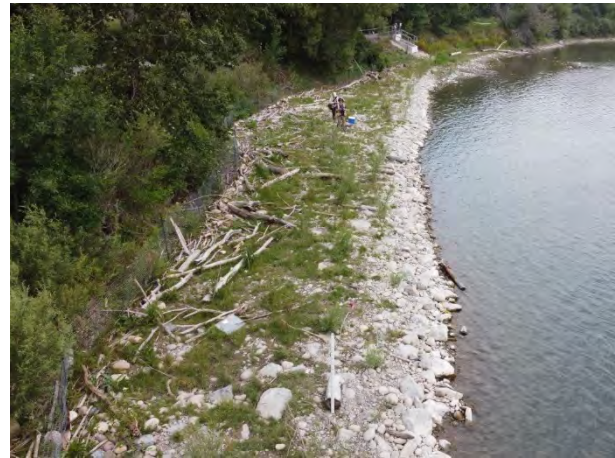
- **Hydromulch and Seeding:** Hydromulch was installed at Site 1, Site 2, and Site 4 for erosion control and seeding. The hydromulch had washed away at the upstream end of Site 1; however, natural regeneration is occurring at this location as shown in Photo 5-5. It was noted that the seeding application rate was higher than the design, which has resulted in herbaceous vegetation competition with woody vegetation and girdling by rodents such as field mice and voles who benefit from the thick herbaceous vegetation for their habitat.

Photo 5-5: Natural regeneration at upstream end of Site 1 (July 21, 2021)

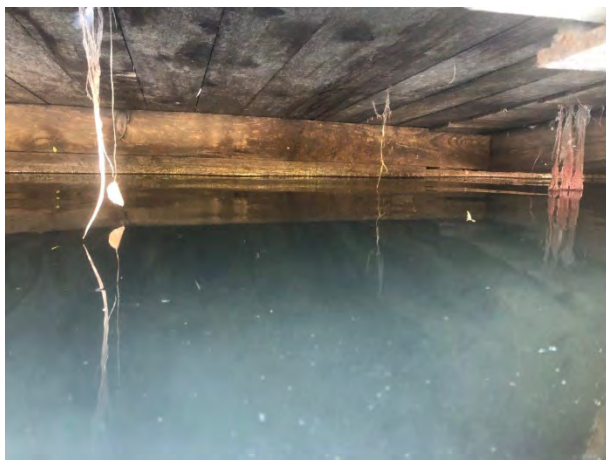
- **Wood Materials:** The wood materials used at the site consist of timber for the timber crib wall, posts for the box fascine, posts for the brush mattress, and permanent wood fence at Site 2. In general, the condition of the posts and fence used is very good with no concerns for long-term durability. Concern with the timber quality used in the crib wall at Site 1 was noted during the 2019 assessment. The timber crib wall was observed to be stable with no observable change in condition during the 2021 assessment (Photo 5-2, Photo 5-6 and Photo 5-7).

Photo 5-6: View under the fish shelter structure in the timber crib wall. Note the roots growing through the structure and extending into the water (Sept 13, 2021)

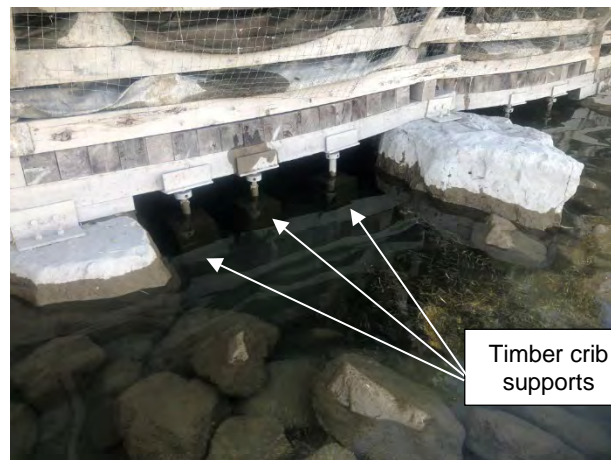
Photo 5-7: Fish shelter and timber crib wall supports (September 13, 2021)

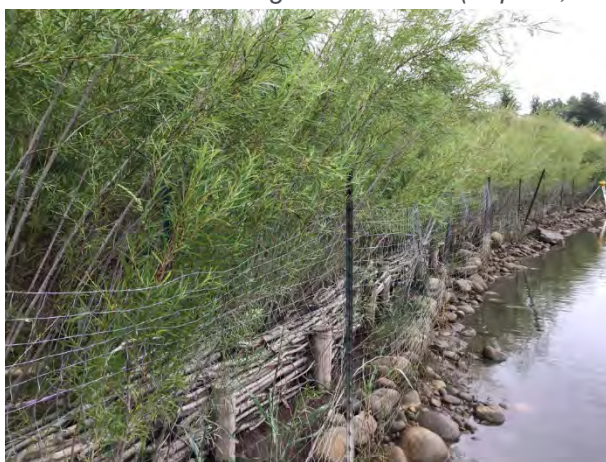
Photo 5-8: Temporary rodent fencing at Site 2 (July 20, 2021)

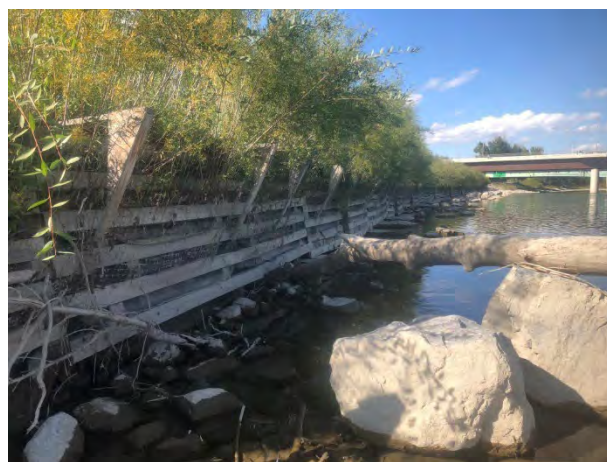
Photo 5-9: Timber crib wall at Site 1 on September 13, 2021

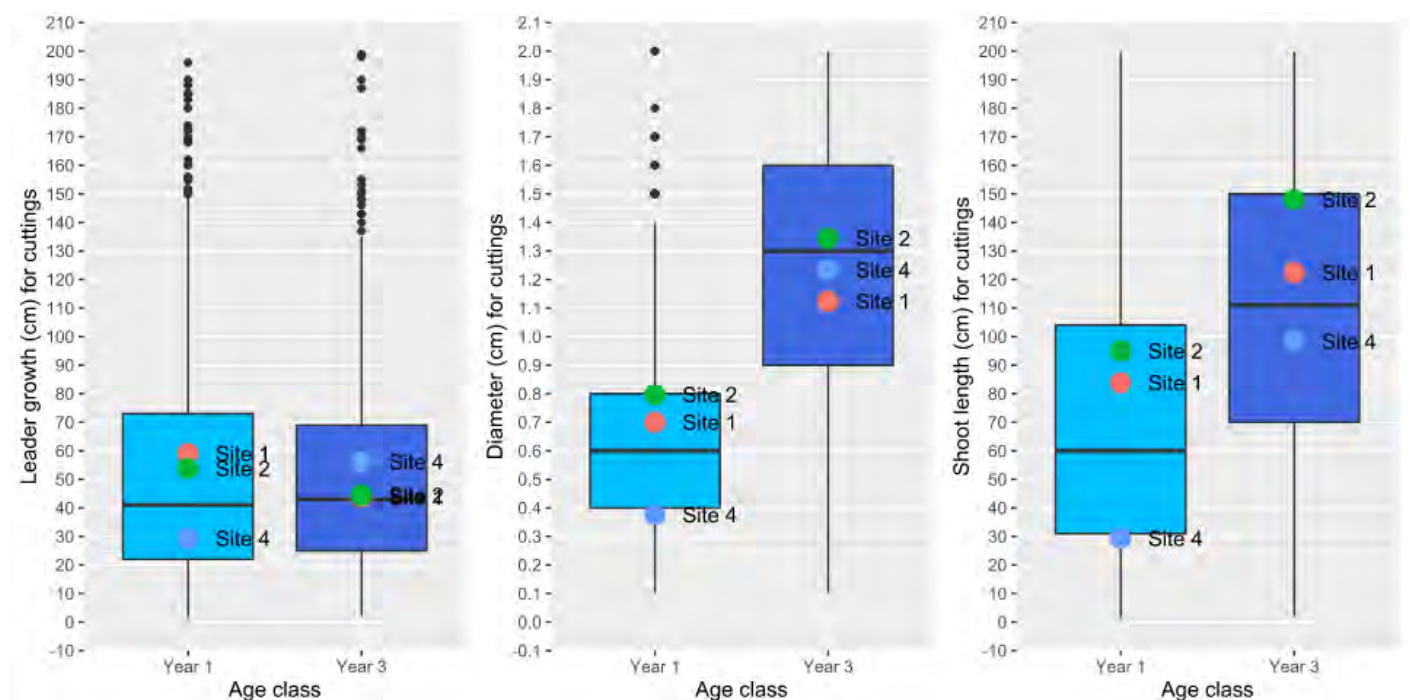
Figure 5-3: Live Cuttings Establishment at BDEP Site 1, 2, and 4 Compared to Mean Year 1 and Year 3 Data from the Riparian Monitoring Program for Mean Leader Growth (left); Diameter (middle); and Shoot Length (right) ⁵

Comparison of leader growth, mean diameter, and shoot length for woody vegetation installed at Site 1, Site 2 and Site 4 to median, 25th percentile and 75th percentile RMP data from 2018-2021 are shown in Figure 5-3 for live cuttings and in Figure 5-4 for plantings. In Year 1 (2019), Site 1 and Site 2 live cutting leader growth, shoot length, and diameter were above the median and are all higher than Site 4. Results for Site 4 were at or near the 25th percentile. In Year 3 (2021), the results for leader growth were closer to the median for Site 1 and Site 2, and the results for Site 4 were higher than the other sites. The Year 3 results for diameter show that Site 1 and Site 4 mean diameter are both less than the median, while Site 2 is slightly above. Year 3 results for the live cuttings shoot length at Site 1 and Site 2 is larger than the median, which indicates above-average vegetation establishment at Site 1 and Site 2. However, Site 4 results are below the median and indicate that remedial actions, including replanting, may be required.

These results indicate that the vegetation establishment trajectory at Site 1 and Site 2 is in line with expectations for leader growth, shoot length and diameter for both live cuttings and plantings. No changes to current maintenance practices or remedial actions are recommended for these sites. The vegetation establishment trajectory for plantings at Site 4 is also meeting expectations; however, the establishment of live cuttings at Site 4 is not meeting expectations. Replanting has already occurred in 2021 to address the live cutting establishment issues at Site 4.

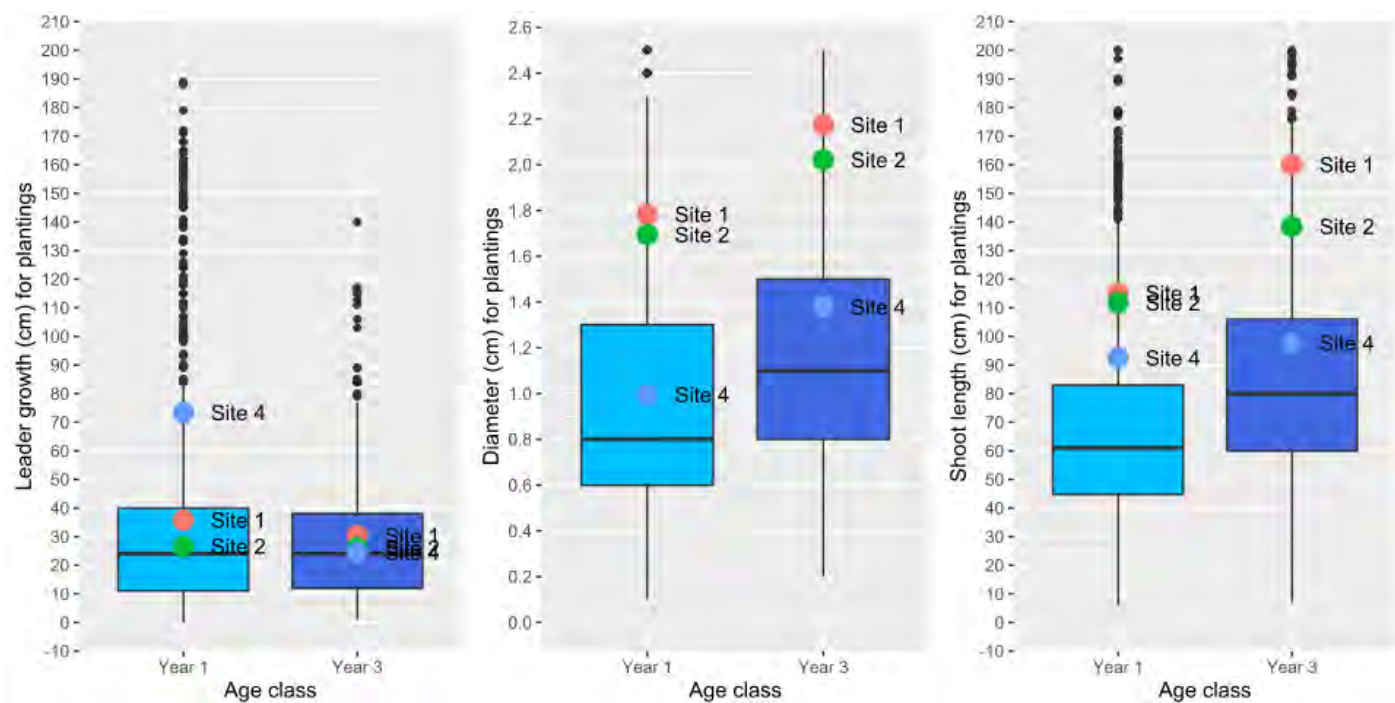
Figure 5-4: Plantings Establishment at BDEP Site 1, 2, and 4 Compared to Mean Year 1 and Year 3 Data from the Riparian Monitoring Program for (a) Mean Leader Growth and Shoot Length; and (b) Mean Diameter²

As shown in Figure 5-4, the Year 1 (2019) plantings leader growth for Site 4 is higher than for Site 1 and Site 2, whereas the diameter and shoot length for Site 1 and Site 2 plantings are higher than Site 4. While Site 1 and Site 2 leader growth results are closer to the median, results for diameter and shoot length are well above the 75th percentile for both Year 1 and Year 3 results. Results for Site 4 plantings range between the median and the 75th percentile, with the exception of Year 1 leader growth and Year 1 shoot length that were both greater than the 75th percentile.

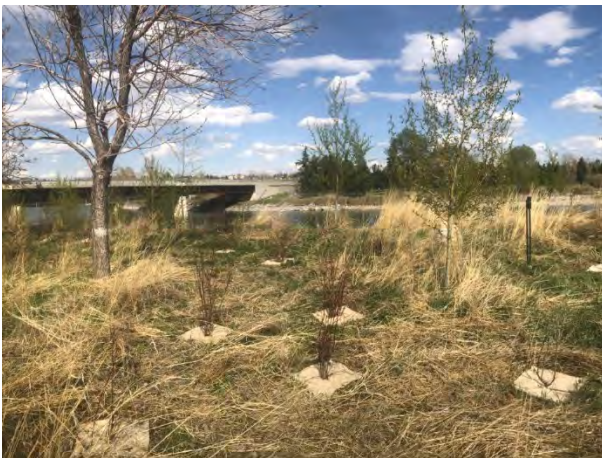
Photo 5-10: Hemp squares as an herbaceous vegetation suppressant at Site 1 (May 14, 2021)

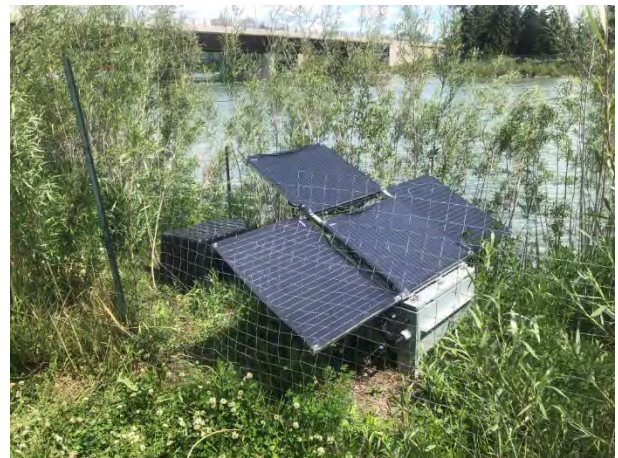
- At **Site 1**, overall woody vegetation canopy cover was 38% in 2021, which is higher than in 2020 (31%) and 2019 (33%). This result is highly influenced by the potted plant canopy cover (25% in 2021, 24% in 2020, and 16% in 2019) since potted plants were installed in about three-quarters of the overall site in the riparian area above the bank. The potted plant canopy cover has increased over the 3 years of monitoring, partially due to maintenance measures including cutting herbaceous vegetation around the woody plants, installing hemp mats around the plants to reduce competition (Photo 5-10), weeding, and irrigation (Photo 5-11). Many of the planted shrubs were also staked to help identify their location and keep them upright.

Photo 5-11: Drip irrigation system at Site 1 (June 18, 2021)

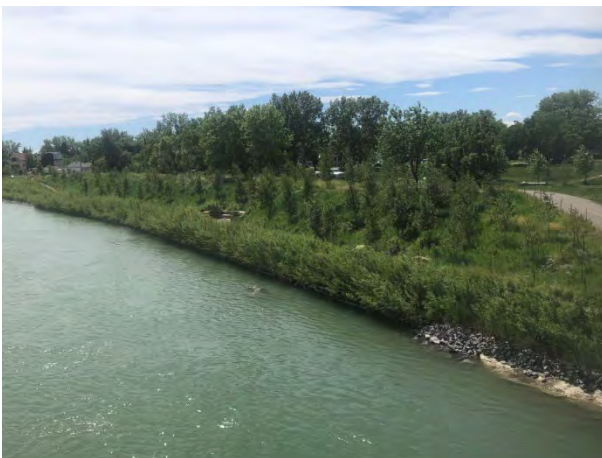
- The live cutting canopy cover at **Site 1** was measured to be 89% in 2021, 53% in 2020 (may not be representative due to the use of a different measurement method as described in Box 1), and 88% in 2019 and indicates successful establishment of the cuttings in the timber crib wall and vegetated soil wraps in the middle section the site (Photo 5-12). Woody vegetation canopy cover for the timber crib wall and soil wrap techniques were 80% and 94%, respectively, in 2021. Woody vegetation canopy cover for the brush layers and brush mattress techniques at the downstream end of Site 1 (Photo 5-13) were 82% and 98%, respectively, in 2021.

Photo 5-12: Good and vigorous growth at timber crib wall, vegetated soil wraps and riparian area of Site 1 – looking downstream (June 18, 2021)

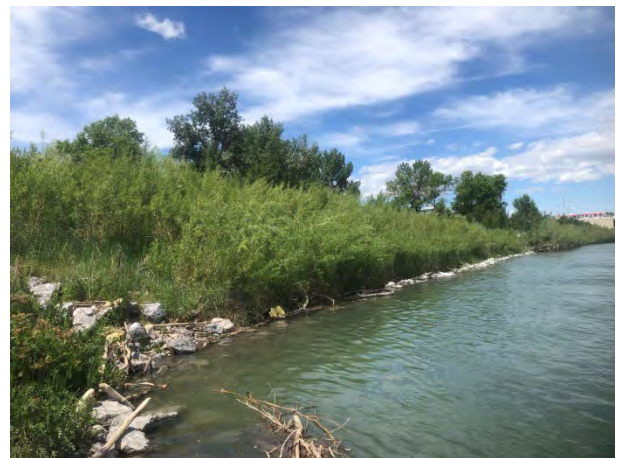
Photo 5-13: Good and vigorous growth in brush layers and brush mattress at downstream end of Site 1 – looking upstream (June 18, 2021)

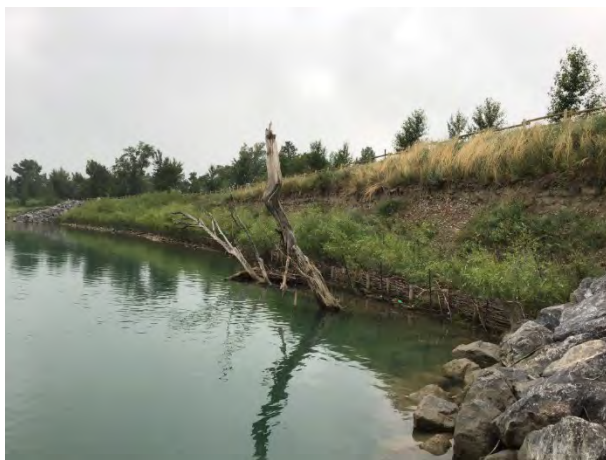
- The live cutting canopy cover at **Site 2** was measured to be 83% in 2021, 69% in 2020 (may not be representative due to the use of a different measurement method as discussed in Box 1), and 89% in 2019 and indicates successful establishment of the cuttings in the box fascine (Photo 5-14), brush mattress, contour fascine, hedge brush layer, and live staking (Photo 5-15). Woody vegetation canopy cover for the box fascine, brush mattress, contour fascine, hedge brush layer, and live staking techniques was 91%, 94%, 84%, 94%, and 56%, respectively, in 2021. Dense vegetation growth was observed at Site 2, as shown in Photo 5-16, with root growth observed into native substrates at the toe of the site as shown in Photo 5-17. These photos indicate that the vegetation canopy is protecting the soil surface from erosion and the roots are binding the soil below the surface.

Photo 5-14: Good and vigorous growth at Site 2 – looking downstream from upstream end (July 20, 2021)

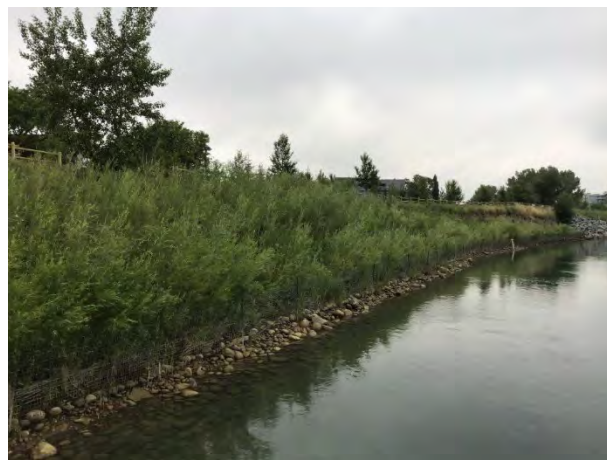
Photo 5-15: Good and vigorous growth at Site 2 – looking upstream from downstream end (July 20, 2021)

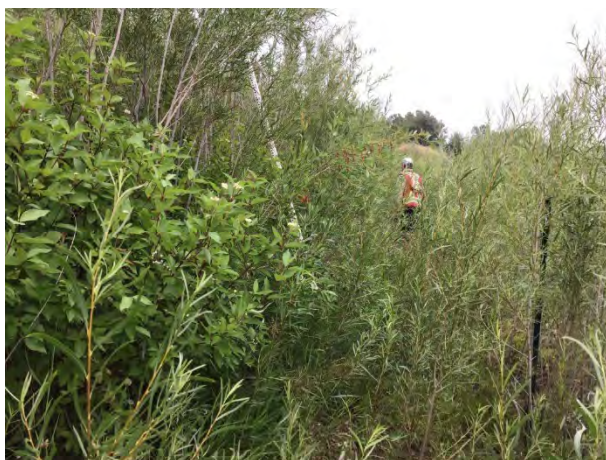
Photo 5-16: Vegetation establishment Site 2 (July 20, 2021)

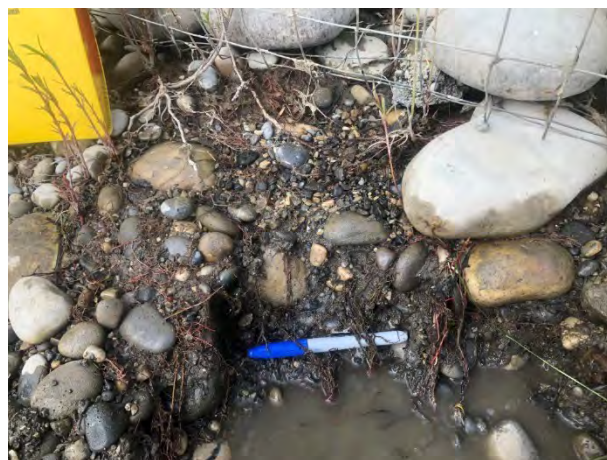
- Roots from the planted live cuttings were observed growing around substrates at Site 2 and through spaces in the timbers in the crib wall at Site 1 towards the river. These roots will aid in binding the substrates together, increasing soil cohesion and erosion resistance. Also, suckering from sandbar willow and balsam poplar was observed between rows of contour fascine, brush layers and hedge brush layers and in front of the box fascine at Site 1 and Site 2.

Photo 5-17: Root growth into native substrates at the toe of Site 2 (July 20, 2021)

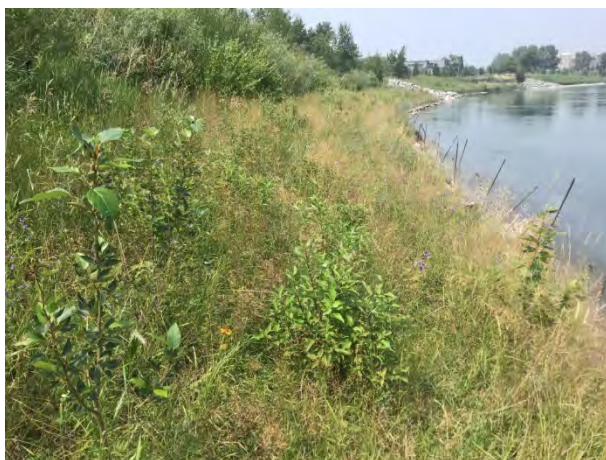
- At **Site 4**, overall woody vegetation canopy cover was 14% in 2021, which is higher than in 2020 (6%) but lower than in 2019 (18%). Woody vegetation canopy cover for both live cuttings and potted plants is lower than expected, which is assumed to be at least partially due to herbaceous vegetation competition (Photo 5-18), but also due to the challenging growing conditions in the existing riprap. A comparison of the techniques used to retrofit existing riprap at Site 4 leads to the result that void-fill with topsoil and plug planting with a 2021 woody vegetation canopy cover of 32% (up from 4% in 2020 and 14% in 2019) is performing better than soil covered riprap with a 2021 woody vegetation canopy cover of 6% (down from 10% in 2020 and 30% in 2019) or void-fill with pitrun and live staking with a 2021 woody vegetation canopy cover of 6% (1% in 2020 and 6% in 2019).

Photo 5-18: Vegetation growth at Site 4 (July 19, 2021)

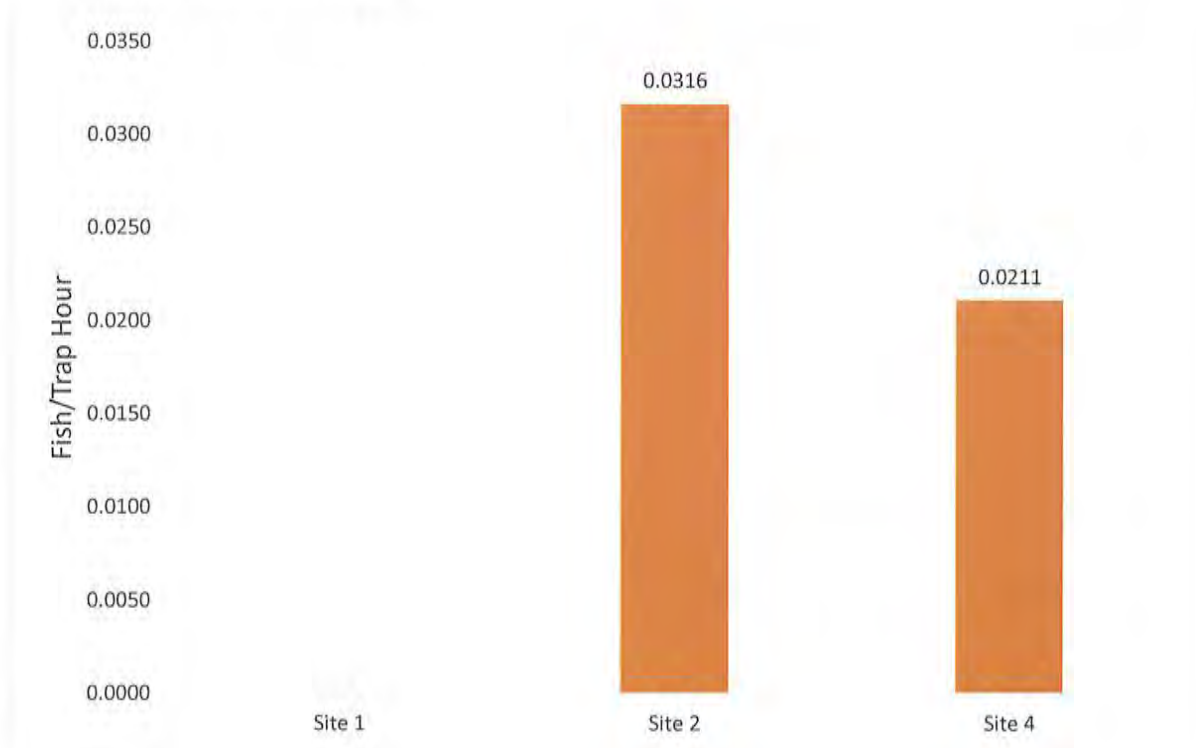
* Site 1 was dry and fish shelters were out of the water during sampling in 2021

Figure 3 2020 Bio-Efficacy Post-Construction Monitoring Program Minnow Trapping CPUE. Site 1 was dry and fish shelters were out of the water during sampling in 2021.

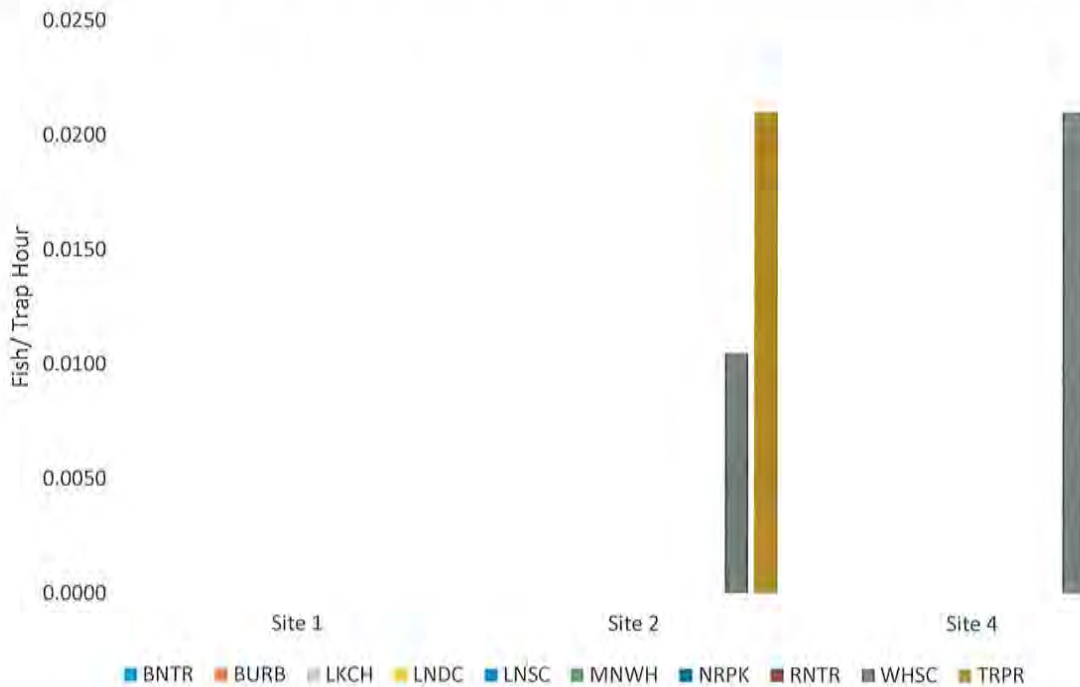
A total of 5 fish and 2 species (i.e., trout perch and white sucker) were captured using minnow trapping. Minnow trap CPUE was determined for each trap as number of fish captured per trap-hour (fish/trap-hour). Minnow trap CPUE was greatest in Site 2 (0.0316 fish/trap-hour) while CPUE at Site 4 was 0.0211 fish/trap hour. **Figure 3** summarizes minnow trap CPUE separated by site. In addition, CPUE was calculated for individual fish species as the number of fish per species per trap-hour (number per species/trap-hour), separated by reach. Overall, white sucker (*Catostomus commersoni*) had the greatest CPUE of all fish captured at each site. **Figure 4** presents minnow trap CPUE for individual fish species separated by site.

Figure 4 2020 Bio-Efficacy Post-Construction Monitoring Program Minnow Trap CPUE for Individual Fish. Site 1 was dry and fish shelters were out of the water during sampling in 2021.

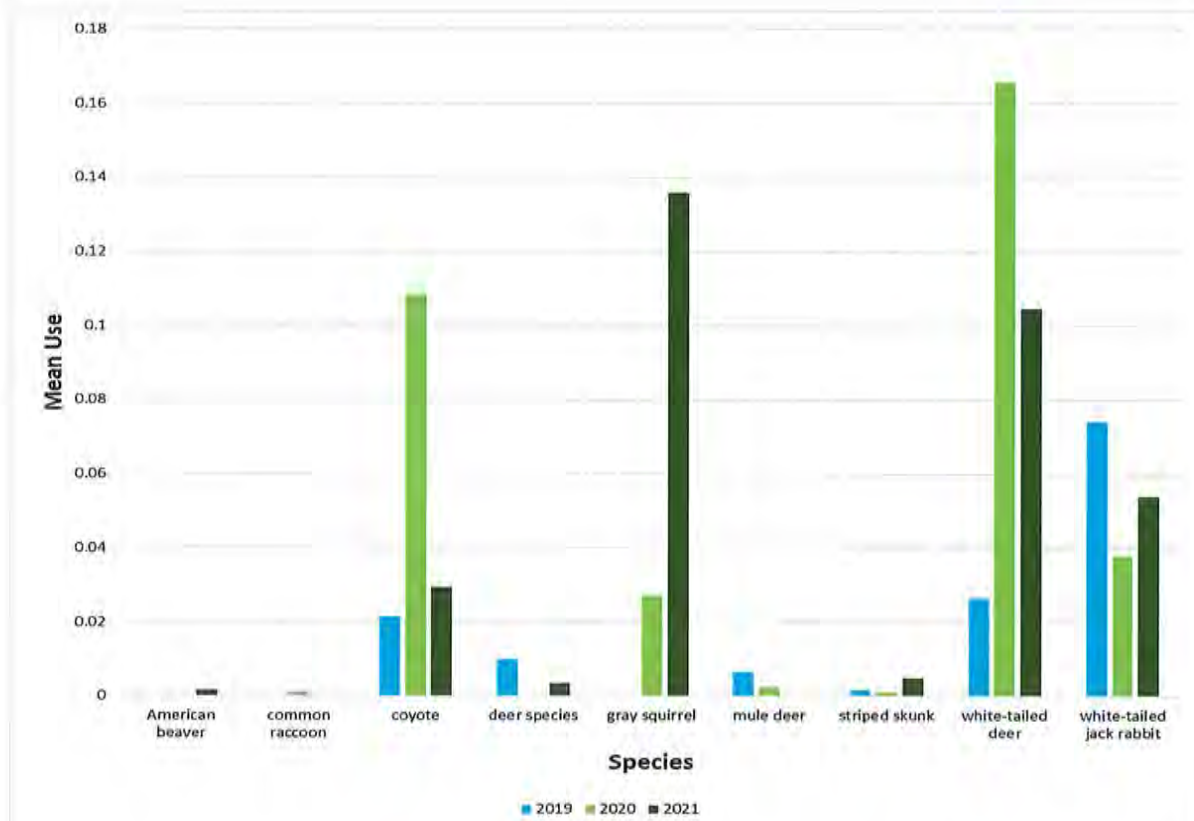
Figure 6 Site 1 Mammal Species Mean Use Comparison from Years 1 to 3

The most consistent mammal activity across all three monitoring years at Site 1 consisted of coyote, white-tailed deer, and white-tailed jackrabbit (**Figure 6**). Coyote mean use increased greatly from Year 1 to Year 2, but then decreased to approximately Year 1 levels again during Year 3. White-tailed deer mean use increased greatly from Year 1 to Year 2 and stayed consistently high in Year 3. On average, white-tailed jackrabbit mean use remained relatively consistent from Year 1 through Year 3. Although the eastern gray squirrel appears to show a high mean use, it was photographed exclusively at the location of Camera 4 and was likely the same individuals photographed daily within their small home range.

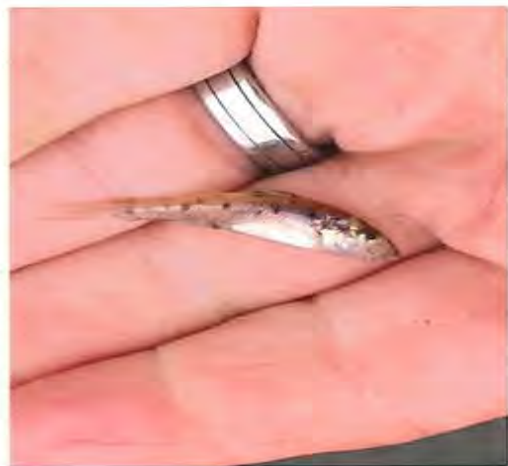
Photo 31 View of a trout perch captured in the Bow River on November 9, 2021.

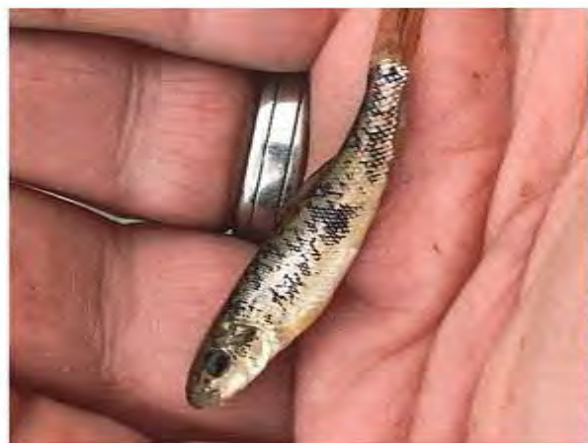
Photo 32 View of a white sucker captured in the Bow River on November 9, 2021.

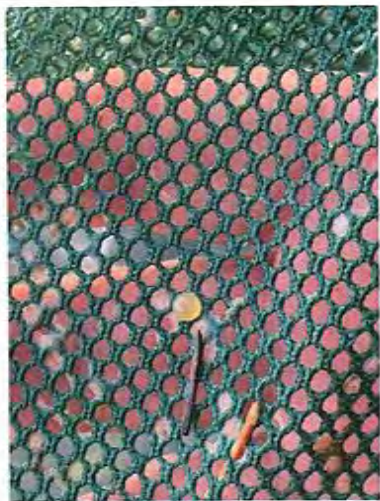
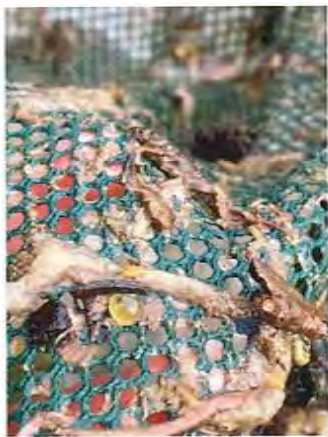
The fall spawning assessment included a brown trout redd survey and kick-net sampling to identify mountain whitefish eggs. The assessment was conducted on November 30, 2021 following the conclusion of brown trout and mountain whitefish spawning periods. No redds were identified within the surveyed reach. Suitable mountain whitefish spawning habitat was identified and kicked sampled for mountain whitefish eggs. Six locations within the upstream extent of Site 1 (i.e., upstream of the Cushing Bridge) were sampled and mountain whitefish eggs were observed at each location (Figure 2, and Attachment A, Photos 33 to 34).

Photo 33 Mountain whitefish eggs collected in the Bow River on November 30,2021.

Photo 34 Mountain whitefish eggs collected in the Bow River on November 30,2021.

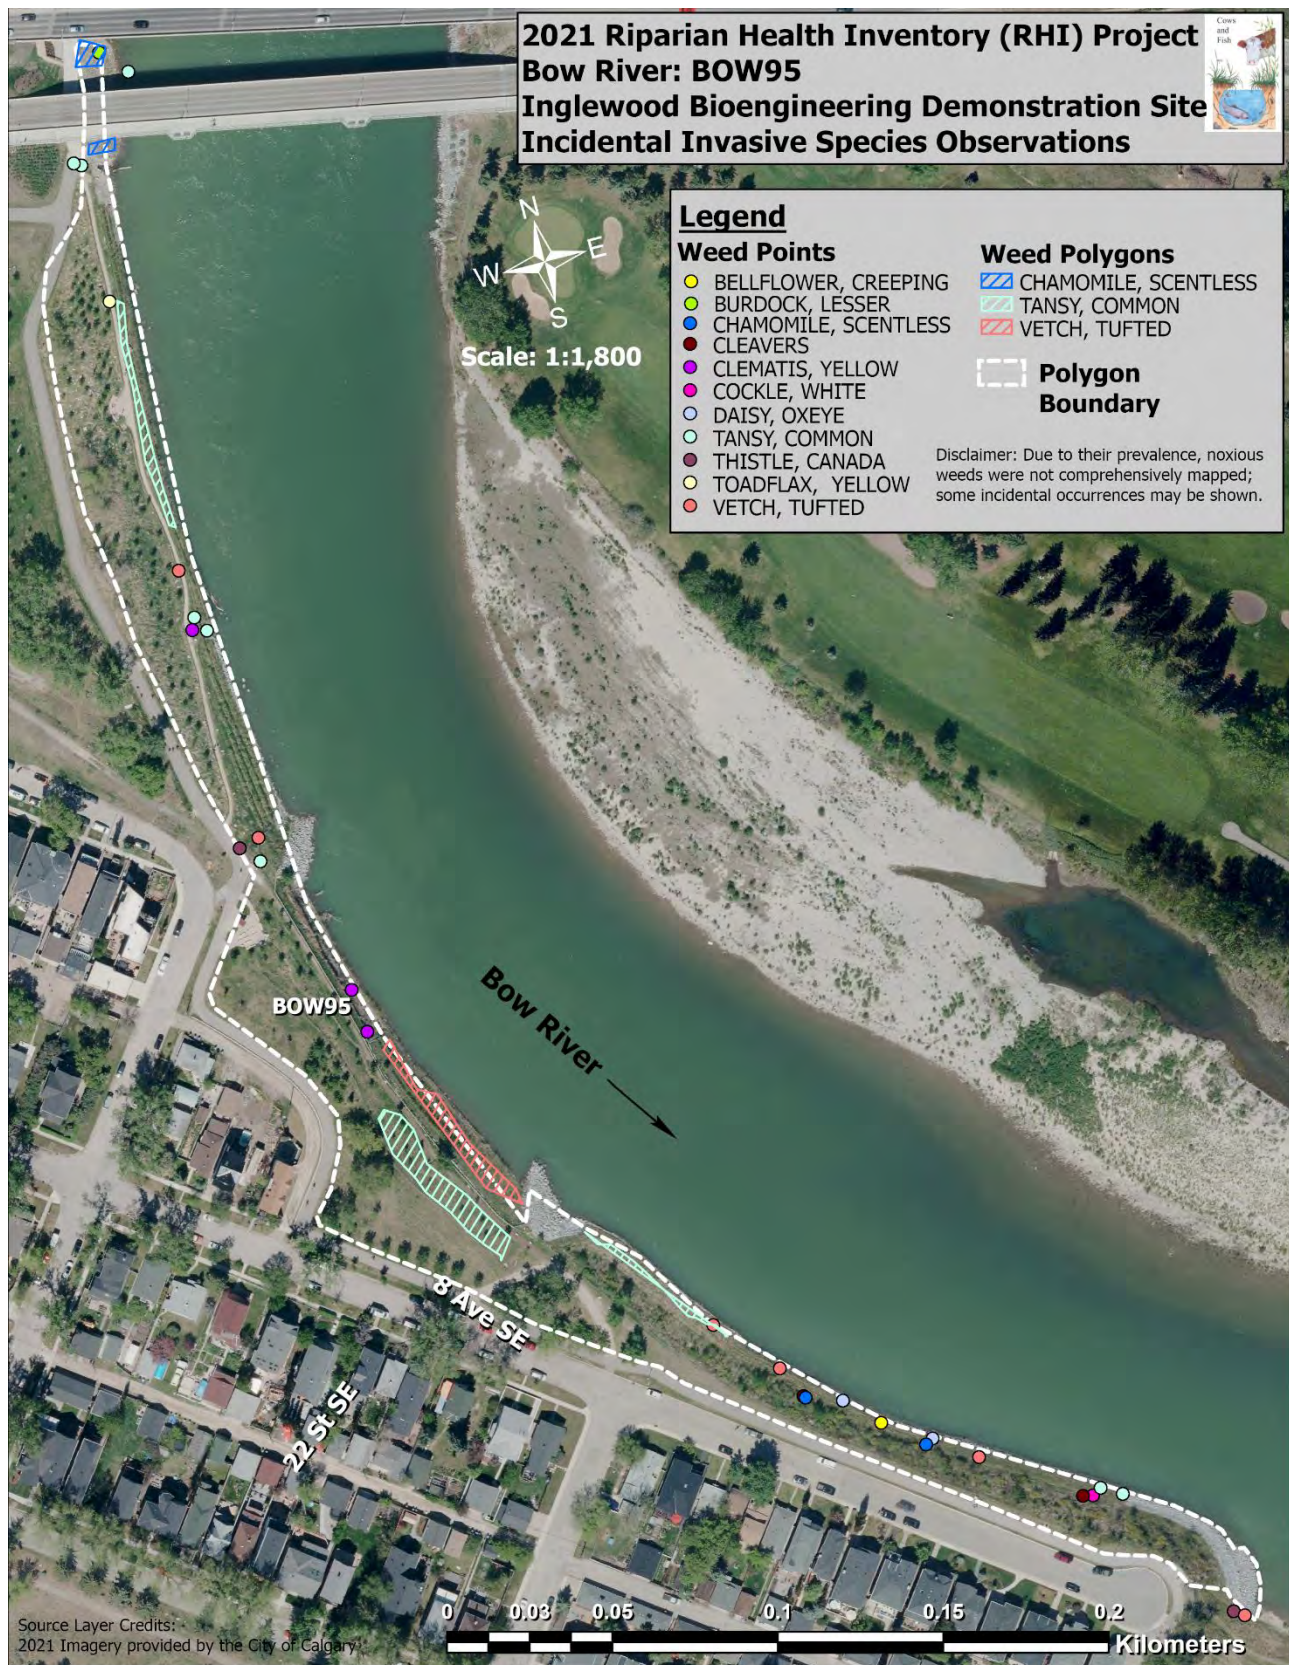
BOW95 (BDEP) Invasive Weed Map
(incidental observations only; not exhaustive)

- There has been a slight increase from 10 to 12 invasive species in this site since 2016 (Table 3.1). New occurrences of ox-eye daisy (*Leucanthemum vulgare*), tufted vetch (*Vicia cracca*), and yellow toadflax (*Linaria vulgaris*) were observed in 2021. Tall buttercup (*Ranunculus acris*) recorded in 2016, was not observed in 2021.

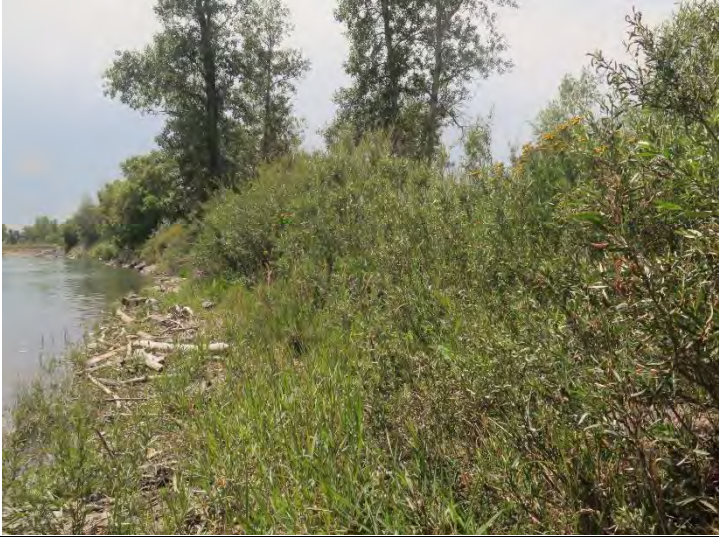
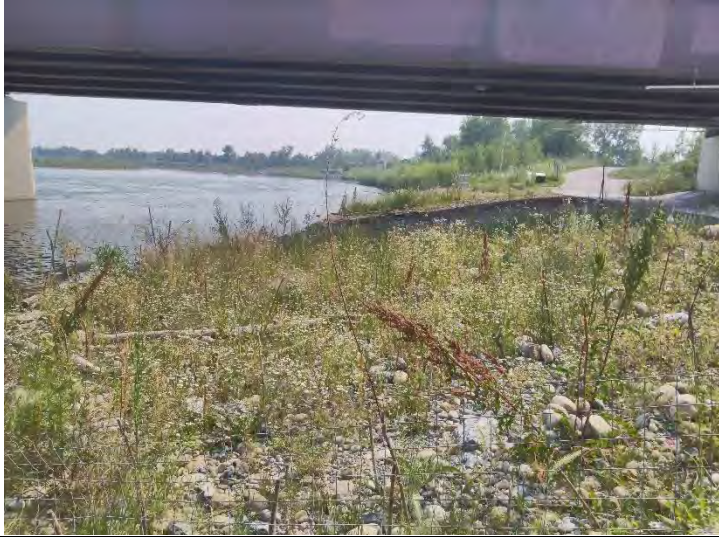
Upstream Benchmark - 2016	Upstream Benchmark - 2021

<p>RHIP95BOW003 (2016, Waypoint U) – Upstream end, view downstream from the 17 Ave SE (Cushing) Bridge into the site. A small portion of the bank at the upstream end was not impacted by the 2013 flood and had some sandbar willow and mature balsam poplar cover in 2016. <i>(Photographer: M. Laing)</i></p>	<p>RHIP95BOW030 (2021, Retake of RHIP95BOW003) – The recently constructed Bus Rapid Transit Bridge resulted in some removal of preferred woody cover. Willow cuttings have been newly installed in this disturbed area which also has weedy species present, mainly scentless chamomile. <i>(Photographer: K. Hull)</i></p>

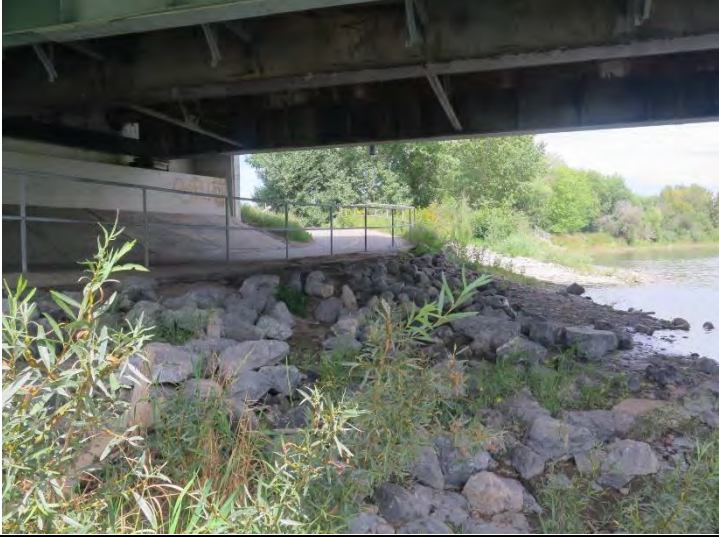
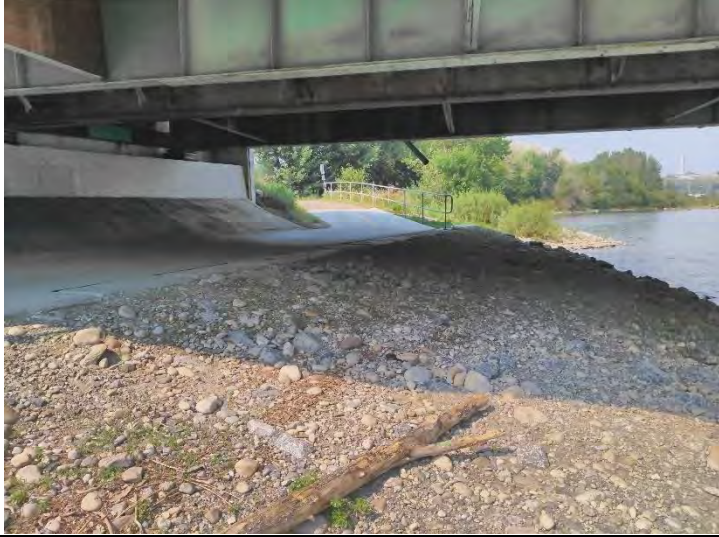
<p>RHIP95BOW001 (2016, Waypoint U) – Upstream end (OUT of the assessed site), view upstream under the 17th Avenue SE bridge showing pre-existing riprap rock armouring. <i>(Photographer: M. Laing)</i></p>	<p>RHIP95BOW028 (2021, Retake of RHIP95BOW001) – Native river gravels were used to infill void-spaces between the riprap rocks and provides a surface that is suitable for wildlife passage. <i>(Photographer: K. Hull)</i></p>

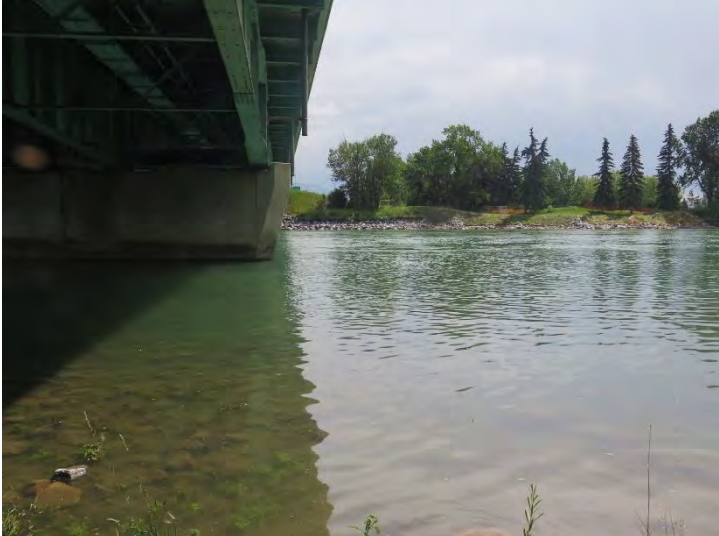
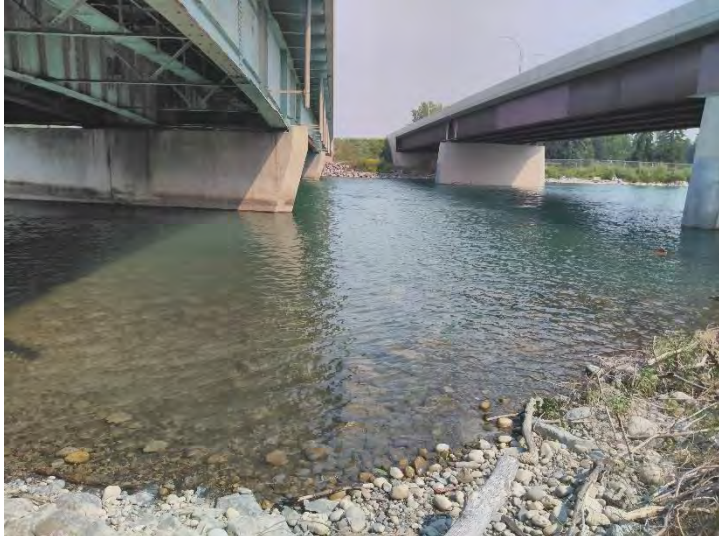
Upstream Benchmark - 2016	Upstream Benchmark - 2021

<p>RHIP95BOW002 (2016, Waypoint U) – Upstream end, view east to the opposite bank beneath the 17th Ave SE (Cushing) Bridge. (Photographer: M. Laing)</p>	<p>RHIP95BOW029 (2021, Retake of RHIP95BOW002) – The Bus Rapid Transit Bridge has been newly installed here since 2016 impacting a small portion of the bank. (Photographer: K. Hull)</p>

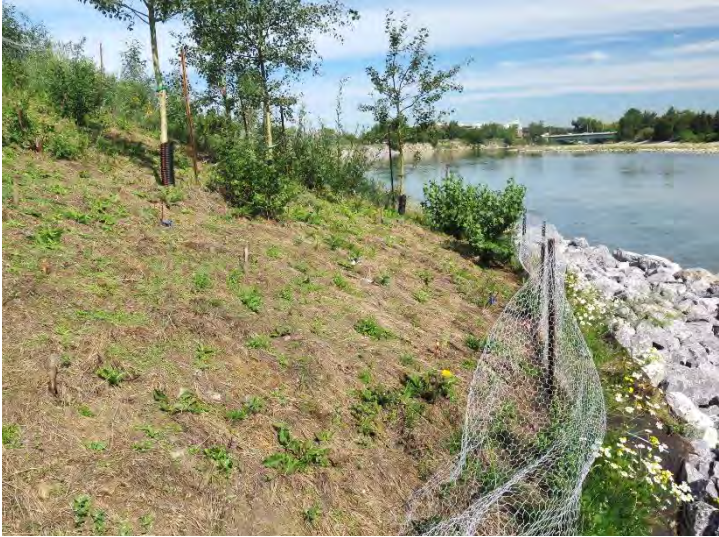
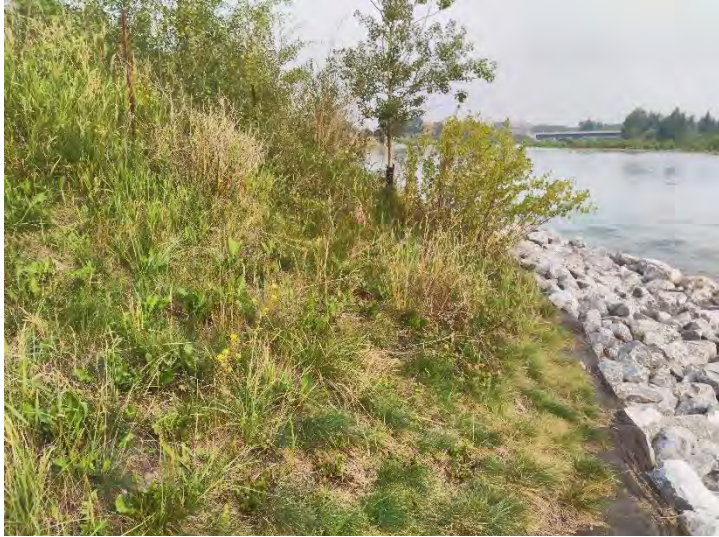
Downstream Benchmark - 2016	Downstream Benchmark - 2021

<p>RHIP95BOW007 (2016, Waypoint L) – View upstream from the downstream end of the site. Extensive bank stabilization works were conducted here after the 2013 flood including bank reshaping, installation of a riprap toe and installation of tree and shrub plantings above the riprap. Exposed geotextile fabric and scentless chamomile (a <i>Noxious weed</i>) were present above the riprap base in 2016. (Photographer: M. Laing)</p>	<p>RHIP95BOW034 (2021, Retake of RHIP95BOW007) – Site 4-4: This 40 m length of bank was left as an untreated ‘control’; no modifications were made to the bank configuration since 2014. Geotextile fabric continues to be exposed above the rock layer; noxious weeds continue to persist on the upper bank. (Photographer: K. Hull)</p>

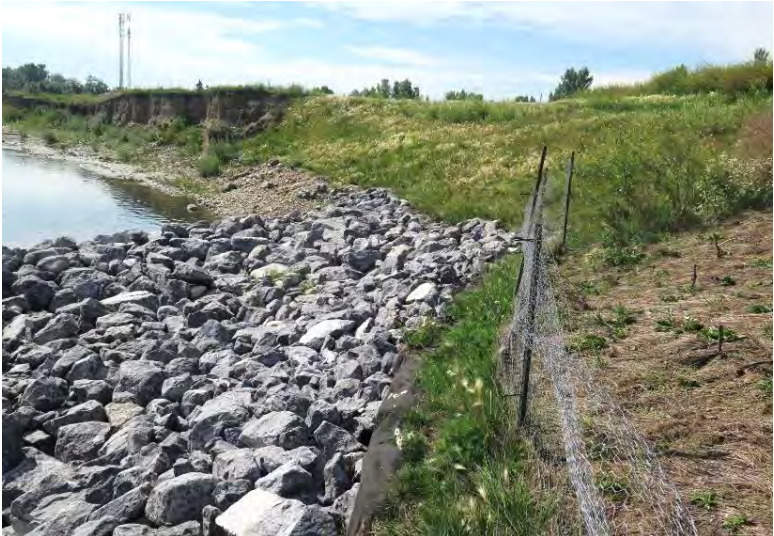
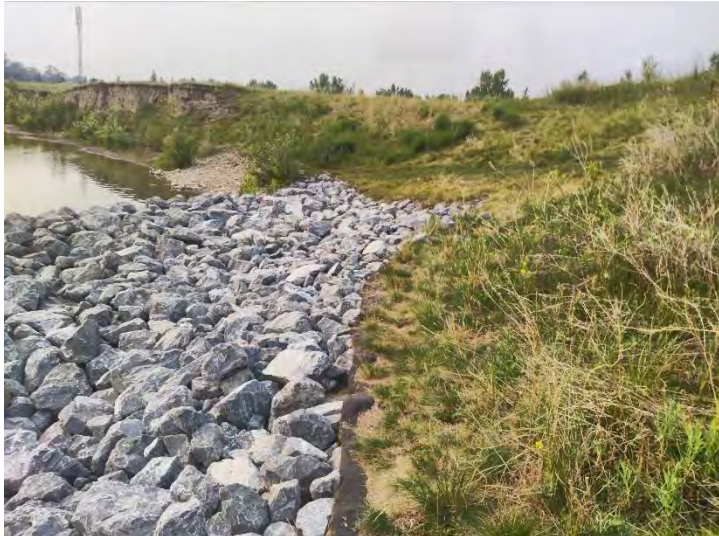
<p>RHIP95BOW004 (2016, Waypoint L) – Downstream end, view downstream out of the BDEP site toward the Inglewood Northfield Site (BOW91). The cutbank to the back provides swallow nesting habitat. (Photographer: M. Laing)</p>	<p>RHIP95BOW031 (2021, Retake of RHIP95BOW004) – This control site shows little change since 2016 except for fair native grass establishment in the BDEP site where a seed mix was applied above the riprap toe. Noxious weeds continue to persist here including Canada thistle, ox-eye daisy and scentless chamomile. (Photographer: K. Hull)</p>
