Bioengineering Demonstration and Education Project - 2021 Monitoring Report – Revision 1

The City of Calgary Riparian Monitoring Program

Report prepared for:
The City of Calgary - Water Resources
August 11, 2022

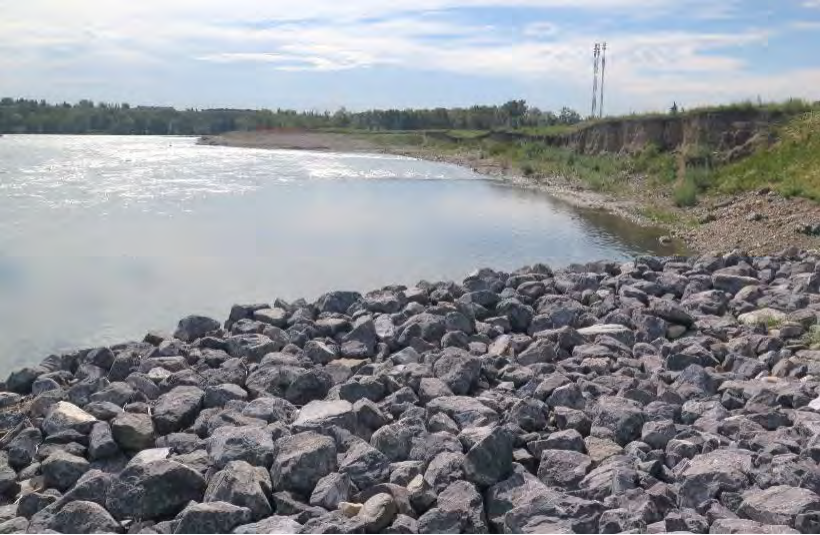
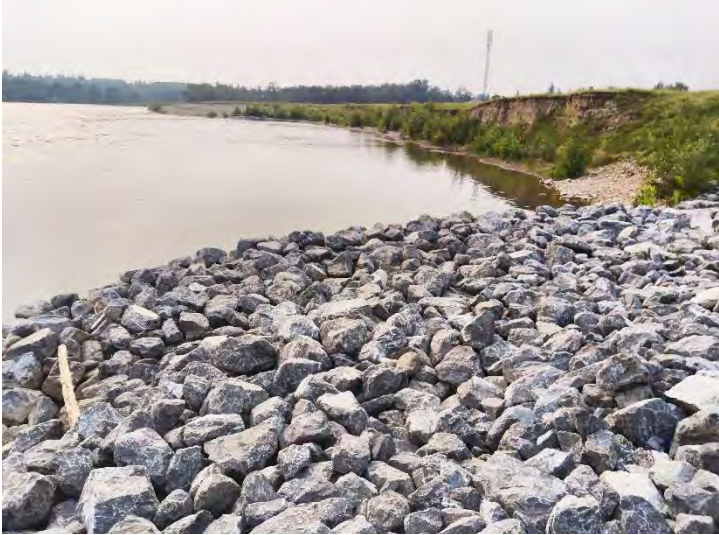
Downstream Benchmark - 2016	Downstream Benchmark - 2021

<p>RHIP95BOW005 (2016, Waypoint L) – Downstream end, view downstream out of the BDEP site toward the Inglewood Northfield Site (BOW91). The cutbank to the back provides swallow nesting habitat. <i>(Photographer: M. Laing)</i></p>	<p>RHIP95BOW033 (2021, Retake of RHIP95BOW005) – Balsam poplar has naturally established along low lying alluvial bars downstream from the BDEP site except where gravel bars were artificially raised. <i>(Photographer: K. Hull)</i></p>

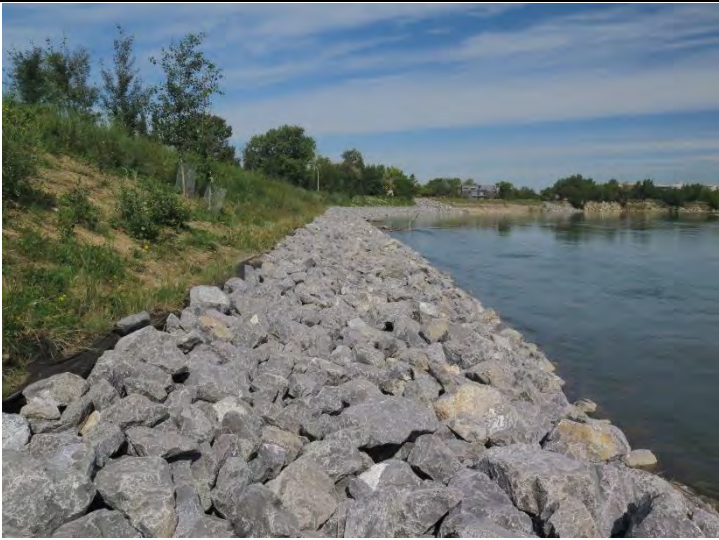
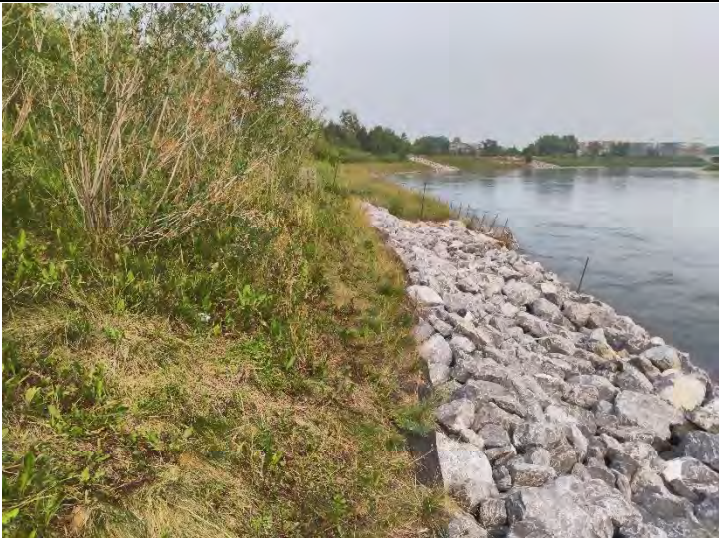
<p>RHIP95BOW009 (2016, Waypoint A) – View upstream from Site 4-4 showing baseline (2016) conditions – native plantings above a wide riprap toe. <i>(Photographer: M. Laing)</i></p>	<p>RHIP95BOW038 (2021, Retake of RHIP95BOW009) – View upstream from Site 4-4 the unmodified ‘control’ reach. Native plantings (installed in 2015) have successfully established above the riprap toe and show vigorous tall growth since 2016 contributing to improved wildlife habitat and bank root mass protection. <i>(Photographer: K. Hull)</i></p>

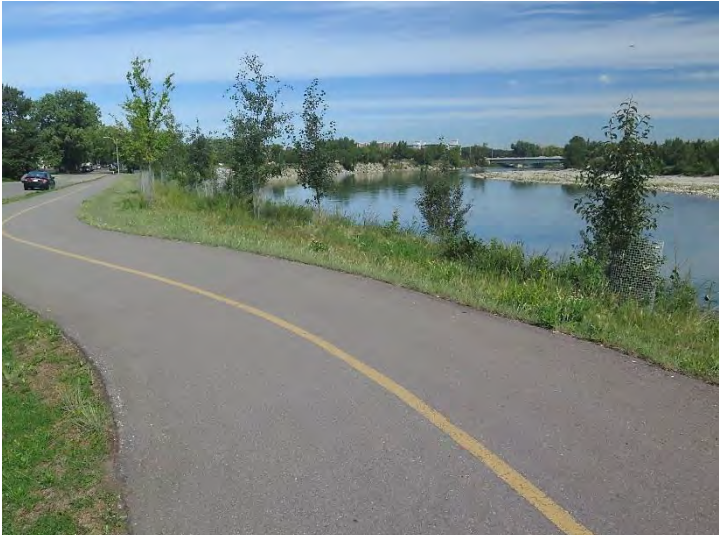
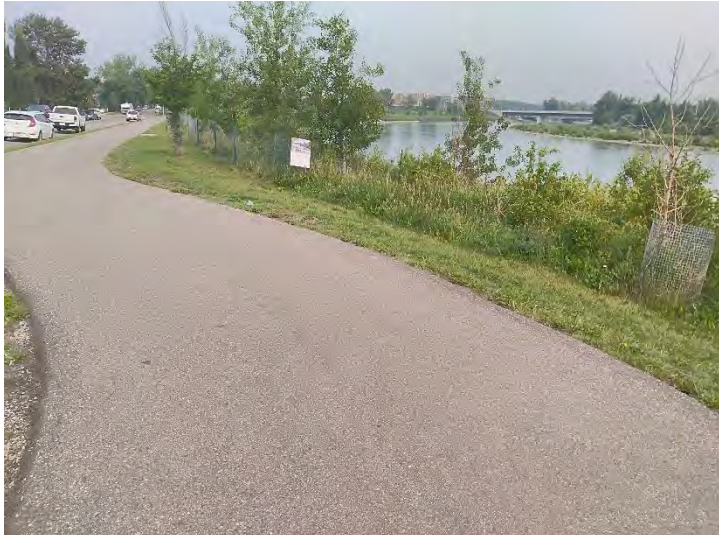
<p>RHIP95BOW010 (2016, Waypoint B) – View 312° NW from the regional paved pathway above the top of the bank. This paved pathway was excluded from the RHI polygon boundary and thus does not factor into RHI scoring. (Photographer: M. Laing)</p>	<p>RHIP95BOW040 (2021, Retake of RHIP95BOW010) – Photo taken above the control Site 4-4. Tree and shrub plantings originally installed in 2015 show excellent growth and establishment success. The paved regional pathway (outside of the RHI site) remains in the same configuration as in 2016 in the downstream reach. (Photographer: K. Hull)</p>

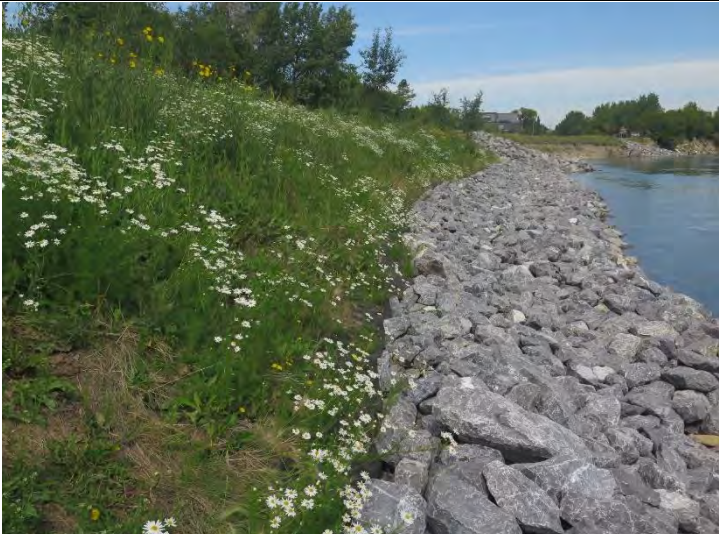
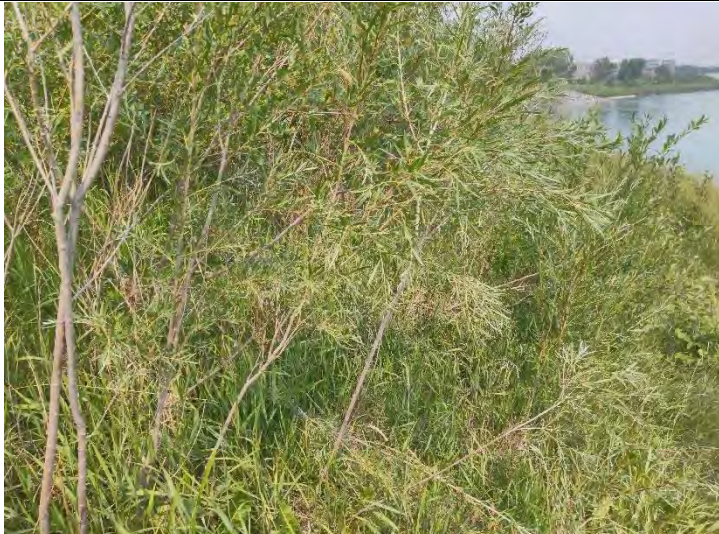
<p>RHIP95BOW013 (2016, Waypoint D) – View upstream. Scentless chamomile, in addition to other invasive <i>noxious weed</i> species, were pervasive along parts of the reconstructed, engineered bank in 2016. (Photographer: M. Laing)</p>	<p>RHIP95BOW044 (2021, Retake of RHIP95BOW013) – View upstream. Successful vegetated riprap with vigorous establishment of sandbar and hungry (yellow) willow since 2018 in Site 4-1. (Photographer: K. Hull)</p>

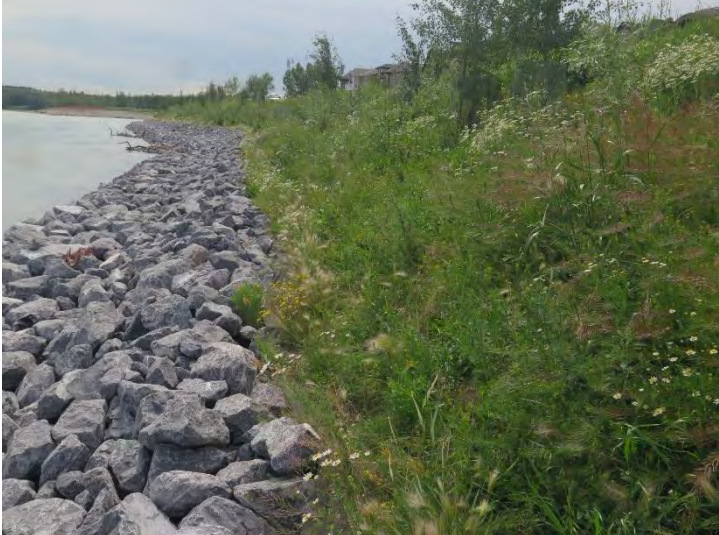
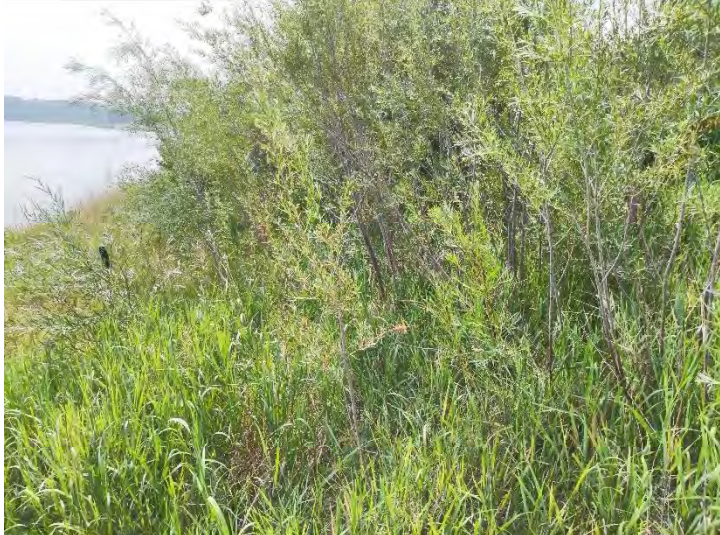
<p>RHIP95BOW012 (2016, Waypoint B) – View downstream showing dense cover from invasive weeds and disturbances grasses above the riprap toe in 2016. (Photographer: M. Laing)</p>	<p>RHIP95BOW043 (2021, Retake of RHIP95BOW012) – View 95⁰ E, successful vegetated riprap with vigorous establishment of sandbar and hungry (yellow) willow since 2018 in Site 4-2 (void filled riprap with plugs). (Photographer: K. Hull)</p>

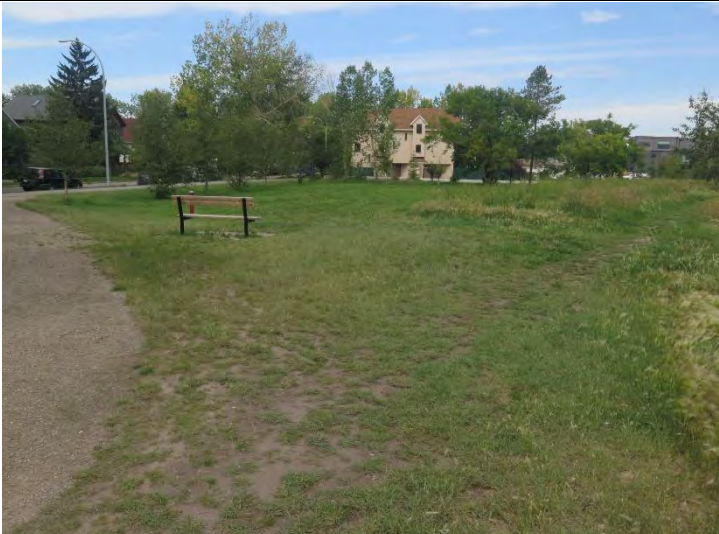
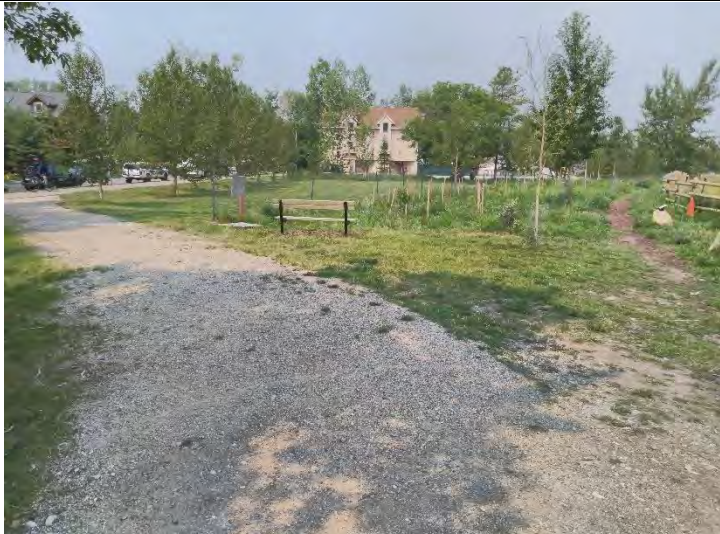
<p>RHIP95BOW016 (2016, Waypoint E) – This mowed and heavily disturbed upper bench was included within the RHI site extent in 2016. Gravel paths and lawns create compacted soil conditions, limiting to moisture infiltration and natural recovery of native vegetation. (Photographer: M. Laing)</p>	<p>RHIP95BOW048 (2021, Retake of RHIP95BOW016) – A 10 to 15 m band extending back from the top of the bank has been naturalized since 2018 including native tree and shrub installations. Manicured lawn areas continue to be maintained adjacent to the street side. (Photographer: K. Hull)</p>

- Follow and implement recommendations for bioengineering repairs and maintenance works as per KWL 2021b.
- Augment native shrub understory plantings within upper bench 'naturalized' buffers (for example, see Waypoint 2B, photos RHIP95BOW052 and 053, page 24).
- Expand and enhance clustered native tree and shrub plantings within manicured lawn portions of the site.

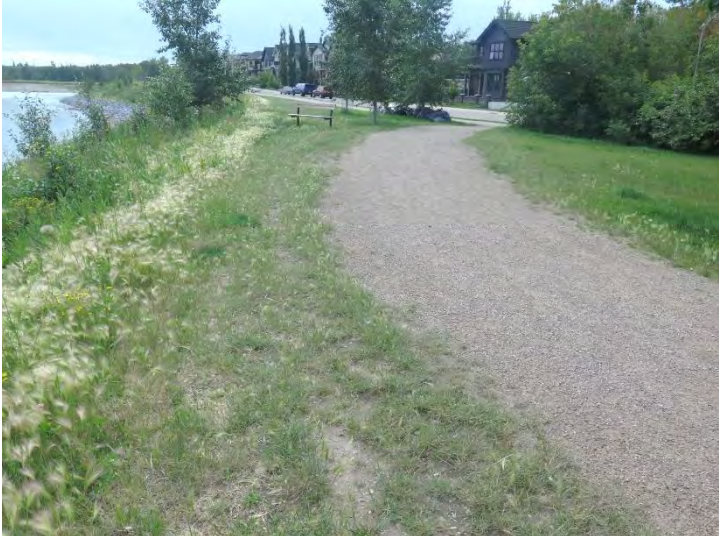
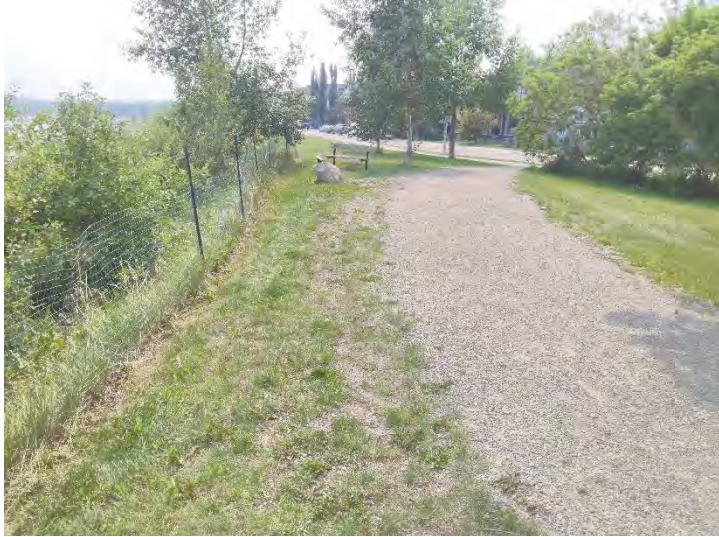
<p>RHIP95BOW014 (2016, Waypoint E) – View 91°E, showing the 2 m wide gravel pathway maintained for recreational access above the top of the bank. Foxtail barley, a native disturbance grass was prevalent along the upper bank in 2016, comprising 30% cover overall. (Photographer: M. Laing)</p>	<p>RHIP95BOW049 (2021, Retake of RHIP95BOW014) – Site 4-1 (soil covered riprap) is shown on the left where there is excellent establishment success of plantings. Fencing will remain in place to curtail wildlife herbivory and recreational access during the maintenance period. (Photographer: K. Hull)</p>

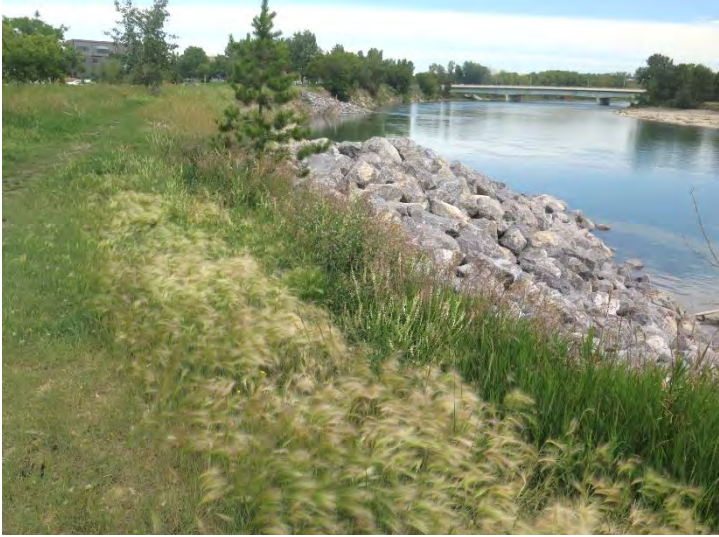
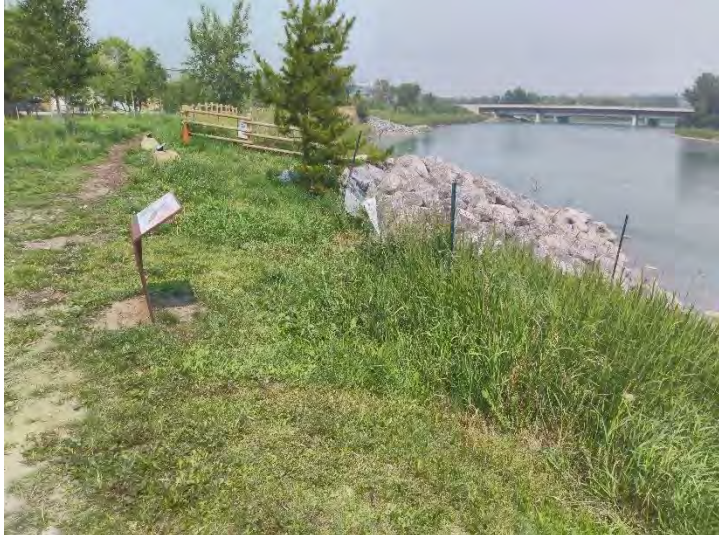
<p>RHIP95BOW015 (2016, Waypoint E) – Riprap rock groynes were installed as an erosion mitigation following the 2013 flood. This bank had mainly herbaceous (non-woody) cover in 2016. (Photographer: M. Laing)</p>	<p>RHIP95BOW050 (2021, Retake of RHIP95BOW015) – Footpaths have been maintained here above the top of the bank which are now bare ground due to heavy use and compaction. A 10 to 15 m wide area at the top of the bank has been naturalized upstream of the rock groyne where wood rail fencing has been installed to preclude access. (Photographer: K. Hull)</p>

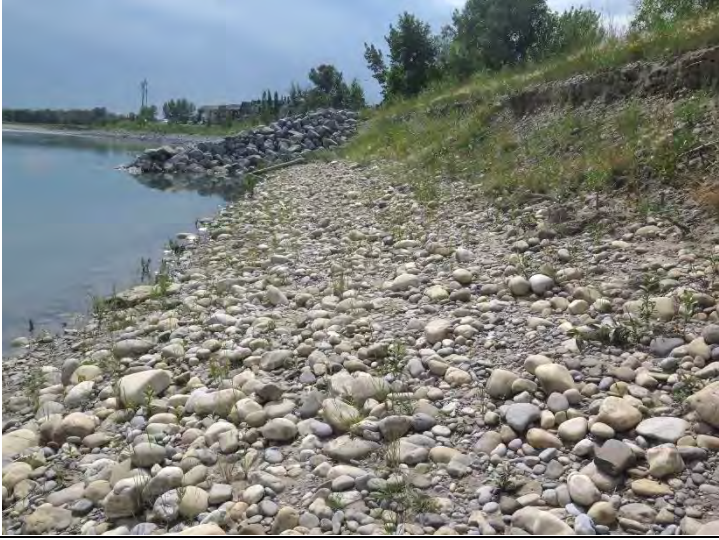
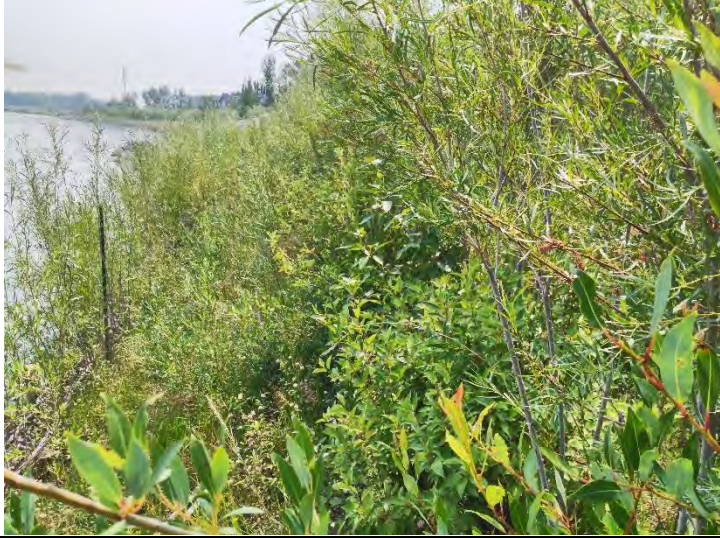
<p>RHIP95BOW017 (2016, Waypoint F) – View downstream toward a riprap groyne showing baseline (2016) unvegetated, steep bank conditions. (<i>Photographer: M. Laing</i>)</p>	<p>RHIP95BOW055 (2021, Retake of RHIP95BOW0017) – Site 2-2 Box fascine with slope treatment. Dense willow plantings (mainly sandbar and hungry willow) have successfully established here, contributing to improved root mass protection and enhanced fish and wildlife habitat. (<i>Photographer: K. Hull</i>)</p>

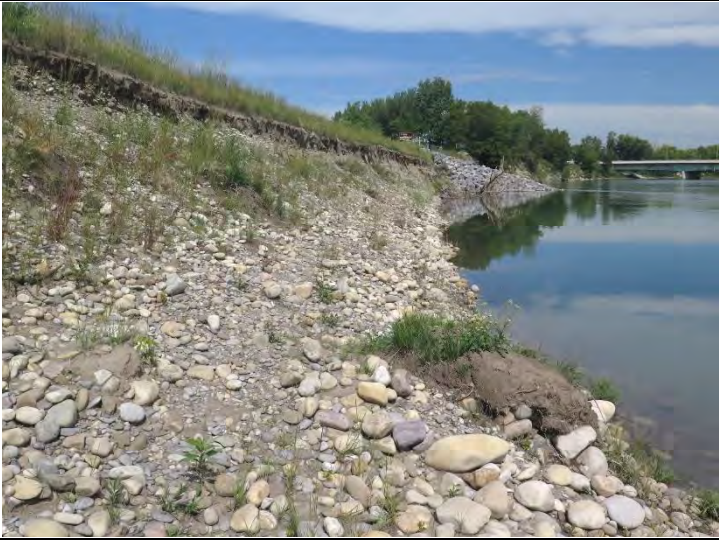
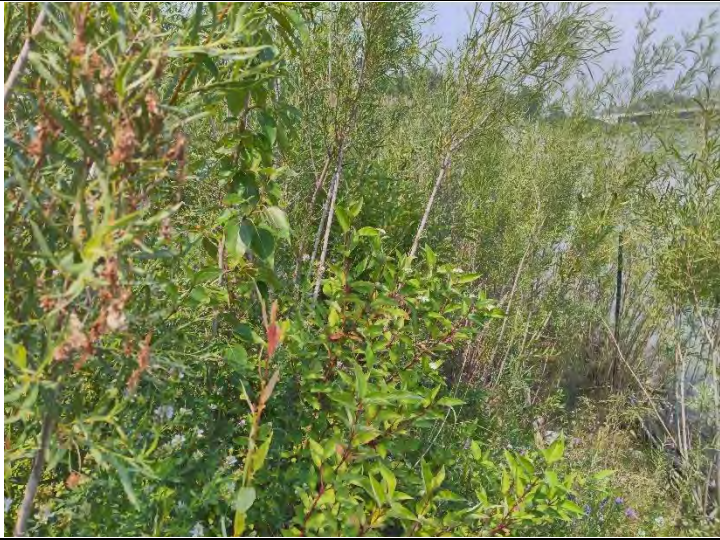
<p>RHIP95BOW018 (2016, Waypoint F) – Baseline conditions within Site 2-1 (2016) showing the pre-existing steep, largely unvegetated bank. (<i>Photographer: M. Laing</i>)</p>	<p>RHIP95BOW054 (2021, Retake of RHIP95BOW018) – Site 2-1, dense vigorous growth of sandbar willow, red osier dogwood, and some young poplars installed as part of slope bioengineering treatments in 2018. (<i>Photographer: K. Hull</i>)</p>

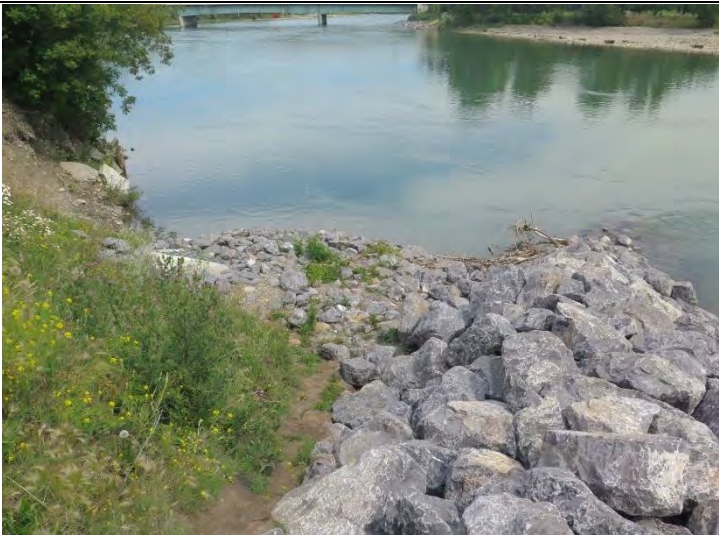
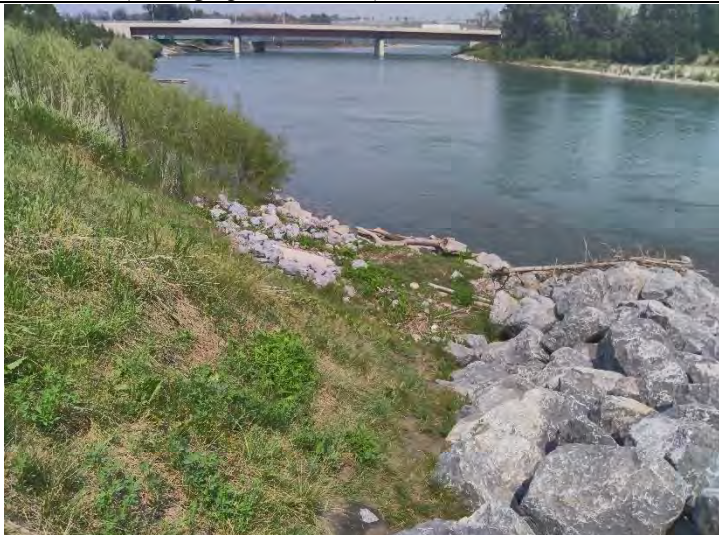
<p>RHIP95BOW020 (2016, Waypoint H) – The B9 outfall and riprap groyne, baseline 2016 conditions including cover from mostly invasive and disturbance weeds. <i>(Photographer: M. Laing)</i></p>	<p>RHIP95BOW059 (2021, Retake of RHIP95BOW020) – Bank recontouring was done upstream from the B9 outfall to create a lower riparian terrace and ameliorate steeply sloping banks. <i>(Photographer: K. Hull)</i></p>

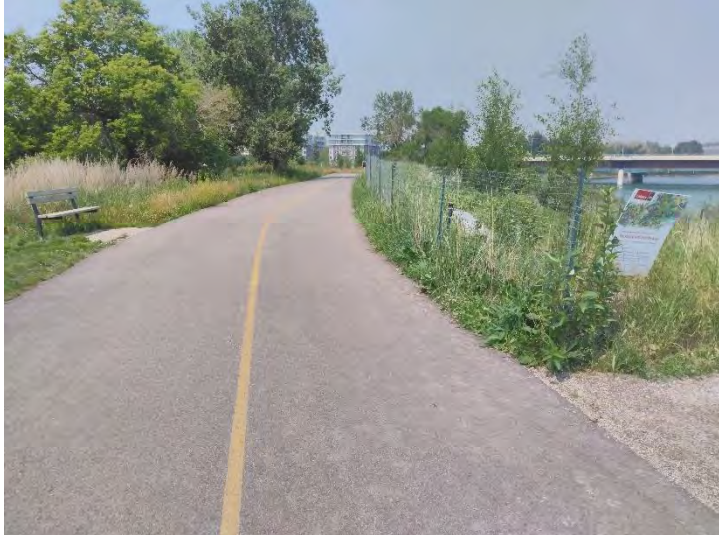
<p>RHIP95BOW022 (2016, Waypoint I) – The 2013 flood damaged portions of this regional pathway that have since been repaired. The paved pathway was excluded from the RHI polygon boundary. <i>(Photographer: M. Laing)</i></p>	<p>RHIP95BOW062 (2021, Retake of RHIP95BOW022) – Bank reshaping done here resulted in some loss of mature tree cover, but dense tree and shrub plantings within Site 1 have compensated for this. The regional pathway (outside of the RHI polygon) has been realigned through this part of the site. <i>(Photographer: K. Hull)</i></p>

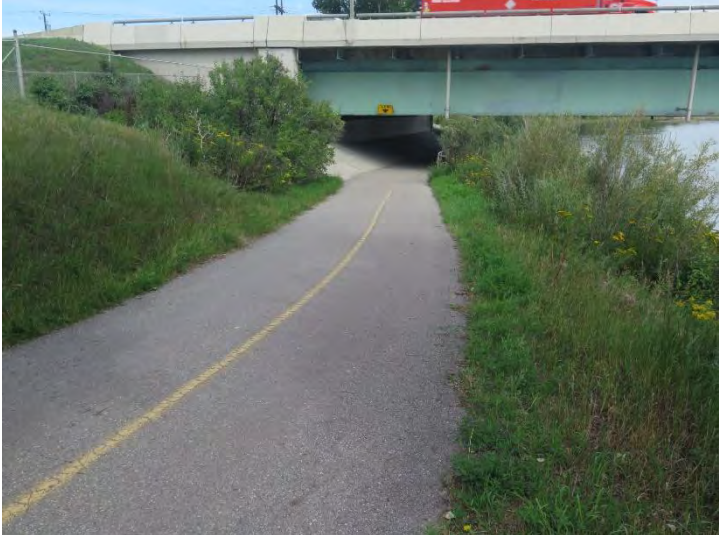
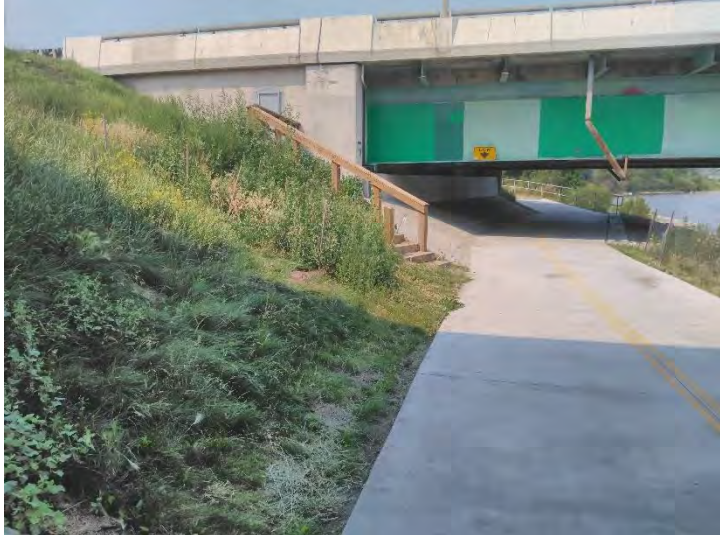
<p>RHIP95BOW025 (2016, Waypoint M) – View upstream below the 17 Ave SE (Cushing) Bridge at the upstream end of the site showing the pre-existing (2016) paved pathway alignment. <i>(Photographer: M. Laing)</i></p>	<p>RHIP95BOW067 (2021, Retake of RHIP95BOW025) – Pathway realignment was done here in addition to creation of a wider wildlife passage on the river side below the bridge. <i>(Photographer: K. Hull)</i></p>

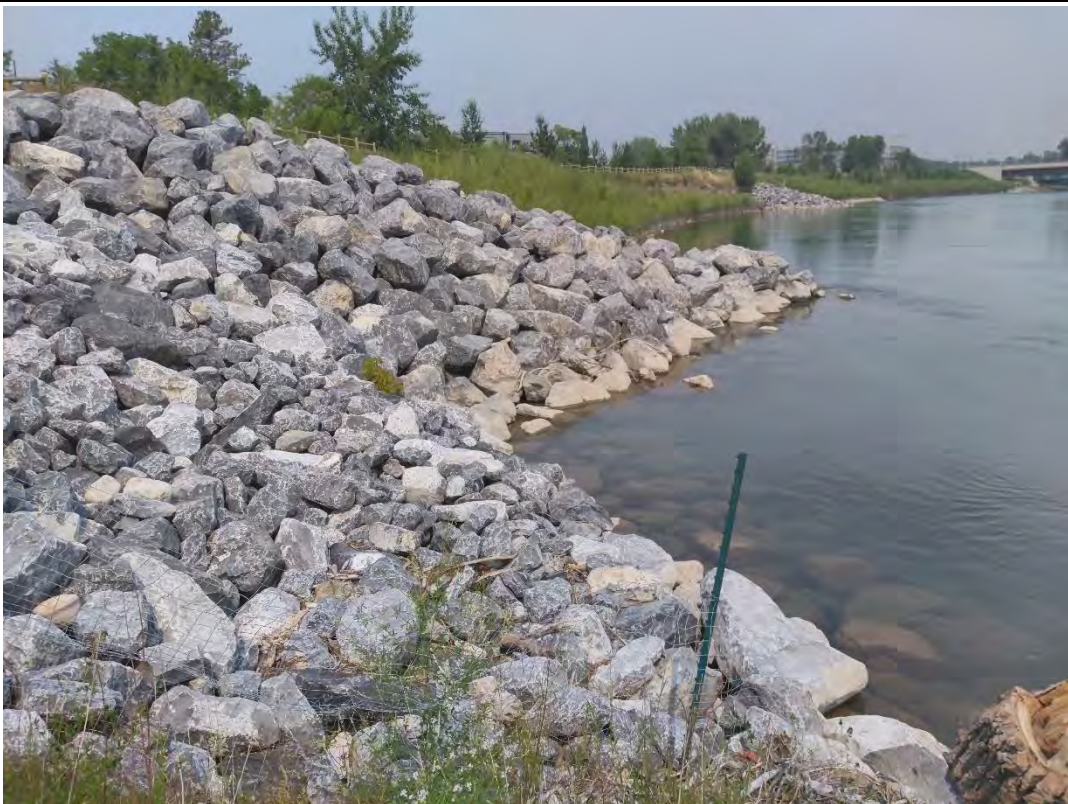
RHIP95BOW047 (2021, Waypoint 2A) – In addition to unvegetated riprap at the downstream end, two large riprap rock groynes were unmodified since 2016. Structural alterations like these detract from the riparian health score. (Photographer: K. Hull)

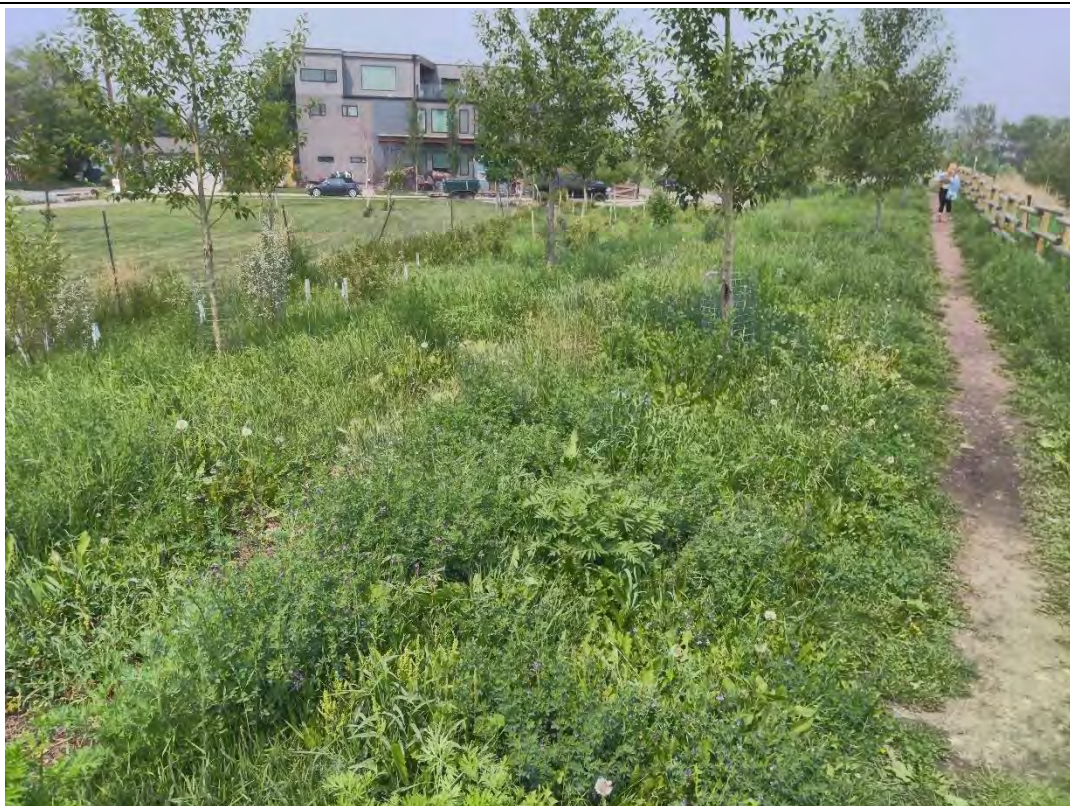
RHIP95BOW052 (2021, Waypoint 2B) – View 287° NW showing a naturalization area (10 to 20 m wide) on the upper bench above top of bank. This area has a mix of rose, saskatoon, silverberry and currant native shrub plantings intermixed with balsam poplar plantings. Herbaceous competition may be a limiting factor to shrub survival due to dense wheatgrass, alfalfa, dandelion and intermixed common tansy weeds (*Photographer: K. Hull*)

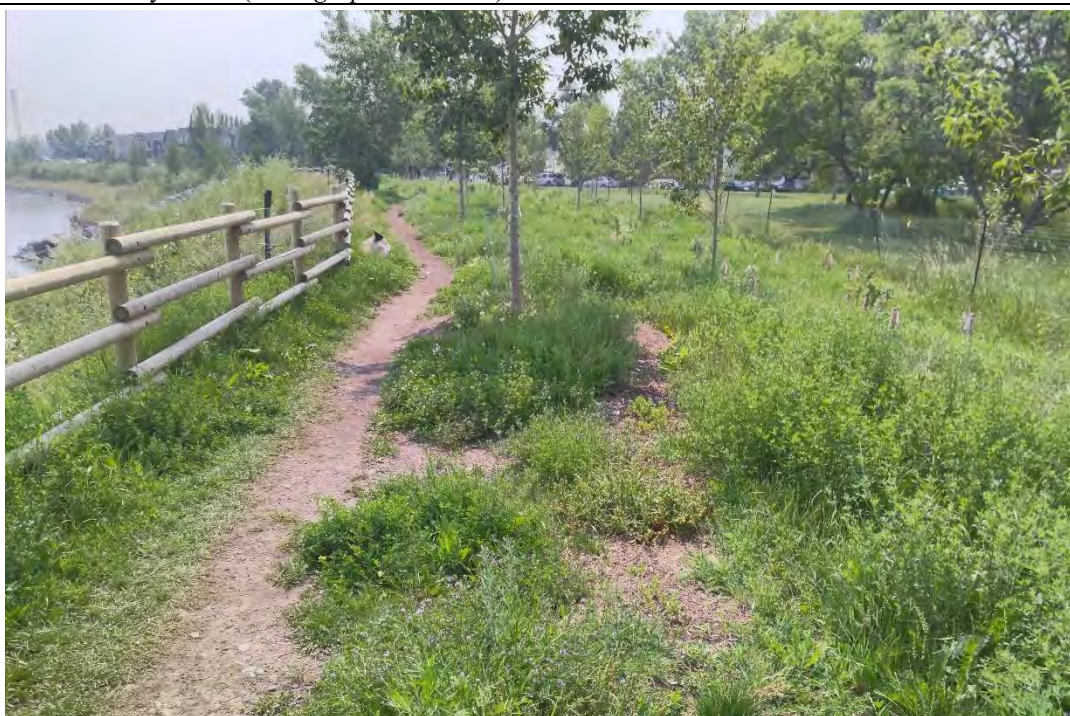
RHIP95BOW053 (2021, Waypoint 2B) – View 170°S showing a riparian planting area adjacent to the top of the bank where additional native shrub plantings should be installed to enhance biodiversity and habitat structure. Dense herbaceous cover may be a limiting factor to success of plantings. (*Photographer: K. Hull*)

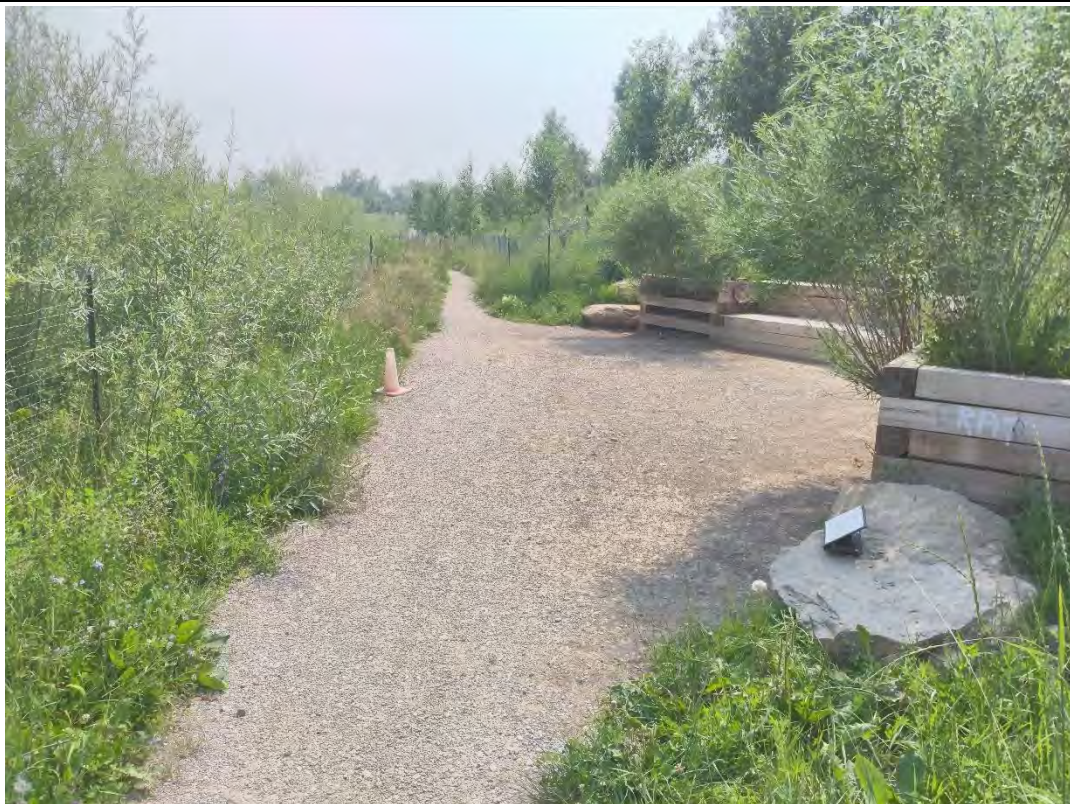
RHIP95BOW066 (2021, Waypoint 2E) – The BDEP site incorporates new seating areas and a gravel path that also serves as a wildlife corridor. (Photographer: K. Hull)

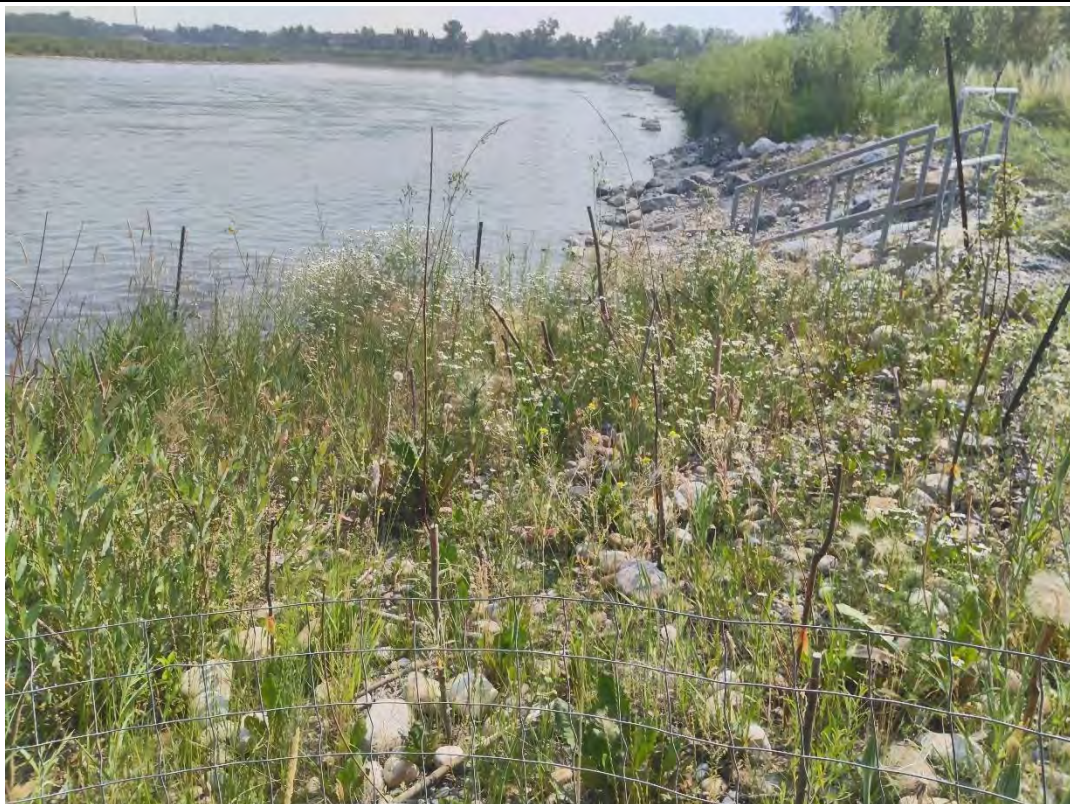
RHIP95BOW069 (2021, Waypoint 2F) – View downstream at the lower end of **Site 1-2**. This disturbed area below the BRT bridge requires ongoing monitoring and maintenance to ensure survival success targets are reached for willow cuttings and to remove scentless chamomile infestations. *(Photographer: K. Hull)*

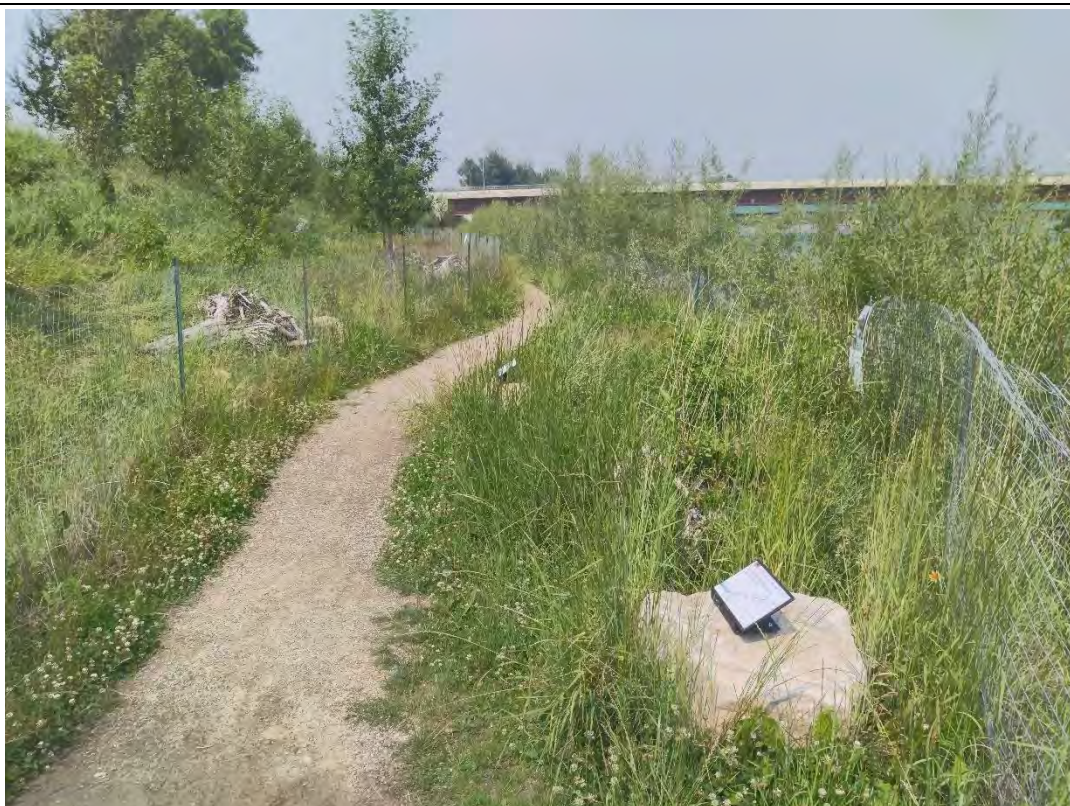
RHIP95BOW065 (2021, Waypoint J) – View toward the Cushing and BRT bridges from within Site 1-3 showing successful balsam poplar and willow establishment on either side of a newly constructed gravel path (recreational access and wildlife passage). (Photographer: K. Hull)

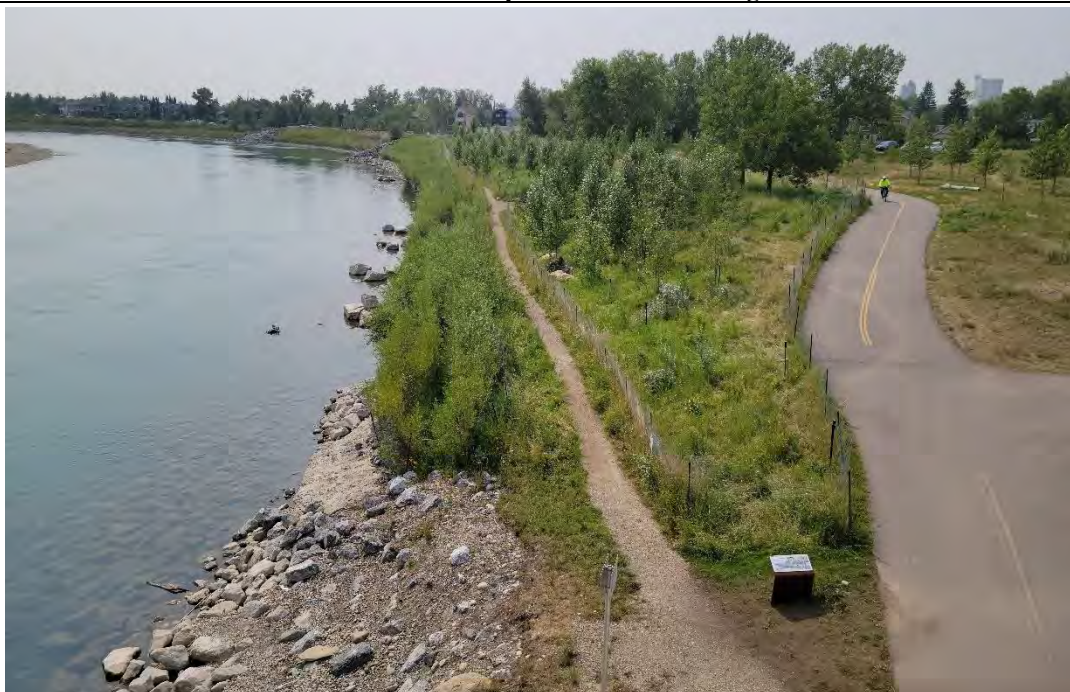
MONT95BOW0002 (2021) – View upstream from the BRT bridge viewing platform showing the BDEP site and successfully established plantings in addition to the reshaped bank and wildlife corridor and repositioned regional paved pathway. (Photographer: K. Boehler)

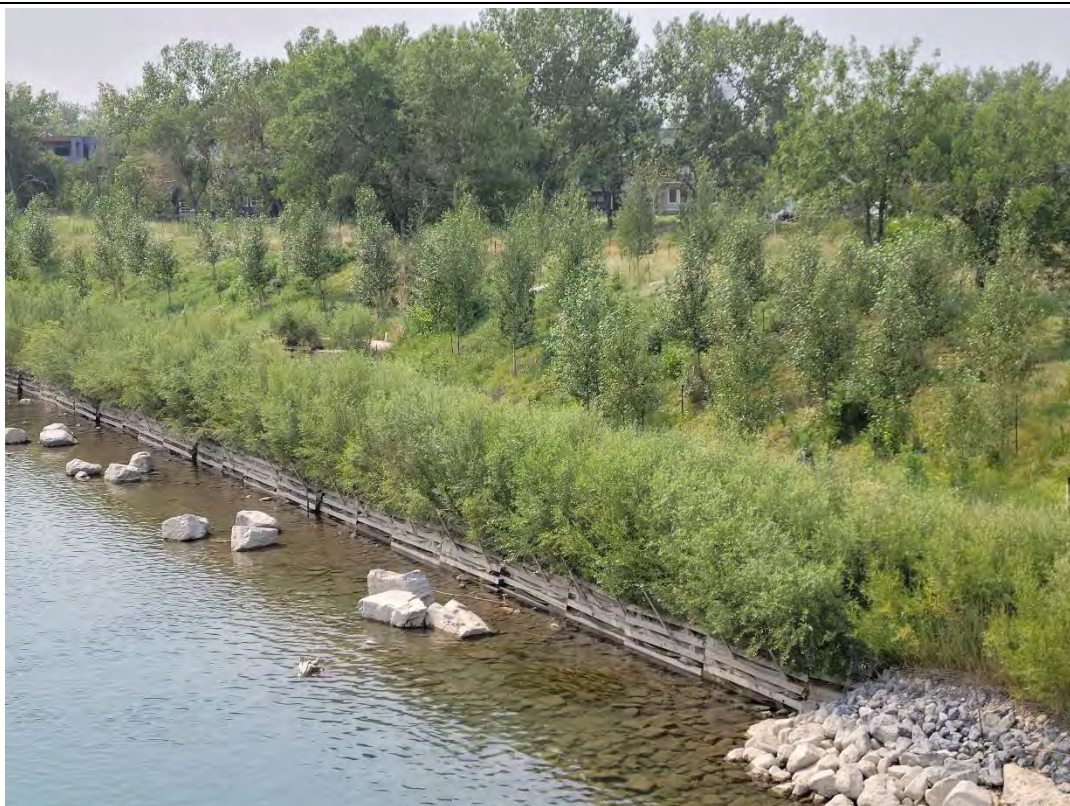
MONT95BOW0005 (2021) – View upstream from the BRT bridge viewing platform showing **Site 1-3**, timber crib wall. Excellent establishment of native plantings have augmented root mass protection, enhanced overall woody cover and wildlife habitat structure. *(Photographer: K. Boehler)*
