# BIOENGINEERING DEMONSTRATION AND EDUCATION PROJECT

## Site Assessment Technical Report

File: 1873-004.01  
September 2016

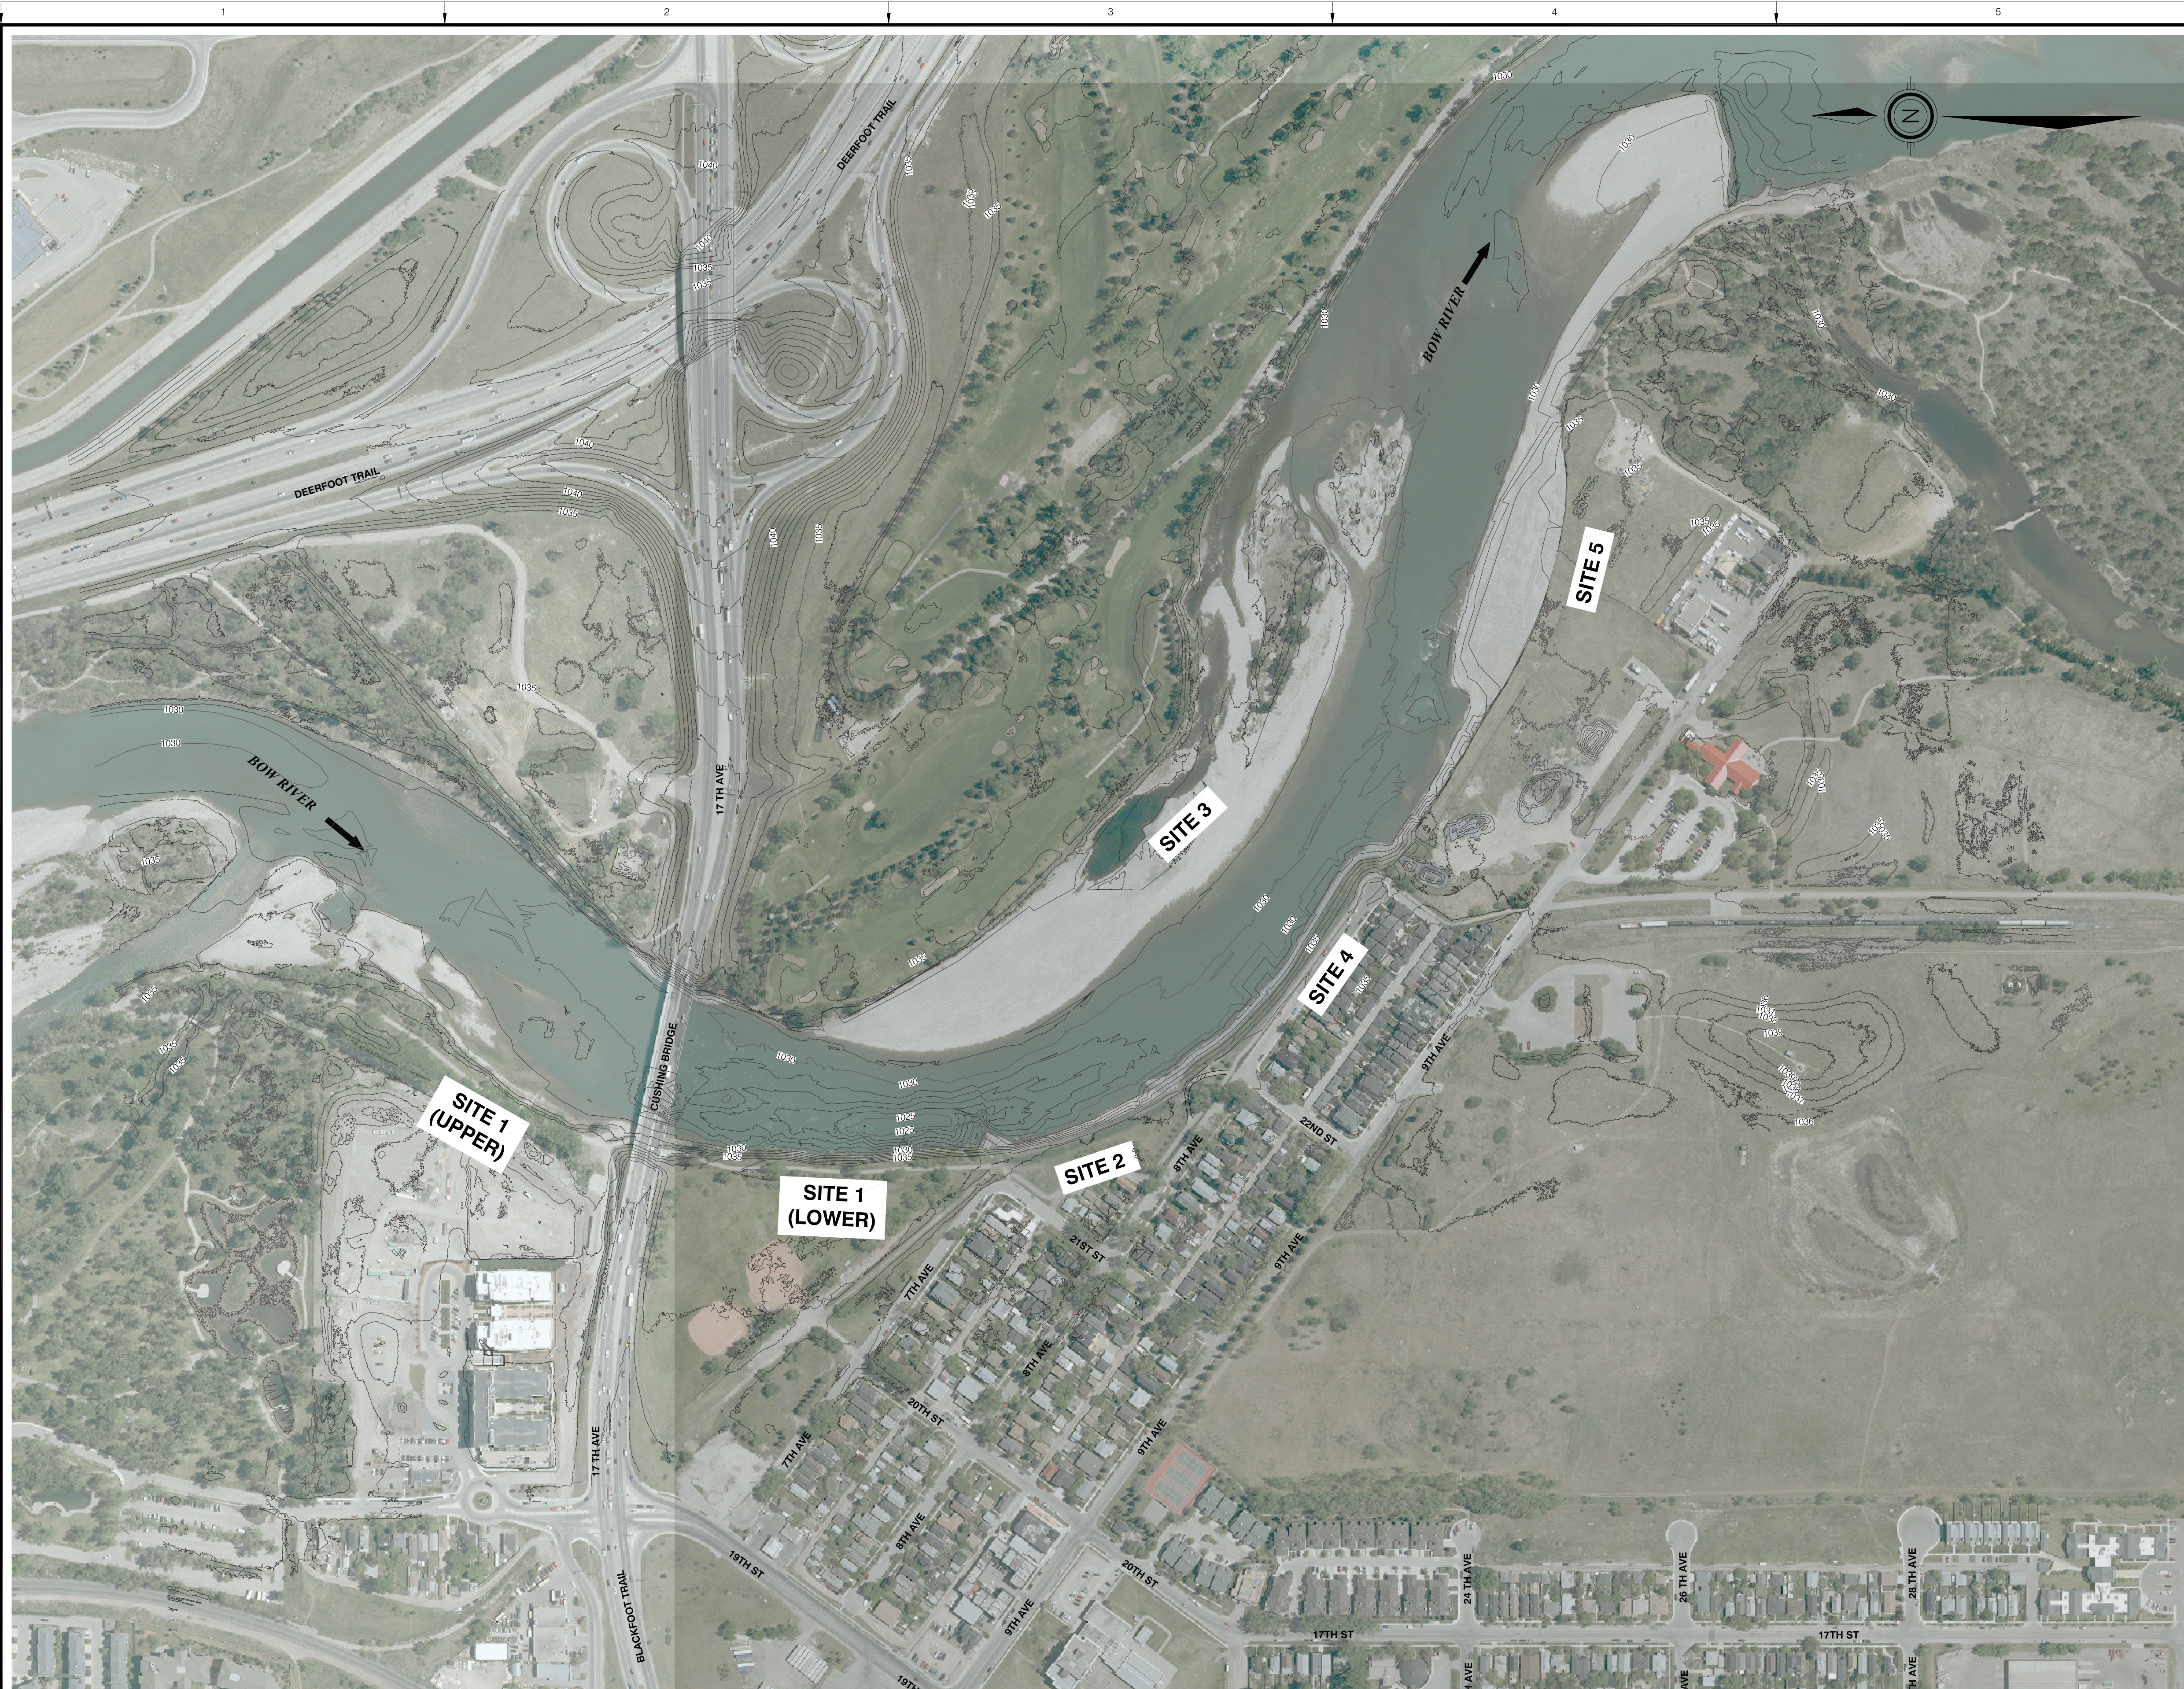
**FIGURE 3**  
**PROJECT SITE TOPOGRAPHY**

- a field survey to complete bathymetric mapping (**Figure 3**);
- a preliminary geomorphology assessment to review the historic planform channel changes on the Bow River with specific attention to the channel morphology immediately downstream of the Cushing Bridge; and,
- a desktop geotechnical assessment to provide a general geotechnical site characterization and consideration of geotechnical and materials engineering aspects including riparian slope stability and related riverbank restoration strategies.

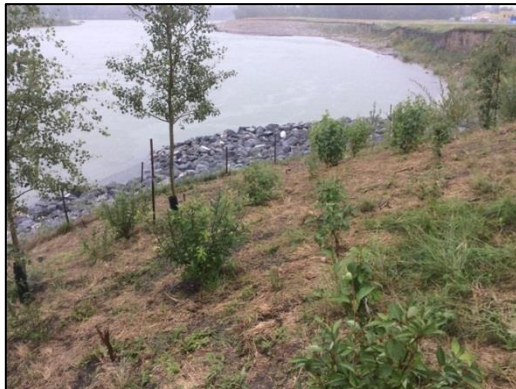
**Photo 3:** Site 4 post-flood bank reconstruction with riparian planting above riprap.

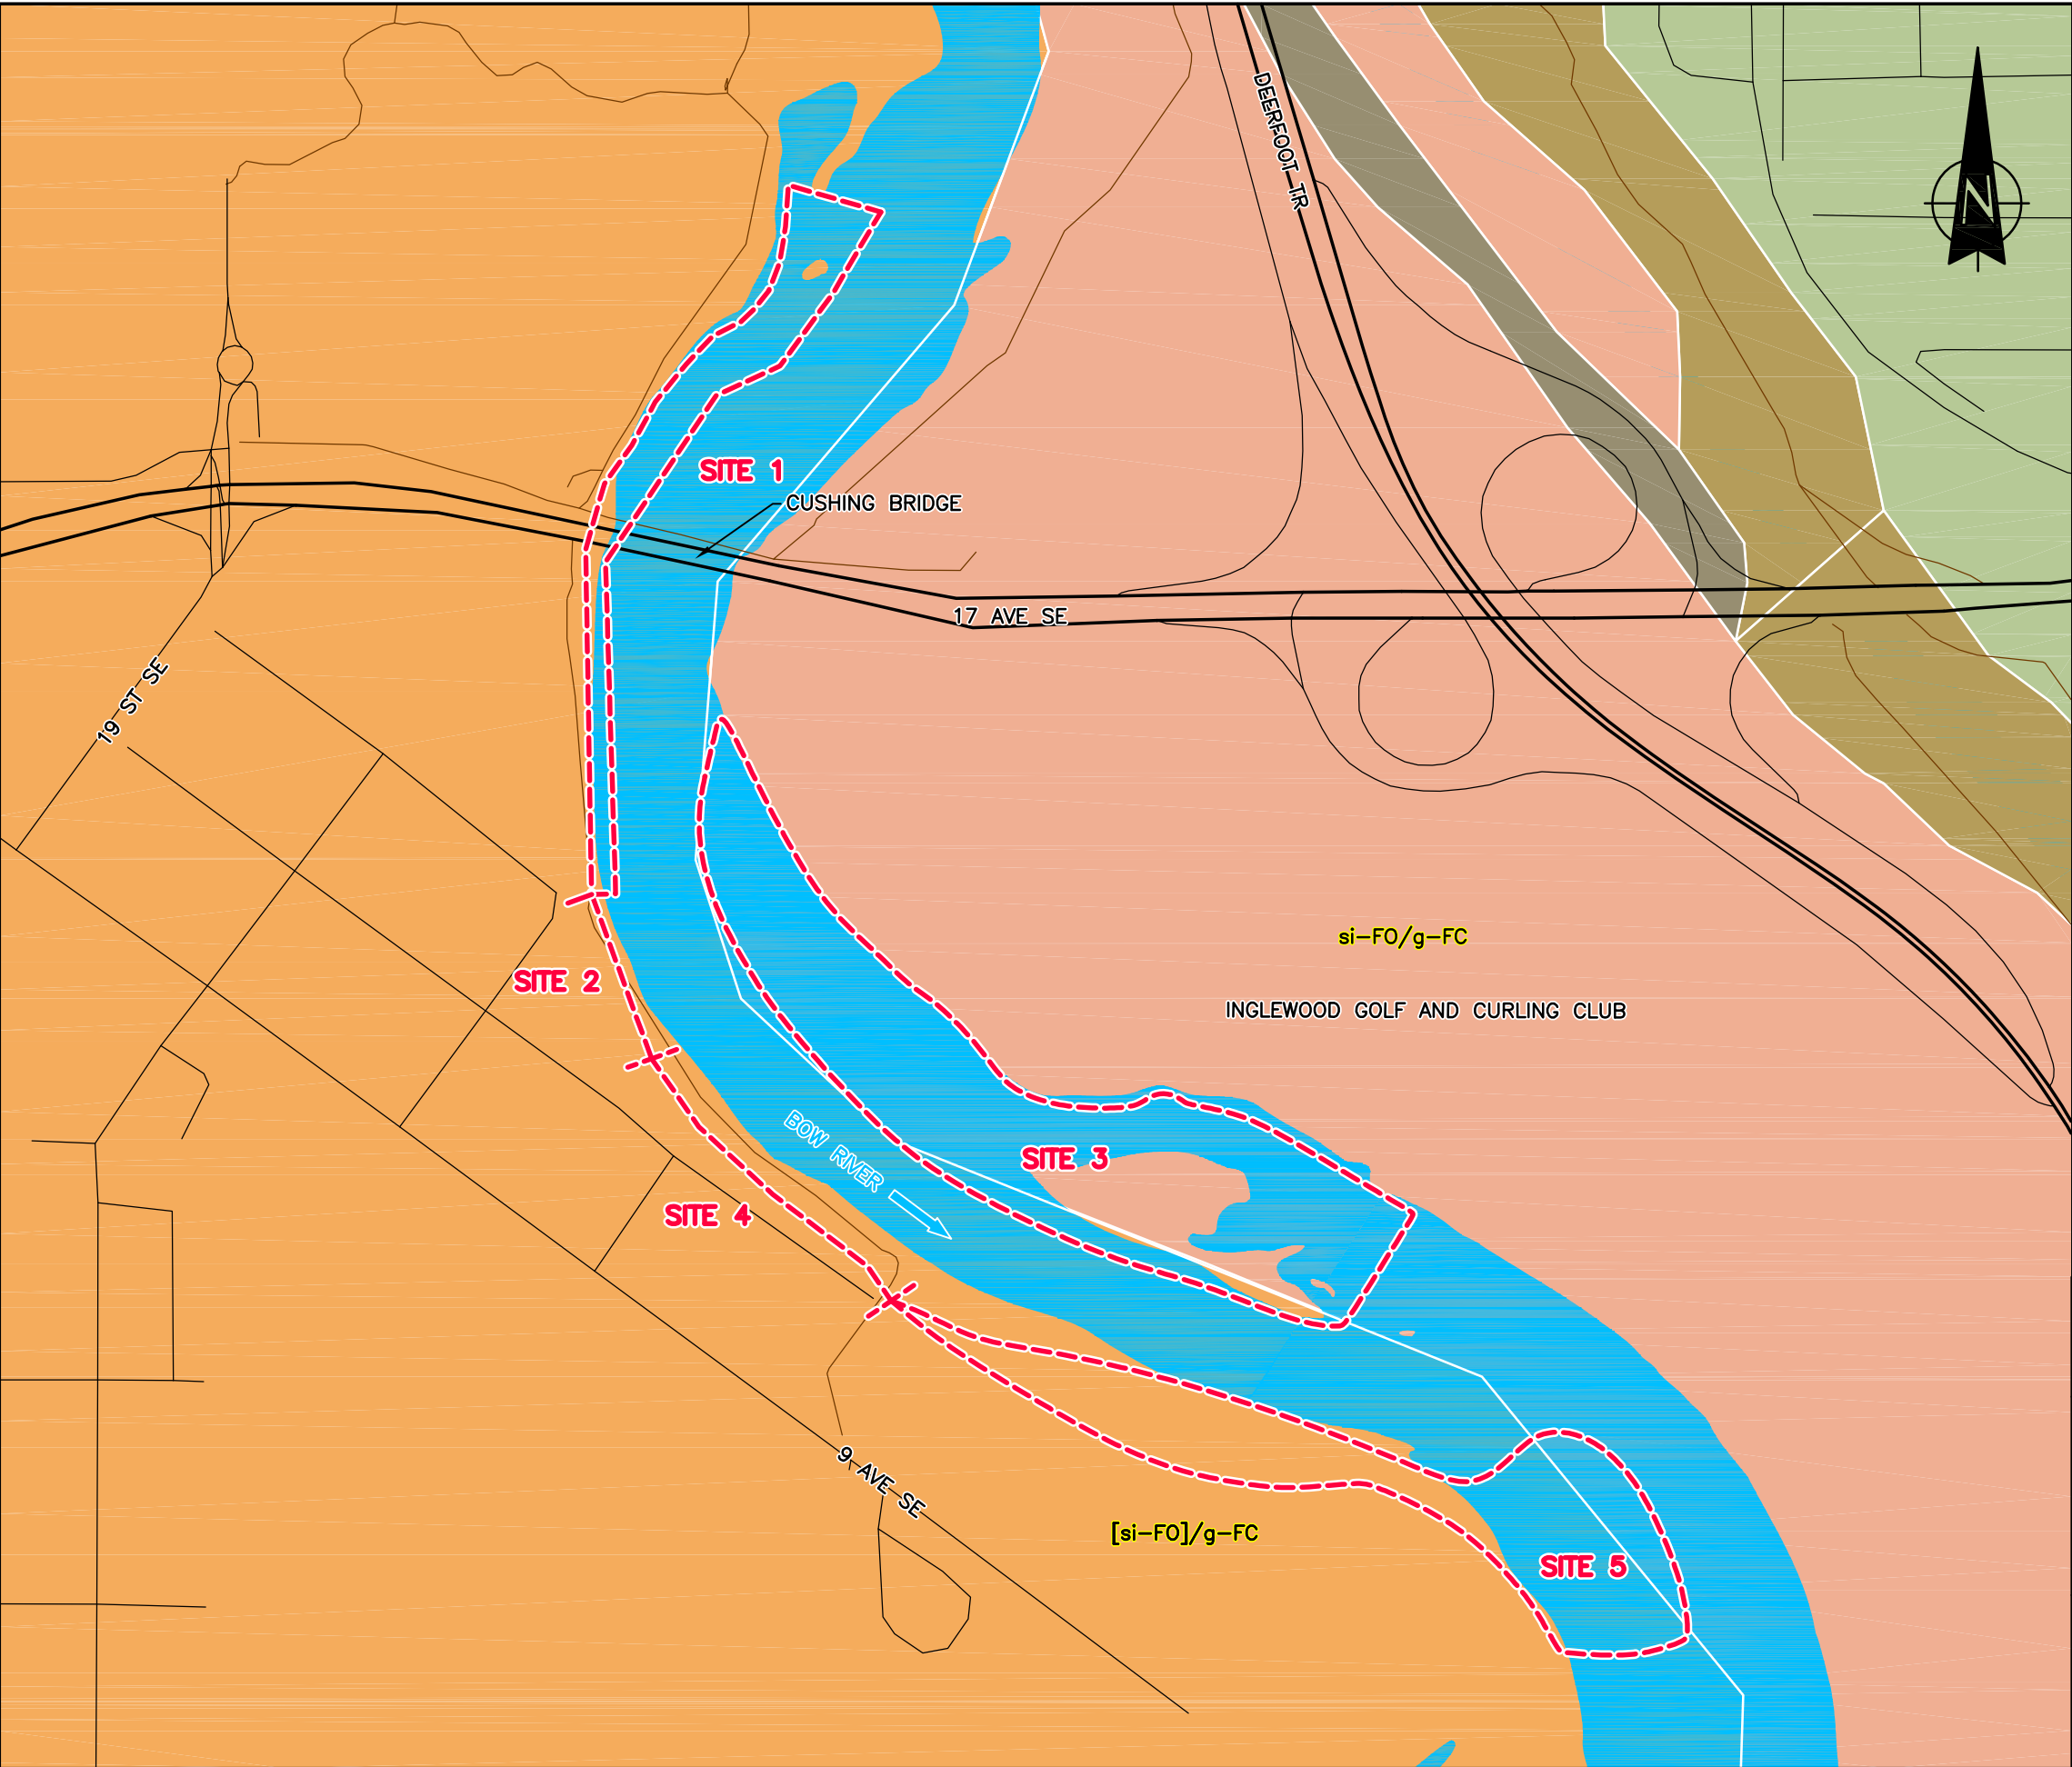
FIGURE 2

The local surficial geological map referenced in Section 2 above indicates the presence of fluvial-overbank sediment consisting primarily of silty soil overlying fluvial-channel sediment consisting of gravelly soil. Figure 2 in Appendix A presents the surficial geology overlain on a site plan. This is generally consistent with our visual observations of the study area.

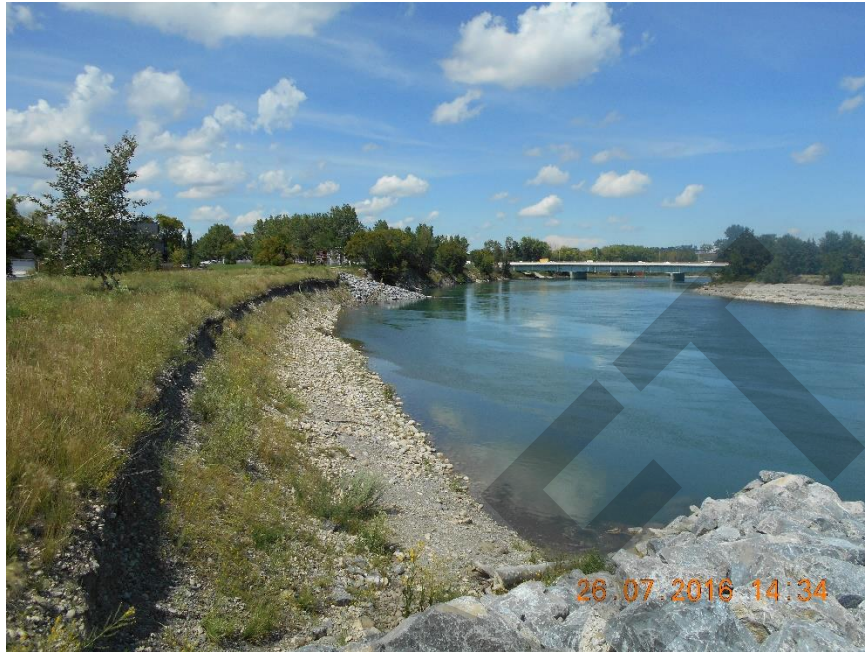
Photo 9. Looking northwest. River bank of Site 2.
