# Mount Pleasant Affordable Housing Parking Assessment

Project #2000258

# The City of Calgary

JCB Engineering

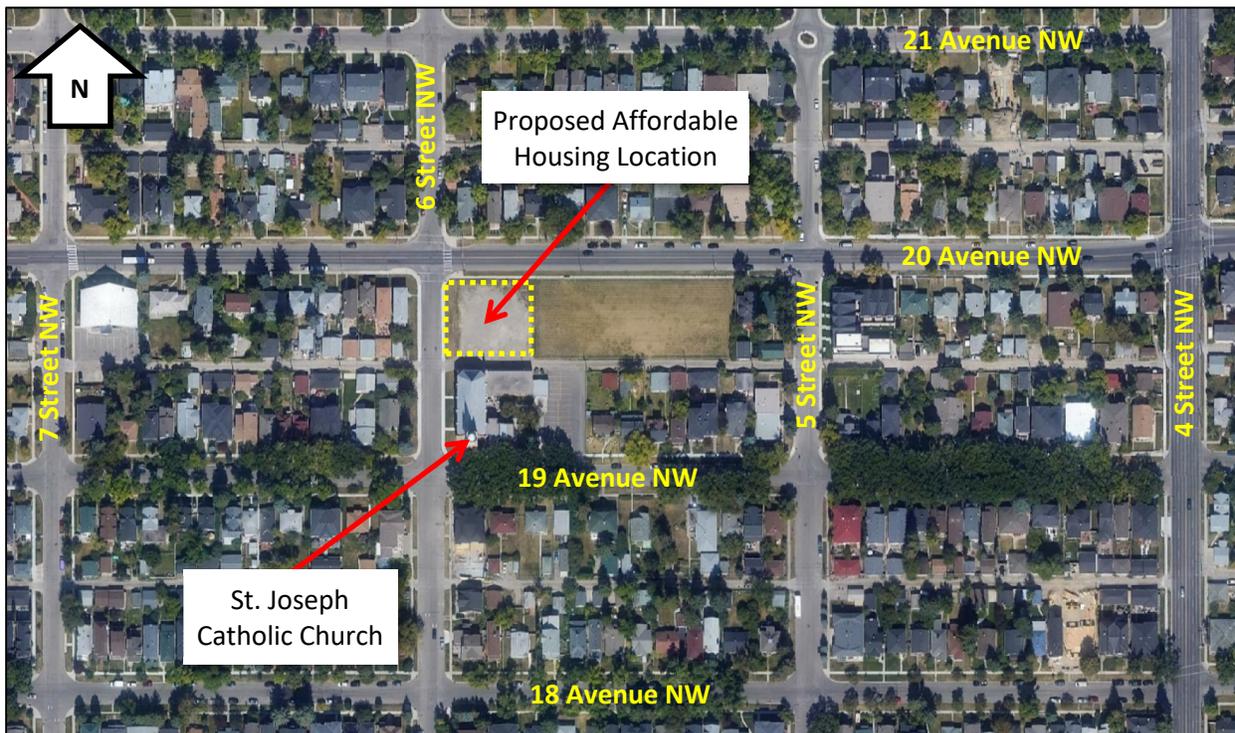
**Figure i-1: Proposed Development Location within the City of Calgary**

The purpose of this study is to conduct a parking assessment of a proposed affordable housing development in the community of Mount Pleasant in the City of Calgary. This development is located at 2020 6 Street NW; the following figure shows the location of the development, the lots to the east at 629 and 615 20 Avenue NW will remain green space and are to be improved as part of this development.

This development is proposed in a well established residential community in the northwest of the City of Calgary. All of the roadways shown on **Figure i-1** are classified as 'local' roadways with the exception of 20 Avenue NW, which is a 'collector' roadway on the City of Calgary Roadway Classification Map. These roadways all have sidewalks on both sides and there is a signed, shared on-street bicycle lane along 19 Avenue NW from 2 Street NW to 9 Street NW. There is a special pedestrian crossing of 20 Avenue NW at the intersection with 6 Street NW, providing residents and visitors to the subject development with a convenient location to cross the collector roadway. This results in a safe and efficient network for walking and bicycling around the community in the vicinity of the subject development.

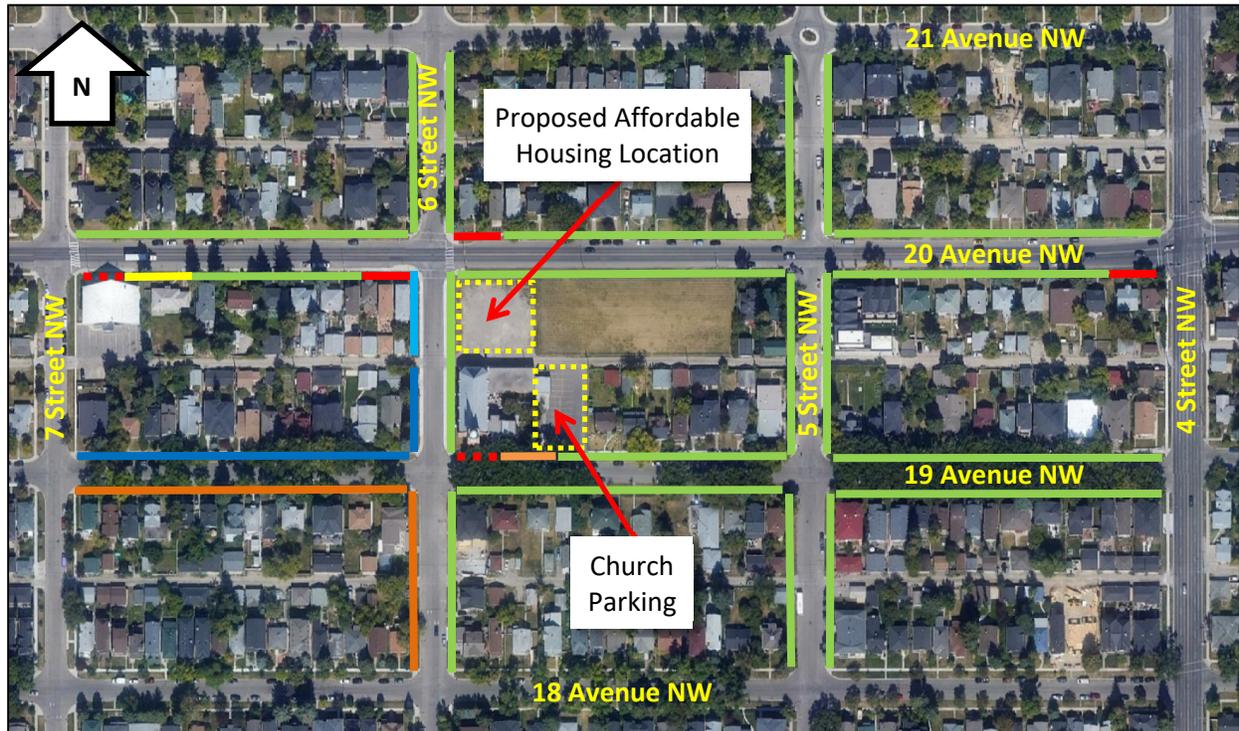
Figure 4-1: Parking Survey Locations and Parking Restrictions

The following figure illustrates the roadways that were surveyed and the parking restrictions that exist for on-street parking. The number of vehicles parked in the lot to the east of St. Joseph Catholic Church and on the subject development site were also counted.

There are few restrictions with regards to on-street parking in this area of Mount Pleasant, there are even limited parking restrictions from residential permit parking. St. Joseph Catholic Church has a 20 minute loading zone on 19 Avenue NW that is near the main entrance to the Church, this is in addition to their parking area on site. There is a short section of time restricted parking on 19 Avenue NW in front of the Church, but during the hours of the mass, with the exceptions of Wednesday and Friday, that restriction is not in effect.

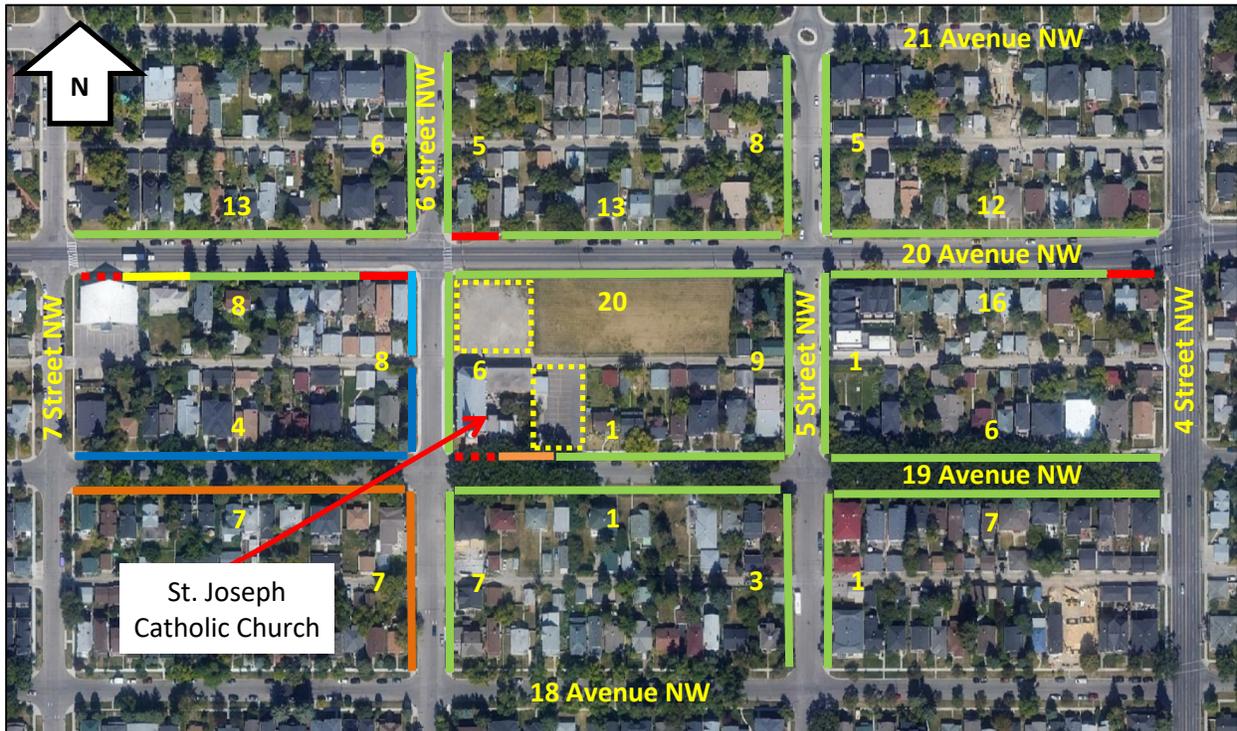
Figure 4-2: Available On-Street Parking Based on Maximum Observed Utilization

The surveys conducted when no mass was being celebrated at the Church demonstrate that the subject development site is not being used for parking by the community, the vehicles observed there are only during mass. As many as 34 vehicles will need to be accommodated by on-street parking if the subject site is no longer available for Church visitors to use based on the maximum parking demand. The following figure summarises the available on-street parking available based on the maximum utilization data observed from the surveys. This is a worst case scenario for on-street parking as the maximum utilization for each roadway section was not observed during the same survey time period, but in the following figure that scenario is assumed.

The existing on-street parking has an adequate supply to accommodate these vehicles that are currently parked in the subject site. The following unrestricted on-street parking could be utilized for Church visitors:

- East side of 6 Street NW; 18 to 19 Avenue NW – 7 stalls
- East side of 6 Street NW; 19 to 20 Avenue NW – 6 stalls
- North and south sides of 19 Avenue NW; 6 to 7 Street NW – 2 stalls
- South side of 20 Avenue NW; 6 to 7 Street NW – 20 stalls

This is 35 on-street parking stalls, which could accommodate the maximum number of vehicles observed to be parked on the subject site. As illustrated on the previous figure there are numerous options of on-street parking for visitors to utilize; and there is still available permit parking for local residents. Visitors using this on-street parking instead of the subject site will have to walk further to the Church, this on-street parking is within a 300 metre distance using the existing sidewalks. The Church does have a loading zone that could be used to drop off and pick up some visitors if the distance to walk from on-street parking is too far.
