Bioengineering Demonstration and Education Project - 2020 Monitoring Report

The City of Calgary Riparian Monitoring Program

June 23, 2021

Report prepared for:
The City of Calgary - Water Resources

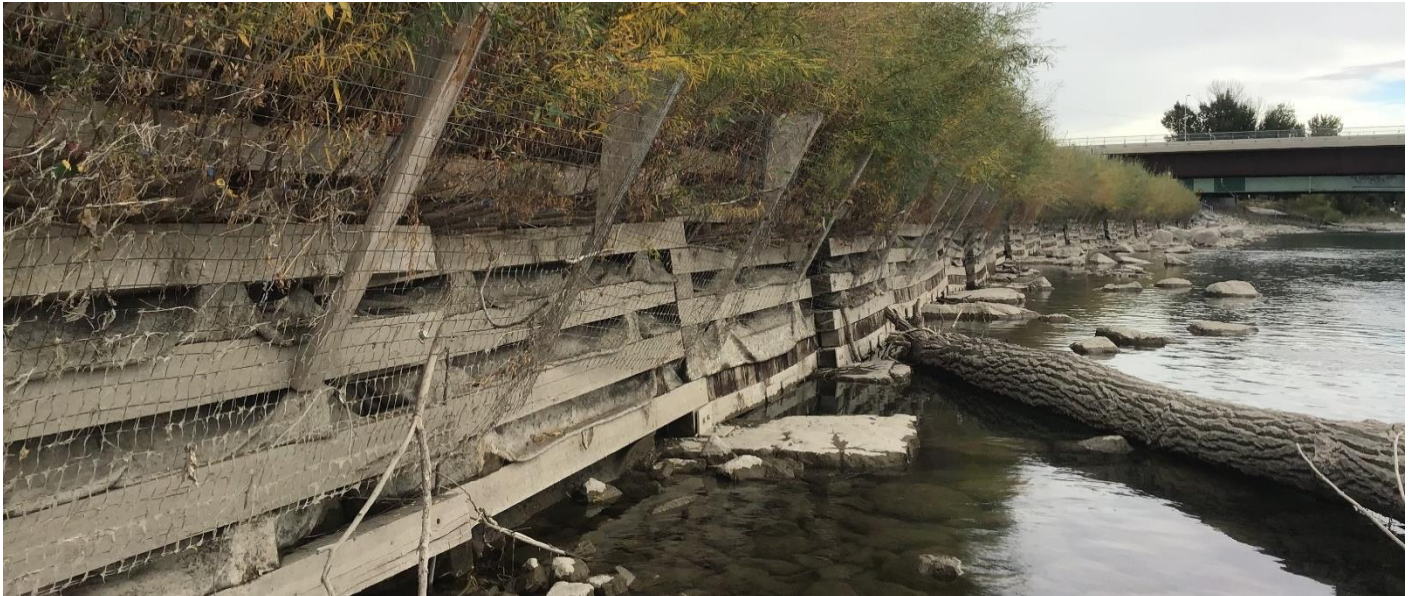
Photo 2-1: Timber crib wall and fish habitat enhancement boulders at Site 1-3.

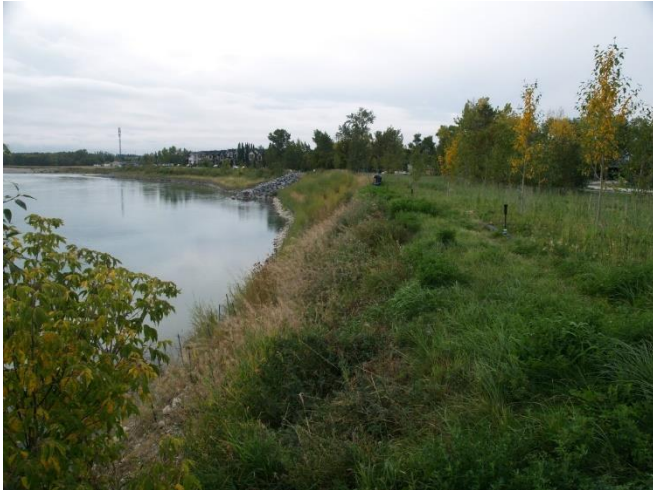
Site 1 is shown in Figure 1-1 and Photo 4-1 and 4-2. Site 1 received a riparian health score of 49% in 2020, which is similar to the 2019 health score (i.e., 51%). Both the 2019 and 2020 health scores are higher than

Photo 4-2: View south of Site #1 from just south of Cushing Bridge (September 9, 2020) (E709336, N5658185)

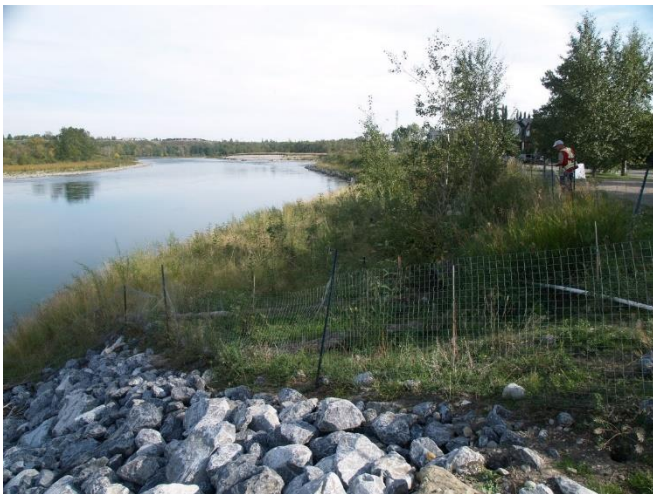
Photo 4-4: View south-southeast from the north end of Site #2 (September 9, 2020) (E709346, N5657964)

Site 2 is shown in Figure 1-1 and Photo 4-3 and 4-4. Site 2 received a riparian health score of 56% in 2020, which is a significant improvement on the score of 29% received in 2016. The bioengineering work completed for the BDEP project is directly responsible for the health improvements observed in Site 2 since 2016. The 2020 riparian health score is similar to the score received in 2019 (i.e., 58%), meaning that the health of site appears to be stable or static. The reason for the slight decrease in score from 2019 to 2020 was due to increased cover of human-caused bare soil (Parameter 10). With the area now open to the public, it has become a popular spot to walk through. This increased human activity has led to the creation of a trail with high cover of exposed soil along the top of the bank. It should also be noted that this score decrease was partially offset by an apparent change in the cover of disturbance-increaser species, which were assessed to be lower in cover in 2020 compared to 2019.

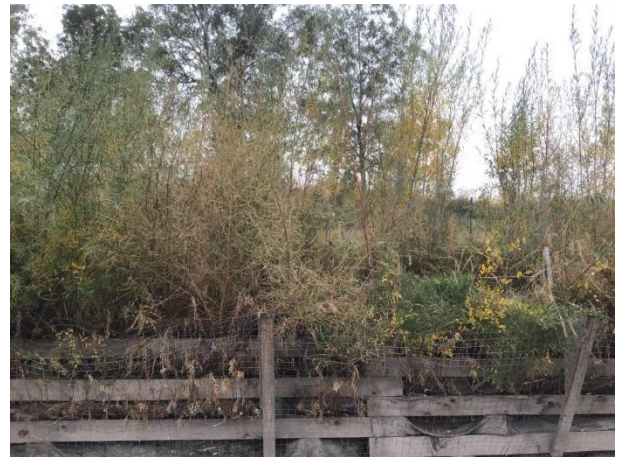
- **Wood Materials:** The wood materials used at the site consist of timber for the timber crib wall, posts for the box fascine, and posts for the brush mattress. In general, the condition of the posts used is very good with no concerns for long-term durability. Concern with the timber quality used in the crib wall at Site 1 was noted during the 2019 assessment. The timber crib wall was observed to be stable with no observable change in condition during the 2020 assessment (Photo 5-2).

Photo 5-2: Typical vegetated timber crib wall section (shown with rodent fencing attached) (Sept 25, 2020)

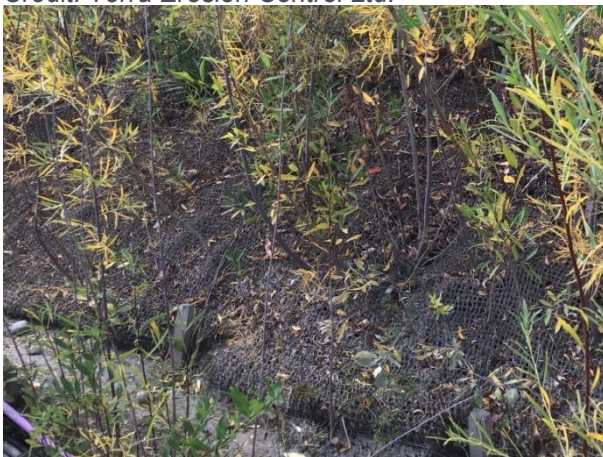
- **Matting, Geogrids and Geotextiles:** Erosion control matting, coir geogrids, and non-woven geotextiles were installed at the BDEP to provide erosion control, material containment and material separation. The erosion control matting is installed at Site 4 to provide erosion control until vegetation established. It was observed in 2020 to be mostly biodegraded with no remaining useful life. Both woody and herbaceous vegetation have established at Site 4, so the matting performed its function within its expected product longevity. The coir geogrid was used at Site 1 in the timber crib wall for material containment, and at Site 1 and Site 2 for erosion control until vegetation establishes. It was observed to be in good condition and there are no concerns with the coir geogrid continuing to provide erosion control until vegetation fully establishes at those sites (Photo 5-3). The non-woven geotextile is used at Site 1 in the timber crib wall for material containment and separation. It is in very good condition with no concerns for long-term durability.

Photo 5-3: Coir geogrid at Site 2 (Sept 25, 2020)

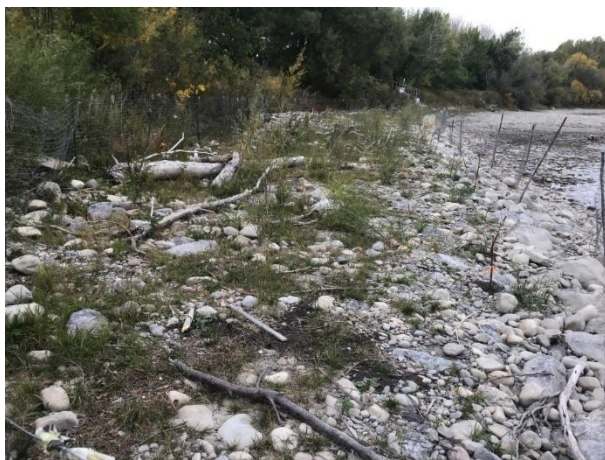
- **Hydromulch and Seeding:** Hydromulch was installed at Site 1, Site 2, and Site 4 for erosion control and seeding. The hydromulch was washed away at the upstream end of Site 1; however natural regeneration is occurring at this location as shown in Photo 5-5. Herbaceous establishment was very high at all sites with high invasive weed cover.

Photo 5-5: Natural regeneration at Site 1 upstream of Cushing Bridge (September 25, 2020)

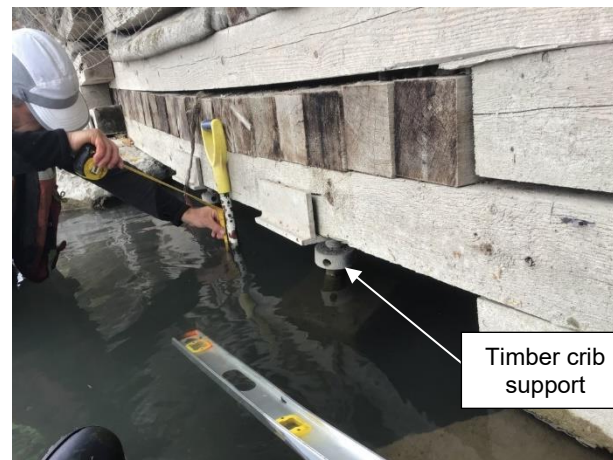
- **Steel:** Steel products were used at several locations at the BDEP site: at Site 1, stainless steel plates and bolts were used to secure neighbouring timber cribs together in the timber crib wall, galvanized spiral shank spikes were used to fasten the timber together in the timber crib wall, and steel jacks were used to support the timber crib wall in the fish shelters; at Site 1 and Site 2, steel wire was used to tie down the box fascine and the brush mattress; and, at Site 4, candy cane rebar were used to secure the wattles. All steel products were observed to be in good to excellent condition with no concerns for long-term durability. The steel supports that were placed under the spanning members in the fish shelters are in very good condition with one loose support at the south end of the crib wall Photo 5-6. It is recommended to tighten the loose support.

- **Fish Shelters:** The fish shelters were inspected on September 25, 2020 and October 27, 2020. Fine sediment was observed to have deposited along the bottom of 9 of the 12 shelters in a layer ranging from 0.05 m to 0.2 m depth and average of 0.1 m depth of but were otherwise clear and providing good fish habitat as shown in Photo 5-7. The large woody debris that was observed on the fish boulders in 2019 was observed again in 2020. No significant change in the condition of the timber crib wall was observed from as-constructed conditions per Photo 5-8, and there was no measured change in the deflection of the spanning members that are supported by the steel supports.

Photo 5-6: Measuring sediment depth in fish shelters and timber crib wall supports (September 25, 2020)

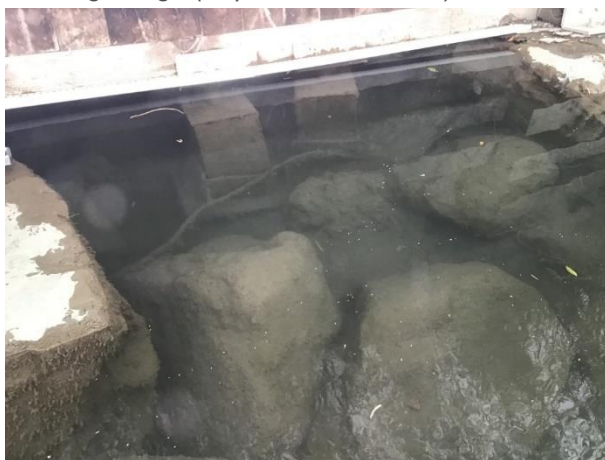
- The fish shelters were observed to have some fine sediment deposited along the bottom but were otherwise clear and providing good fish habitat. No significant change in the condition of the timber crib wall was observed from as-constructed conditions, and there was no observed change in the deflection of the spanning members that are supported by the steel supports.

Photo 5-7: Fish Shelter at Site 1

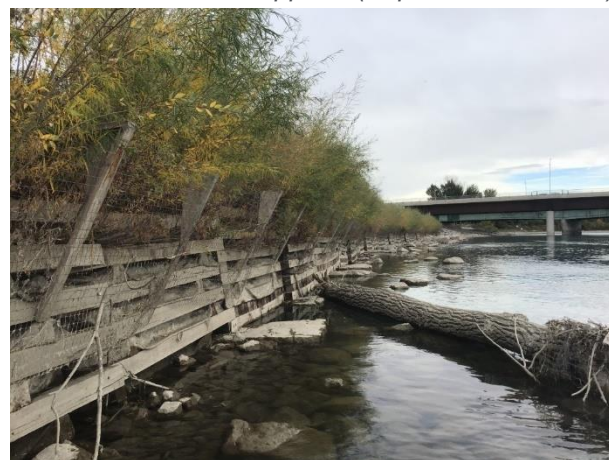
Photo 5-8: Timber crib wall at Site 1

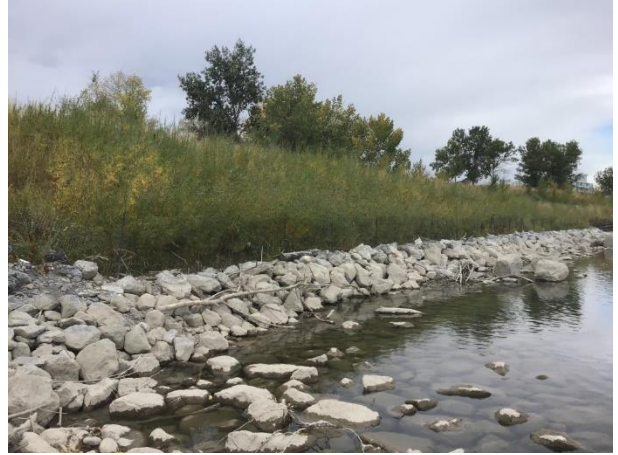
- The brush mattress, brush layer and contour fascine survival at Site 1 is lower in 2020 than 2019; however, there is overall good and vigorous growth establishment in this portion of Site 1 per Photo 5-10.

Photo 5-10: Vigorous growth at the downstream end of Site 1 (September 25, 2020)

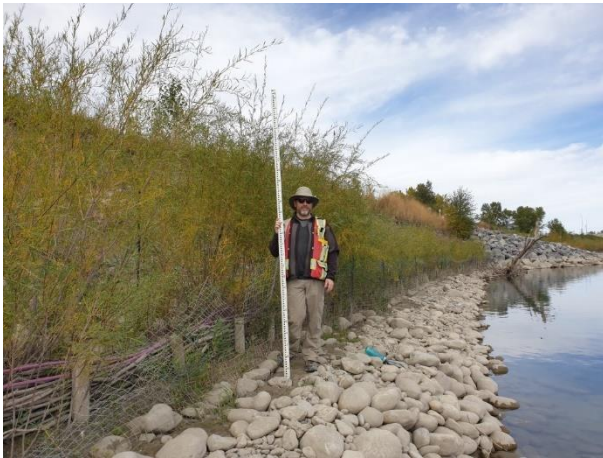
Photo 5-11: Box fascine growth at Site 2 (September 25, 2020) Credit: Terra Erosion Control Ltd.

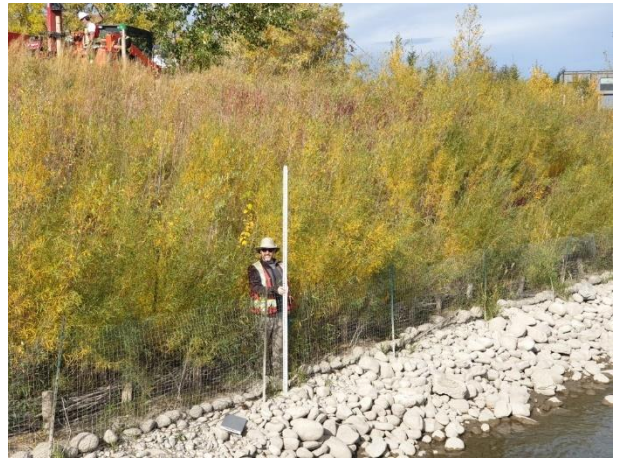
Photo 5-12: Good and vigorous growth in Hedge Brush Layer at Site 2 (September 25, 2020) Credit: Terra Erosion Control Ltd.

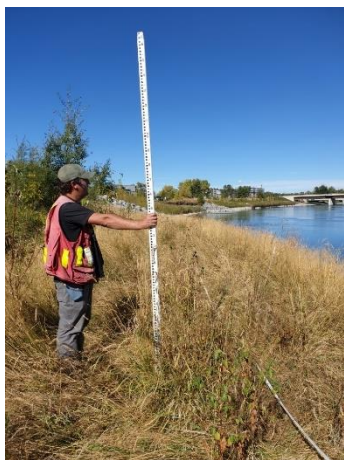
*Photo 5-13: Herbaceous vegetation competition and shrubs with low vigour at Site 4 (September 24, 2020)
Credit: Terra Erosion Control Ltd.*

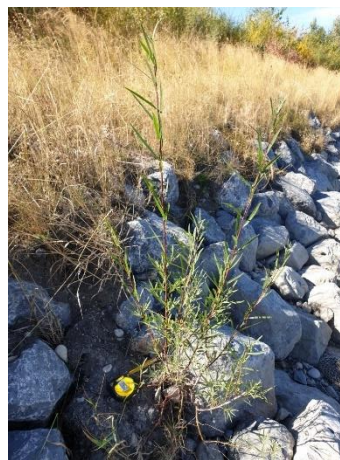
*Photo 5-14: Live cutting at Site 4 (September 24, 2020)
Credit: Terra Erosion Control Ltd.*

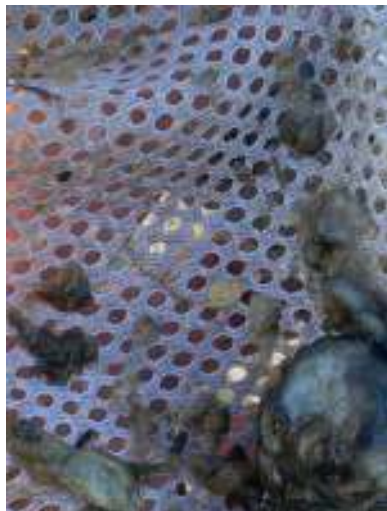
The fall spawning assessment included a brown trout redd survey and kick-net sampling to identify mountain whitefish eggs. The assessment was conducted on December 2, 2020 following the conclusion of brown trout and mountain whitefish spawning periods. No redds were identified within the surveyed reach. Suitable mountain whitefish spawning habitat was identified and kicked sampled for mountain whitefish eggs. Six locations within the upstream extent of Site 1 (i.e., upstream of the Cushing Bridge) were sampled and mountain whitefish eggs were observed at each location (**Figure 2**, and Attachment A, Photos 42 to 43).

Photo 42: Mountain whitefish eggs collected in the Bow River on December 2, 2020.

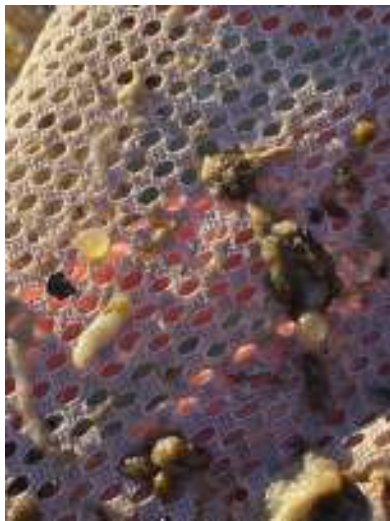
Photo 43: Mountain whitefish eggs collected in the Bow River on December 2, 2020.

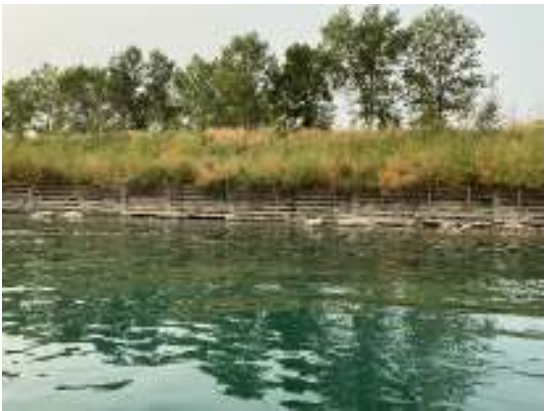
Photo 5: Photo taken at Site 1, view of fish shelters and boulder clusters.

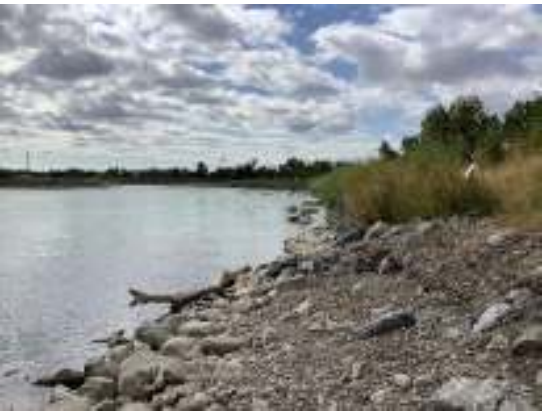
Photo 6: Photo taken at Site 1, view downstream of fish shelters and boulder clusters.

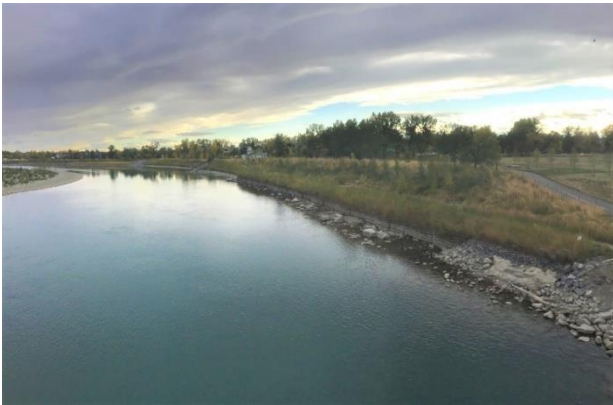
Photo E-1: Site 1 from 17th AVE SE BRT bridge (looking downstream)

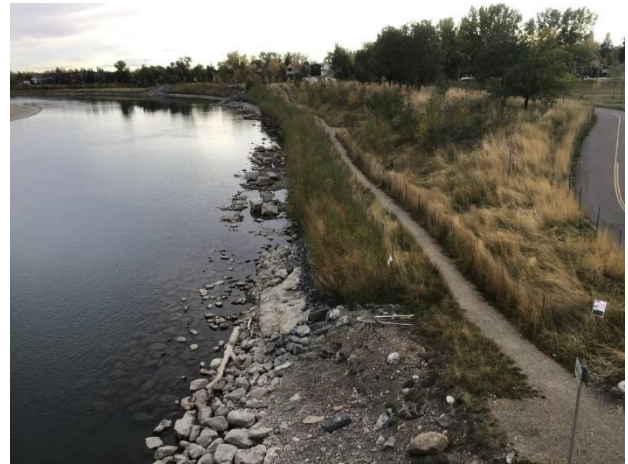
Photo E-2: Site 1 Vegetated Timber Crib wall and wildlife corridor from 17th AVE SE BRT bridge (looking downstream)

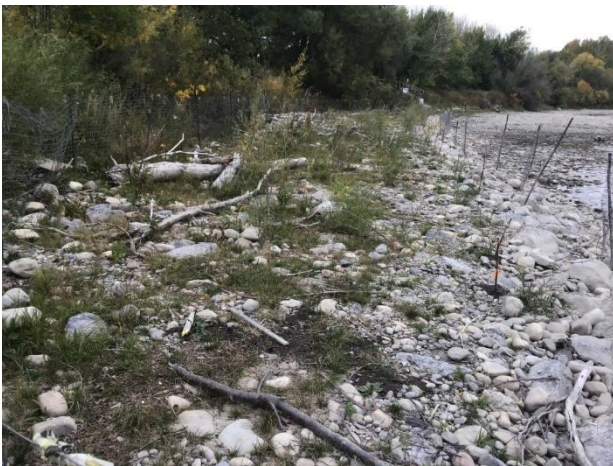
Photo E-3: Site 1 vegetated riprap with rooted live cuttings wildlife corridor upstream of Cushing bridge (looking upstream)

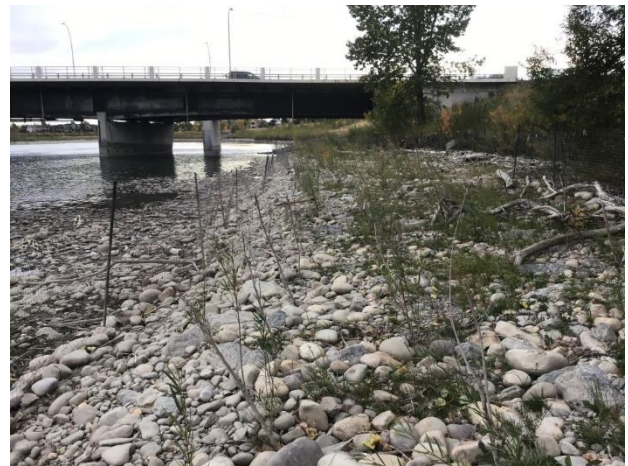
Photo E-4: Site 1 vegetated riprap with rooted live cuttings wildlife corridor upstream of Cushing bridge (looking downstream)

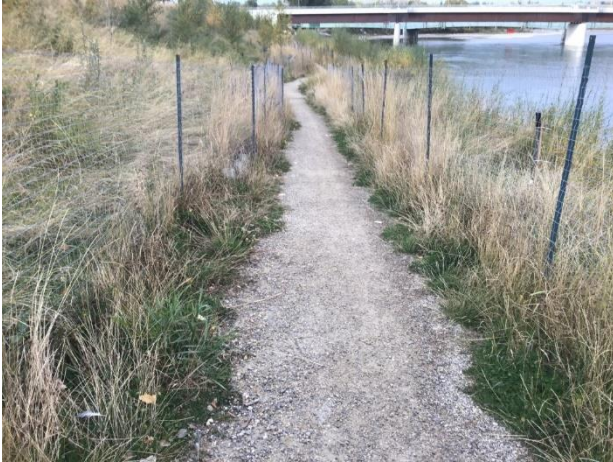
Photo E-5: Site 1 wildlife trail (looking north)

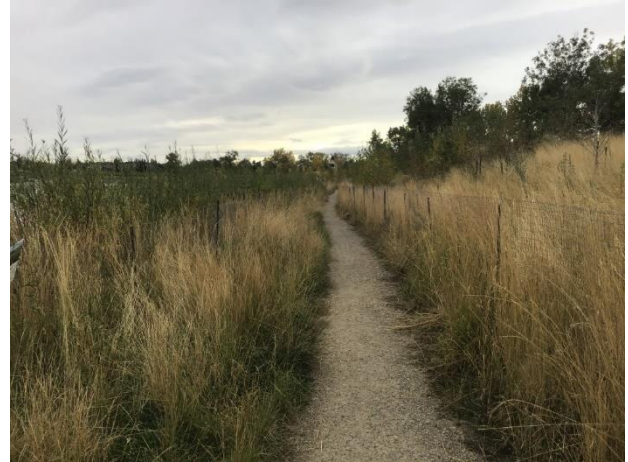
Photo E-6: Site 1 wildlife trail (looking south)

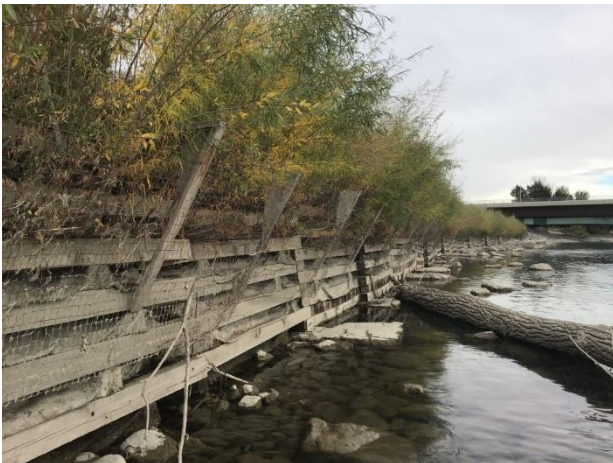
Photo E-7: Site 1 Vegetated timber crib wall (looking upstream)

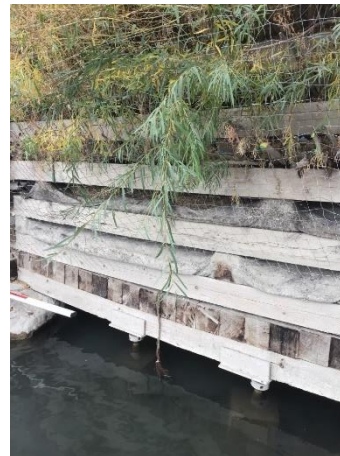
Photo E-8: Site 1 Vegetated timber crib wall – willow roots extending down into the river

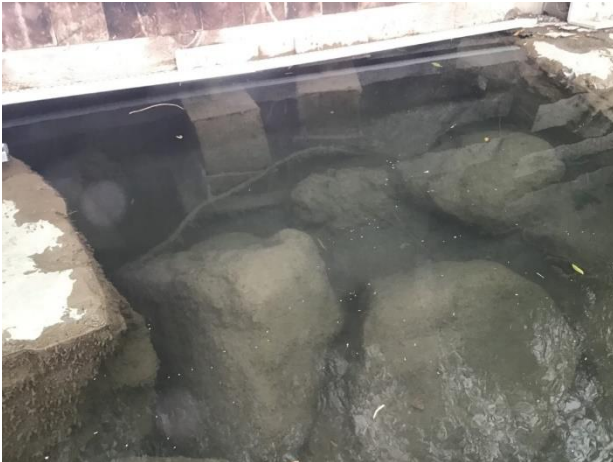
Photo E-9: Site 1 fish shelter

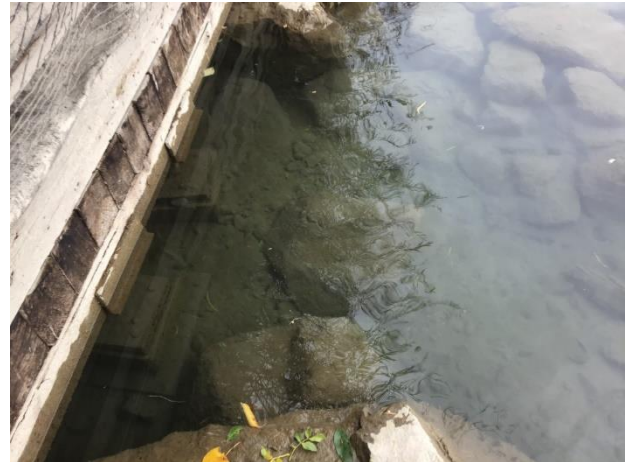
Photo E-10: Site 1 fish shelter

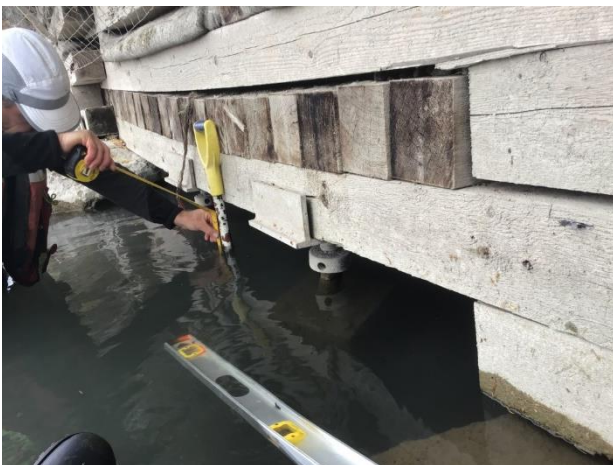
Photo E-11: Site 1 measuring sediment deposition in the fish shelters

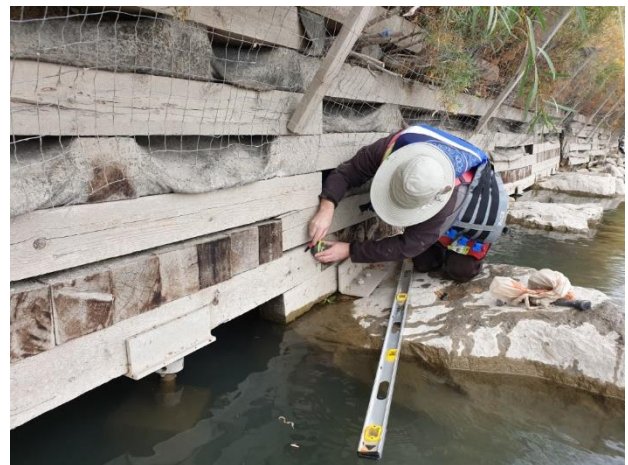
Photo E-12: Site 1 setting up spanning timber member deflection measurement points

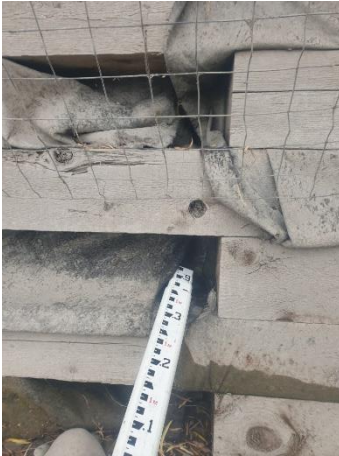
Photo E-13: Site 1 gap in containment materials in the vegetated timber crib wall

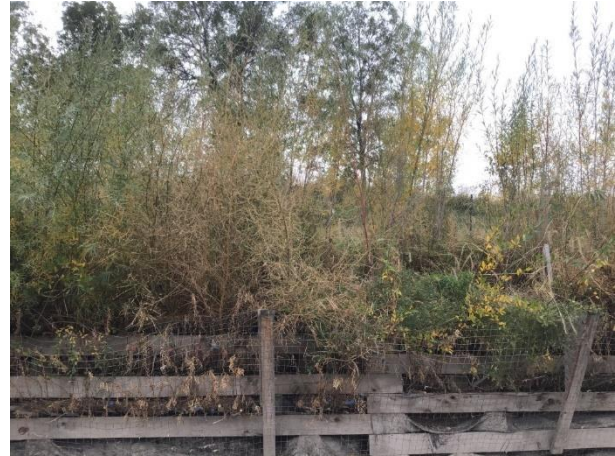
Photo E-14: Site 1 timber crib wall vegetation – note alfalfa and clover infestations

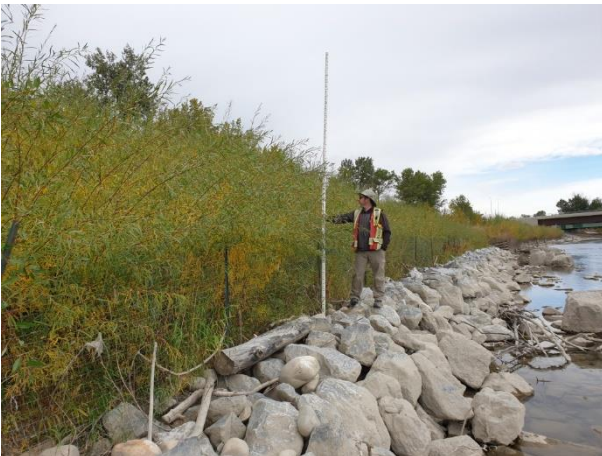
Photo E-15: Site 1 brush mattress with rock toe -note very good establishment (looking upstream)

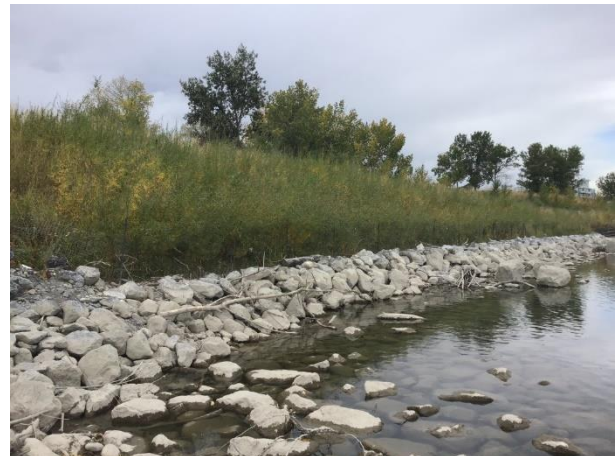
Photo E-16: Site 1 brush mattress with rock toe -note very good establishment (looking west)

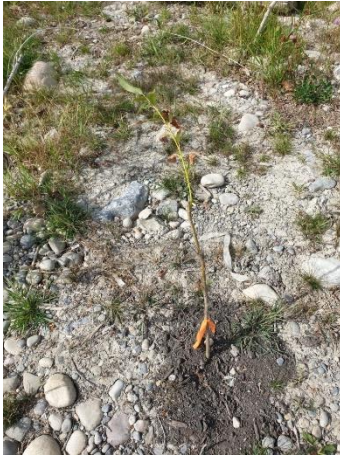
Photo E-17: Site 1 replanted live cuttings in vegetated riprap upstream of Cushing Bridge

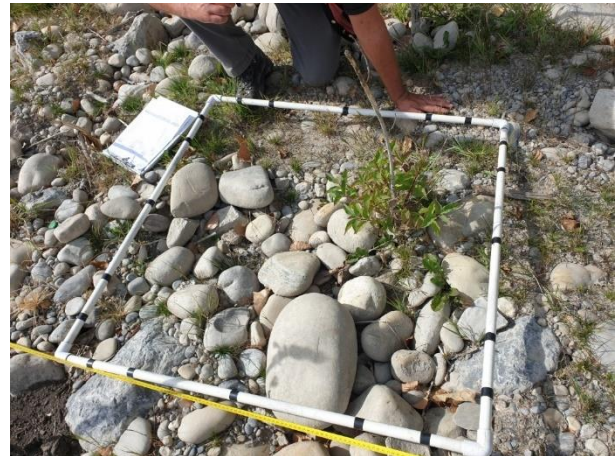
Photo E-18: Site 1 vegetated riprap with rooted long cuttings quadrat assessment

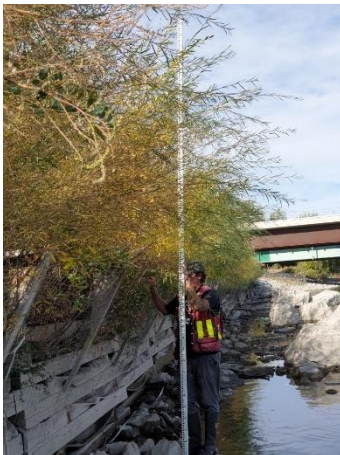
Photo E-19: Site 1 overhanging cover at vegetated timber crib wall (looking upstream)

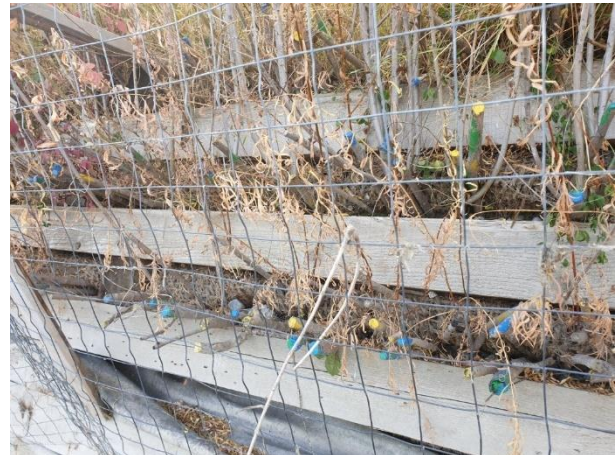
Photo E-20: Site 1 dead cuttings in timber crib wall

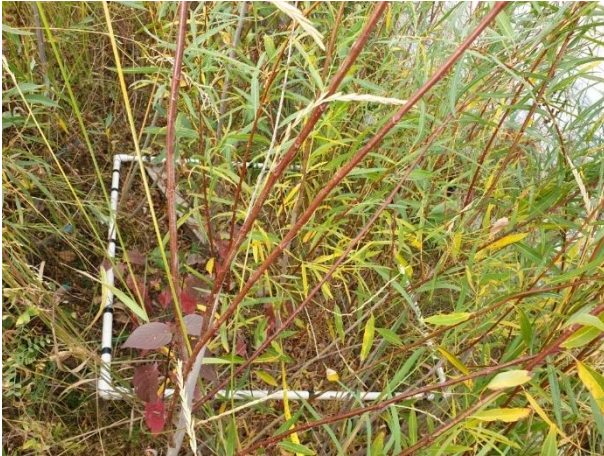
Photo E-21: Site 1 quadrat in vegetated soil wraps

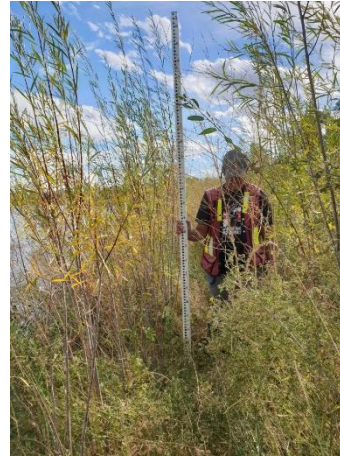
Photo E-22: Site 1 vegetation assessment in vegetated soil wraps

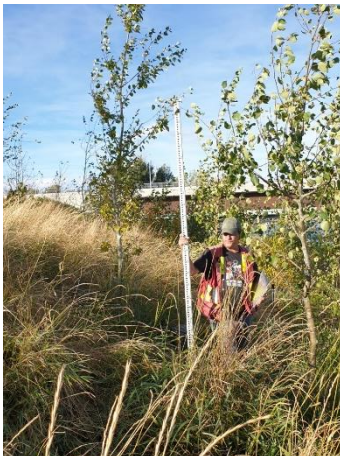
Photo E-23: Site 1 vegetation assessment in wildlife corridor

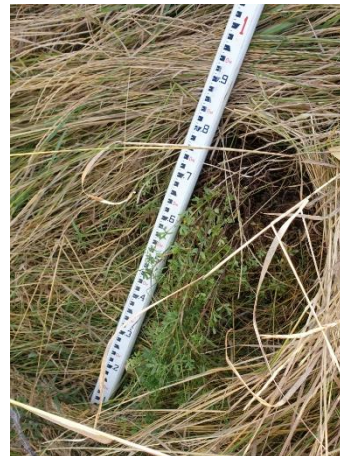
Photo E-24: Site 1 vegetation assessment in wildlife corridor – note thick herbaceous vegetation cover over planted shrub

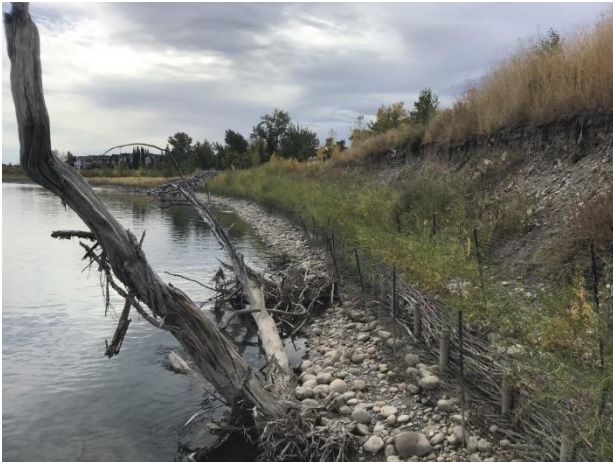
Photo E-25: Site 2 from upstream groyne (looking downstream)

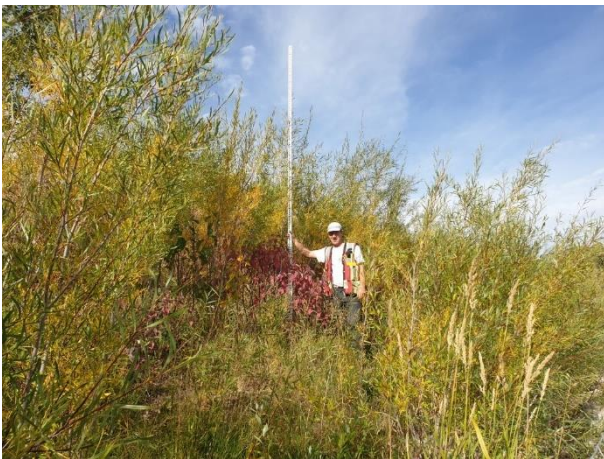
Photo E-31: Site 2 hedge brush layer establishment

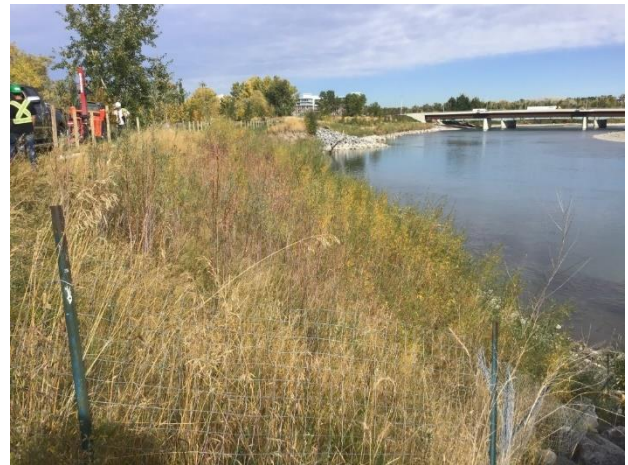
Photo E-32: Site 2 from downstream groyne (looking upstream)

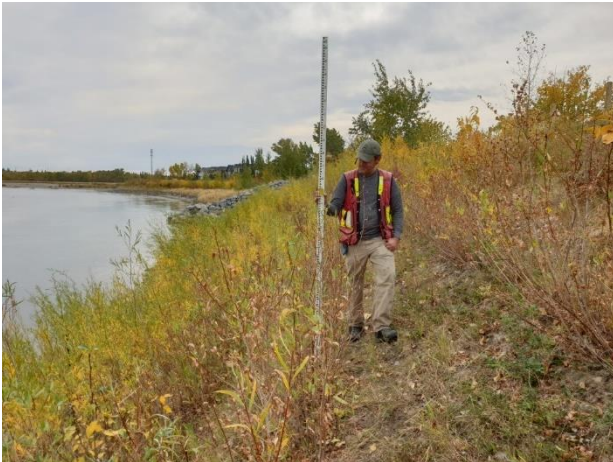
Photo E-33: Site 2 vegetation assessment in the contour fascines

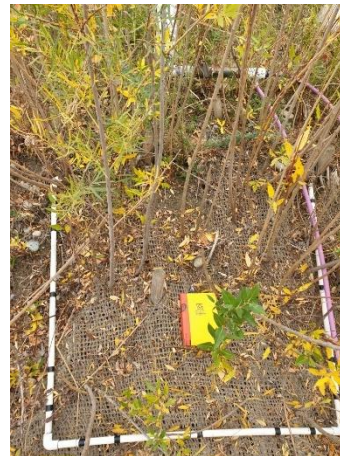
Photo E-34: Site 2 quadrat assessment in the brush mattress

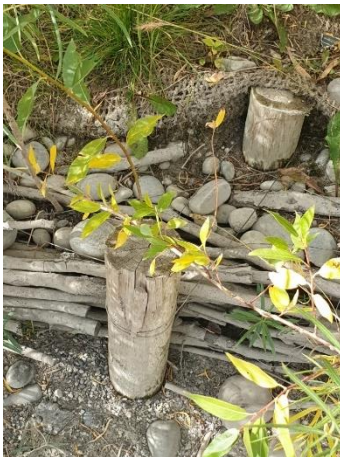
Photo E-35: Site 2 box fascine vegetation assessment

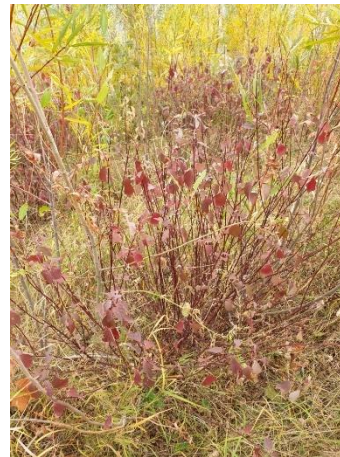
Photo E-36: Site 2 red osier dogwood establishment in the hedge brush layer

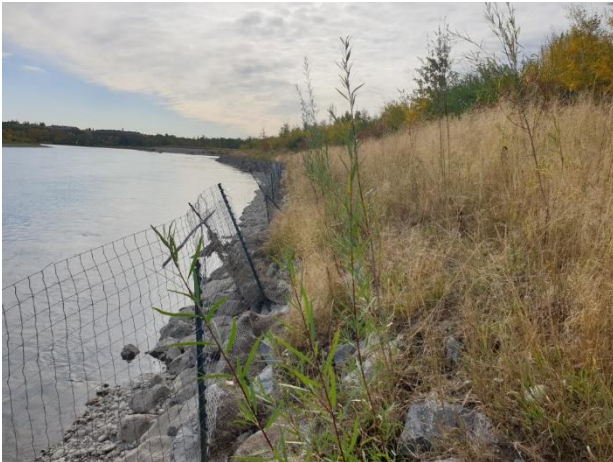
Photo E-37: Site 4 – note heavy herbaceous growth (looking downstream)

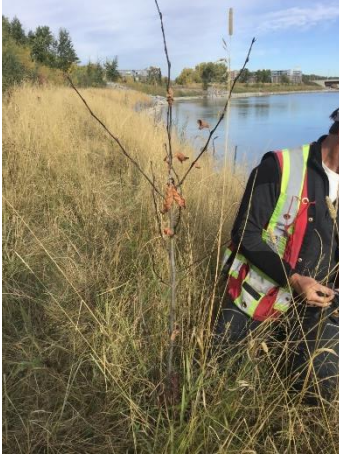
Photo E-41: Site 4 desiccated Balsam poplar

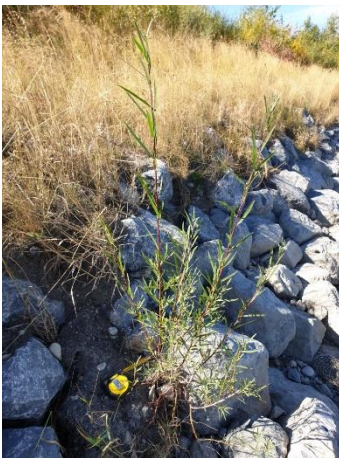
Photo E-43: Site 4 live cutting established around riprap (looking upstream)

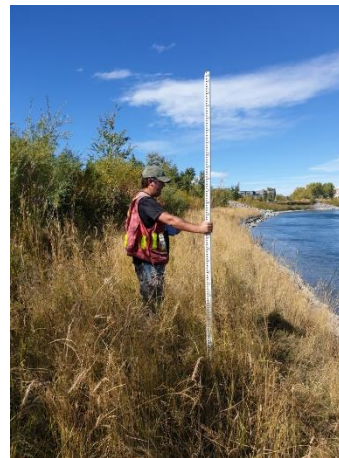
Photo E-44: Site 4 vegetation establishment (looking upstream)
